Defect Listing

Pipe Segment Refere... A44-5A_A44-5	City Oliver Springs	Street 632 Hen Valley Rd.	Material Concrete Pipe (non-...	Location C... Light High...	Sewer Use Sanitary
Upstream MH A44-5A	Total Length 307	Year Laid	Shape Circular	Location Details Burried in road not...	
DS Manhole A44-5	Length surveyed 307	Year Renewed	Height 8	Width 8	Pipe Joint... 4

SPR 180	MPR 9	PO Number 4397-03	Customer GRW
SPRI 3	MPRI 4.5	Work Order 4397-02	Purpose Pre-Rehabilitation Survey
QSR 3K00	QMR 5141		
OPR 189	Surveyed By Dustin	Direction Downstream	Date 20150807
OPRI 3	Certificate Number U-214-06020262	Pre-Cleaning Jetting	Time 10:38
	Date Cleaned 20150807	End Time 10:59	Weather Dry
			Media label
			Additional Info

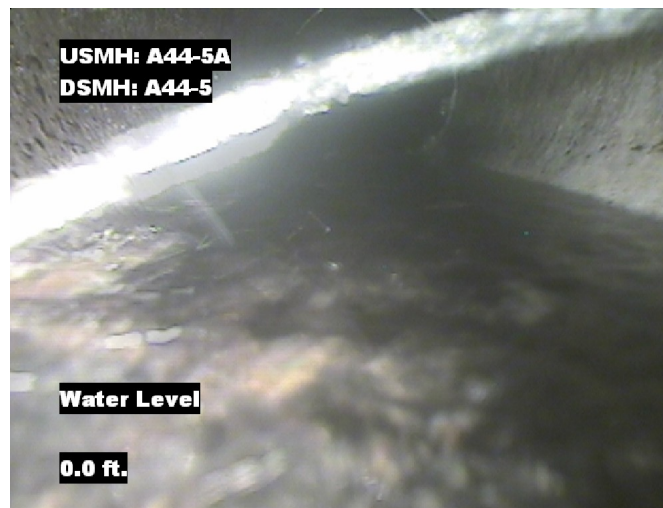
Distance: 0.0 ft. Grade: 0
Condition: Water Level
Remarks: N/A

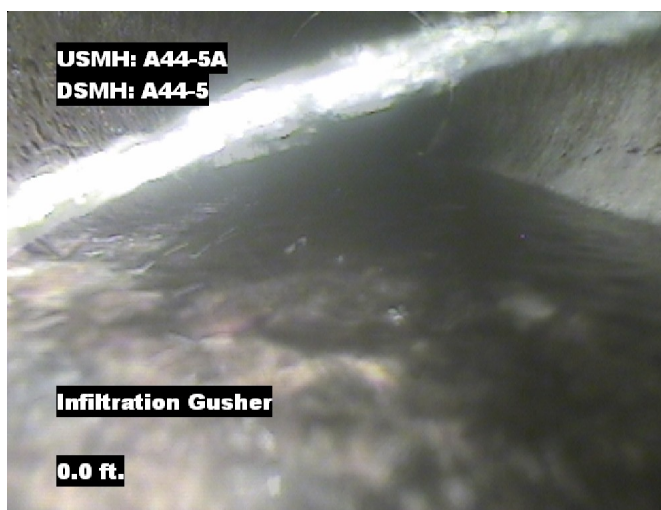
Distance: 0.0 ft. Grade: 5
Condition: Infiltration Gusher
Remarks: N/A

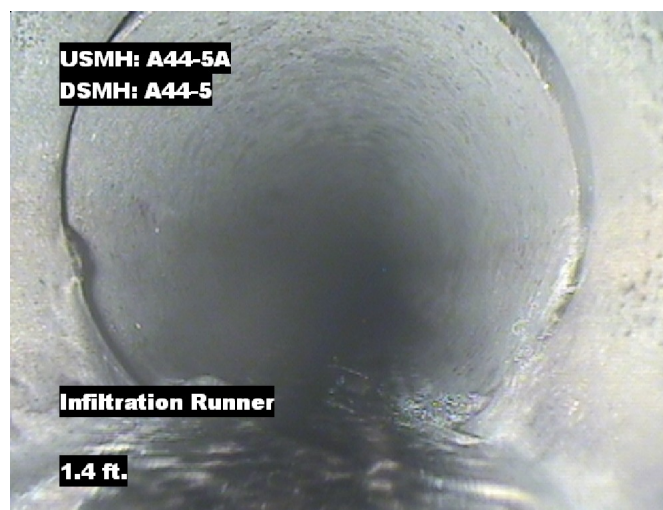
Distance: 1.4 ft. Grade: 4
Condition: Infiltration Runner
Remarks: N/A

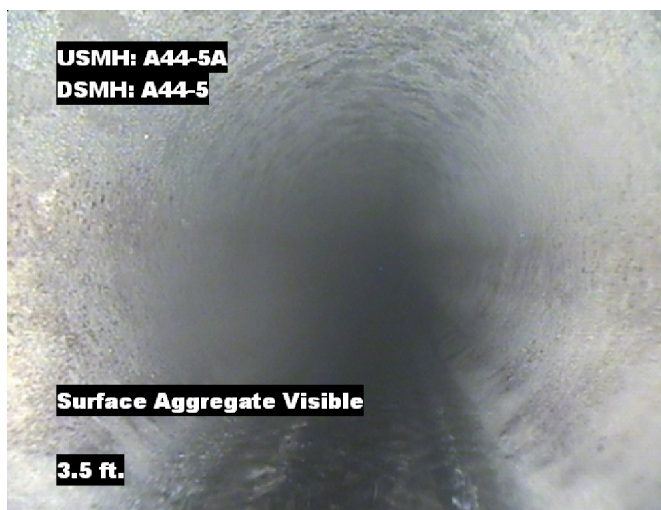
Distance: 3.5 ft. Grade: 3
Condition: Surface Aggregate Visible
Remarks: N/A

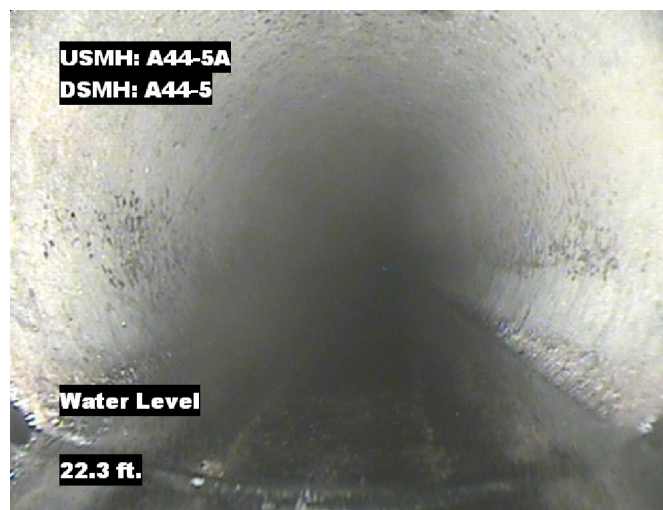
Distance: 22.3 ft. Grade: 0
Condition: Water Level
Remarks: N/A

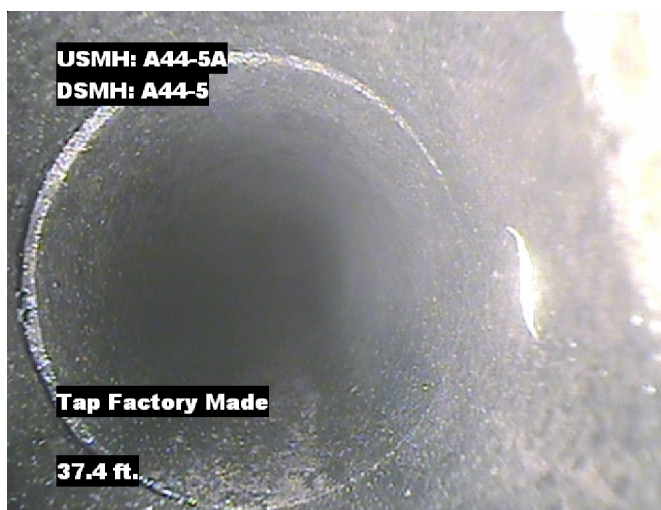
Distance: 37.4 ft. Grade: 0
Condition: Tap Factory Made
Remarks: N/A

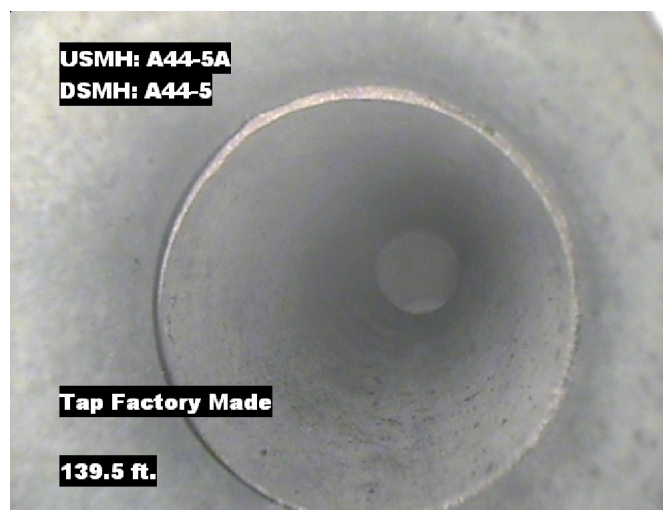
Distance: 139.5 ft. Grade: 0
Condition: Tap Factory Made
Remarks: N/A

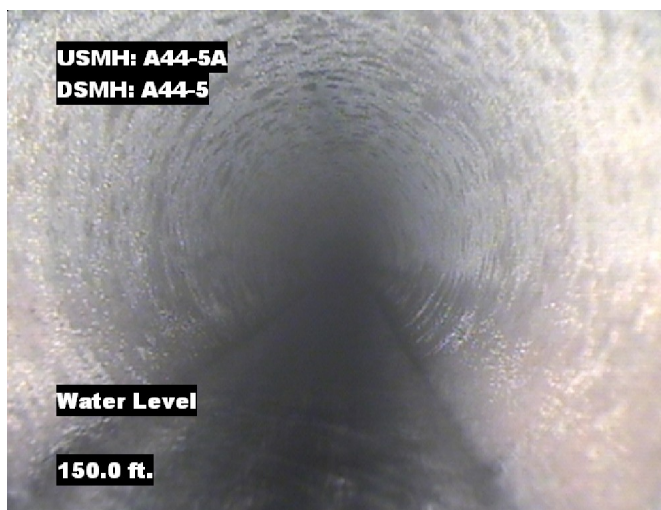
Distance: 150.0 ft. Grade: 0
Condition: Water Level
Remarks: N/A

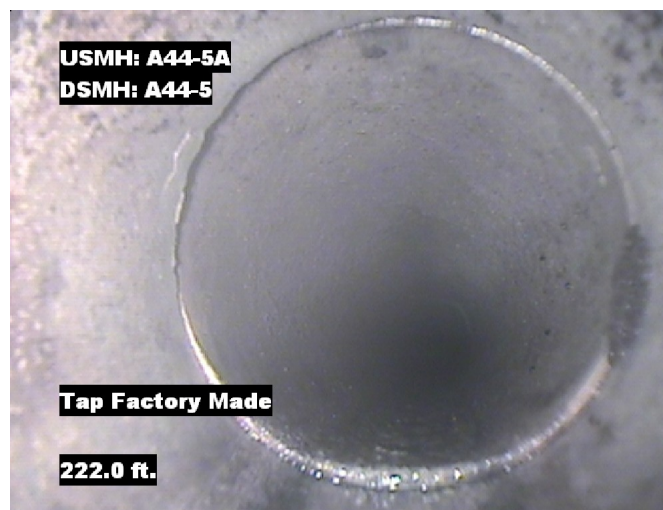
Distance: 222.0 ft. Grade: 0
Condition: Tap Factory Made
Remarks: N/A

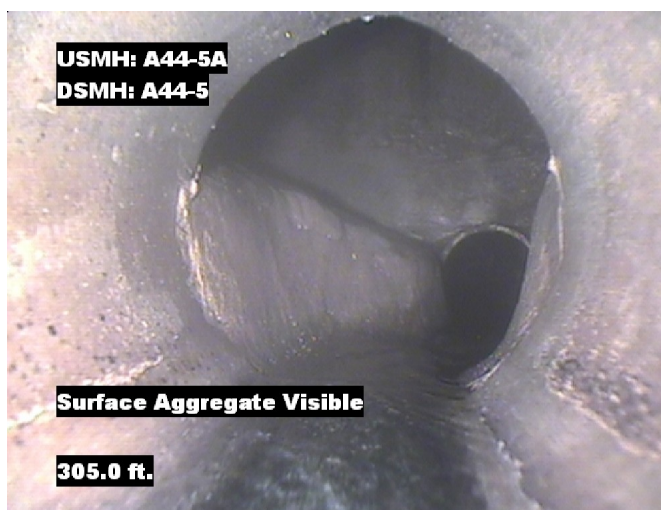
Distance: 305.0 ft. Grade: 3
Condition: Surface Aggregate Visible
Remarks: N/A

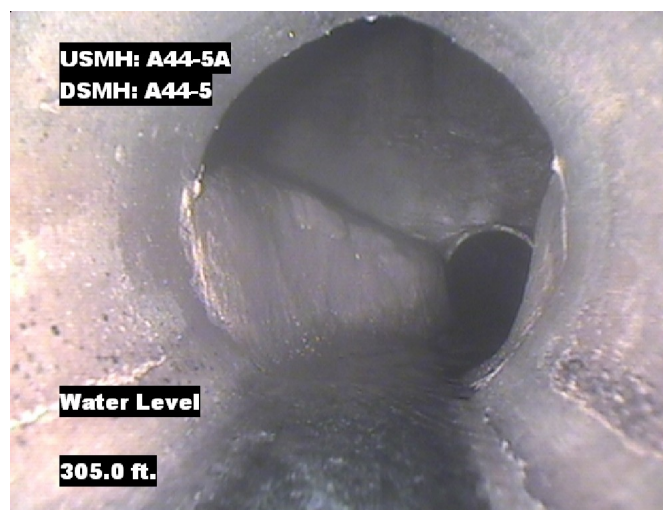
Distance: 305.0 ft. Grade: 0
Condition: Water Level
Remarks: N/A
