Defect Listing

Pipe Segment Refere... A44-6_A44-5A	City Oliver Springs	Street 632 Hen Valley Rd.	Material Concrete Pipe (non-...	Location C... Light High...	Sewer Use Sanitary
Upstream MH A44-6	Total Length 204.4	Year Laid	Shape Circular	Location Details Middle of the road	
DS Manhole A44-5A	Length surveyed 204.4	Year Renewed	Height 8	Width 8	Pipe Joint... 4

SPR N/A	MPR 5	PO Number 4397-03	Customer GRW
SPRI N/A	MPRI 5	Work Order 4397-02	Purpose Pre-Rehabilitation Survey
QSR N/A	QMR 5100		
OPR 5	Surveyed By Dustin	Direction Downstream	Date 20150807
OPRI 5	Certificate Number U-214-06020262	Pre-Cleaning Jetting	Time 10:11
	Date Cleaned 20150807	End Time 10:31	Weather Dry
			Media label
			Additional Info

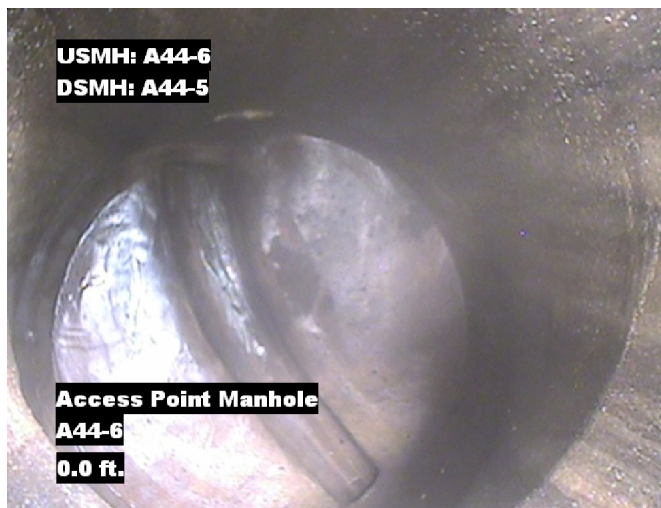
Distance: 0.0 ft. Grade: 0
Condition: Access Point Manhole
Remarks: A44-6

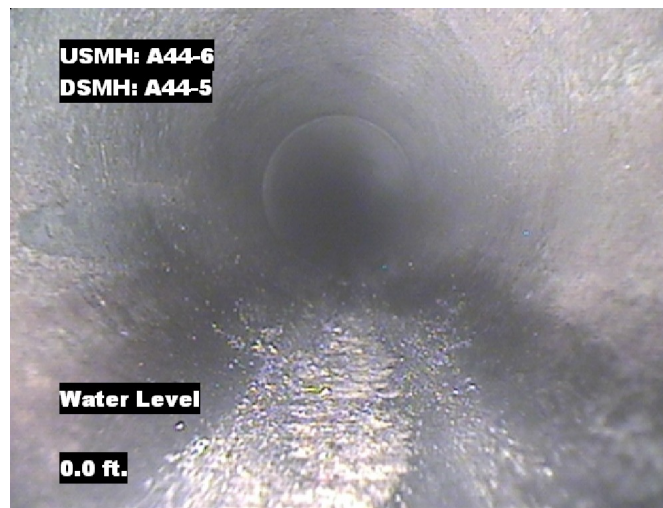
Distance: 0.0 ft. Grade: 0
Condition: Water Level
Remarks: N/A

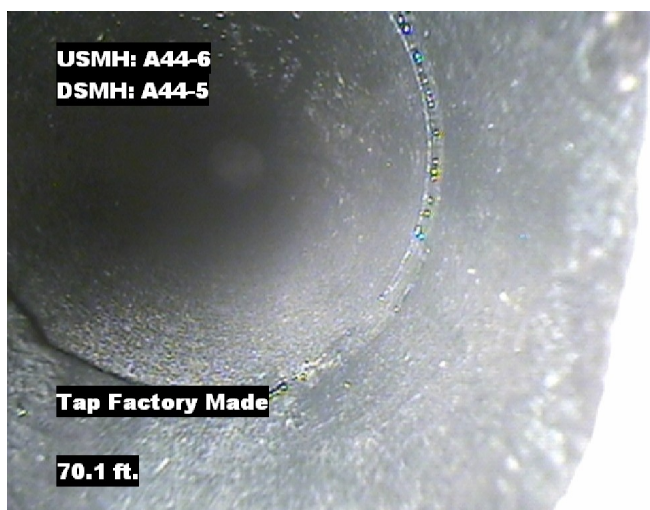
Distance: 70.1 ft. Grade: 0
Condition: Tap Factory Made
Remarks: N/A

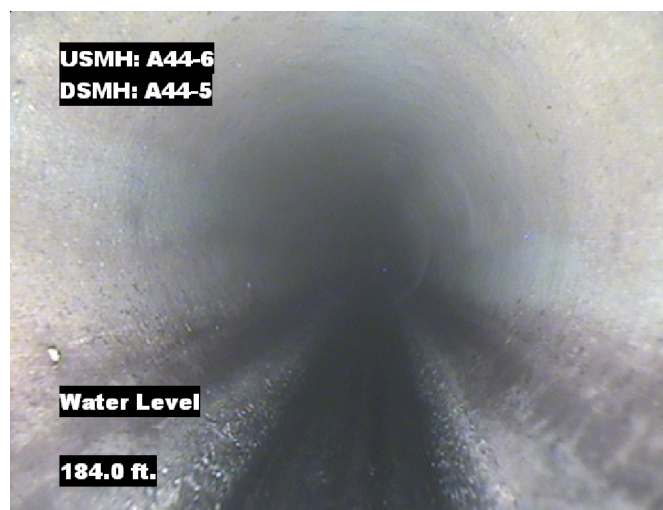
Distance: 184.0 ft. Grade: 0
Condition: Water Level
Remarks: N/A

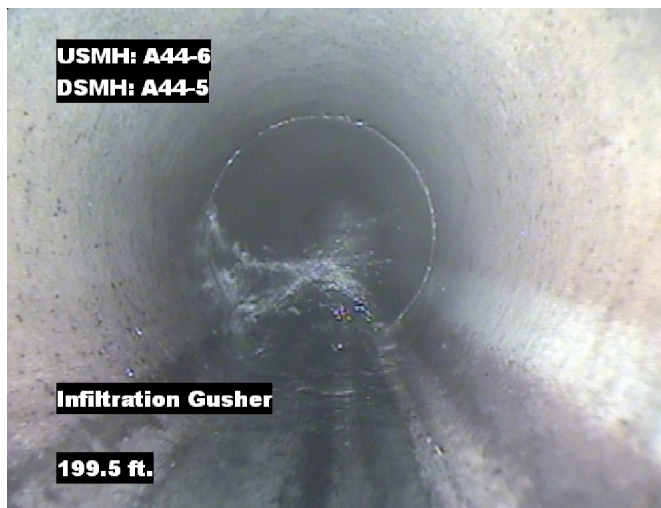
Distance: 199.5 ft. Grade: 5
Condition: Infiltration Gusher
Remarks: N/A

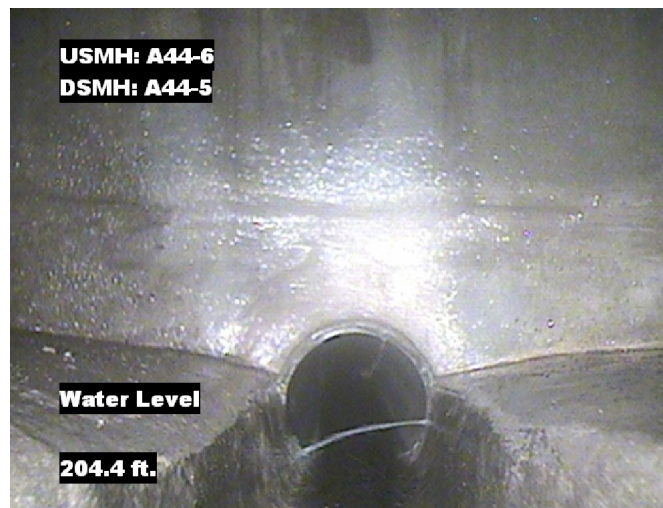
Distance: 204.4 ft. Grade: 0
Condition: Water Level
Remarks: N/A

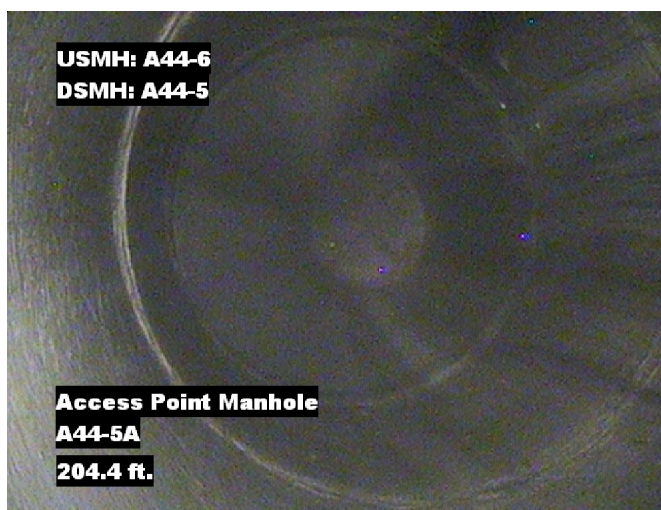
Distance: 204.4 ft. Grade: 0
Condition: Access Point Manhole
Remarks: A44-5A
