Defect Listing

Pipe Segment Refere... A5-3_A5-2	City Oliver Springs	Street Wright Dr	Material Concrete Pipe (non-...	Location C... Easement/R...	Sewer Use Sanitary
Upstream MH A5-3	Total Length 215.7	Year Laid	Shape Circular	Location Details	
DS Manhole A5-2	Length surveyed 215.7	Year Renewed	Height 8	Width 8	Pipe Joint... 4

SPR 3	MPR N/A	PO Number 4397-03	Customer GRW
SPRI 3	MPRI N/A	Work Order 4397-02	Purpose Pre-Rehabilitation Survey
QSR 3100	QMR N/A		
OPR 3	Surveyed By Charlie Gordon	Direction Upstream	Date 20150824
OPRI 3	Certificate Number U-615-07000491	Pre-Cleaning Jetting	Time 14:18
	Date Cleaned 20150824	End Time 14:34	Weather Dry
			Media label
			Additional Info

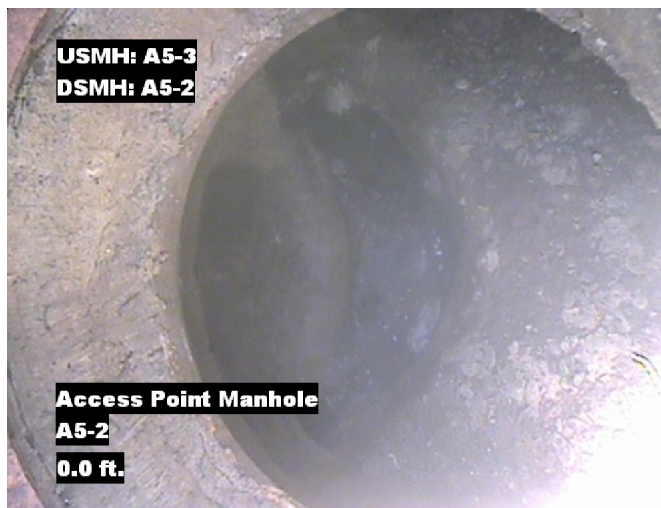
Distance: 0.0 ft. Grade: 0
Condition: Access Point Manhole
Remarks: A5-2

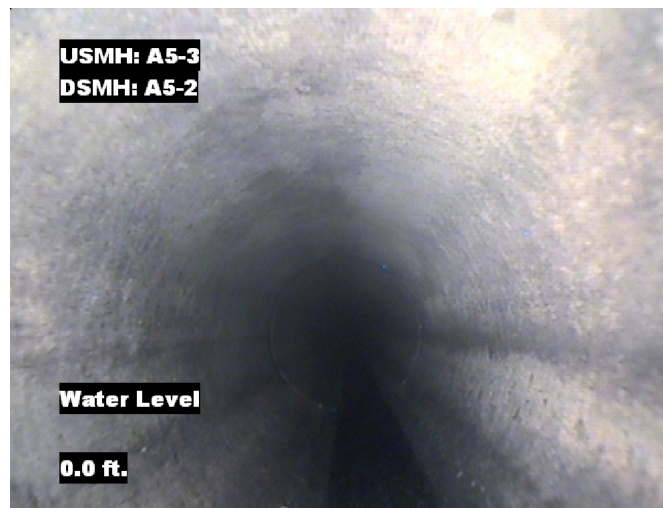
Distance: 0.0 ft. Grade: 0
Condition: Water Level
Remarks: N/A

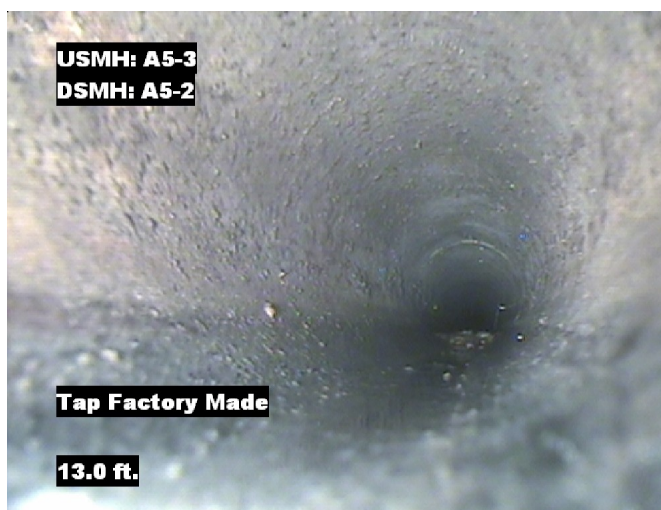
Distance: 13.0 ft. Grade: 0
Condition: Tap Factory Made
Remarks: N/A

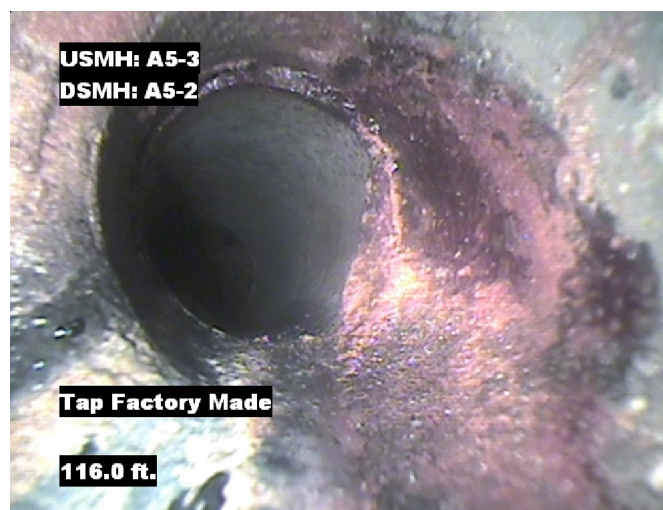
Distance: 116.0 ft. Grade: 0
Condition: Tap Factory Made
Remarks: N/A

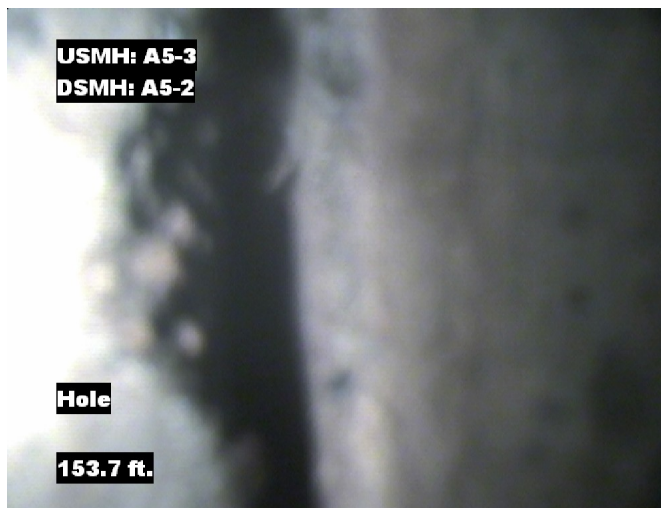
Distance: 153.7 ft. Grade: 3
Condition: Hole
Remarks: N/A

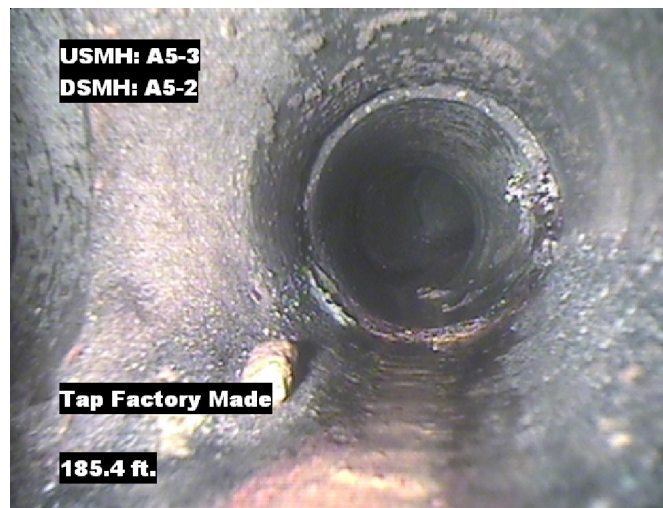
Distance: 185.4 ft. Grade: 0
Condition: Tap Factory Made
Remarks: N/A

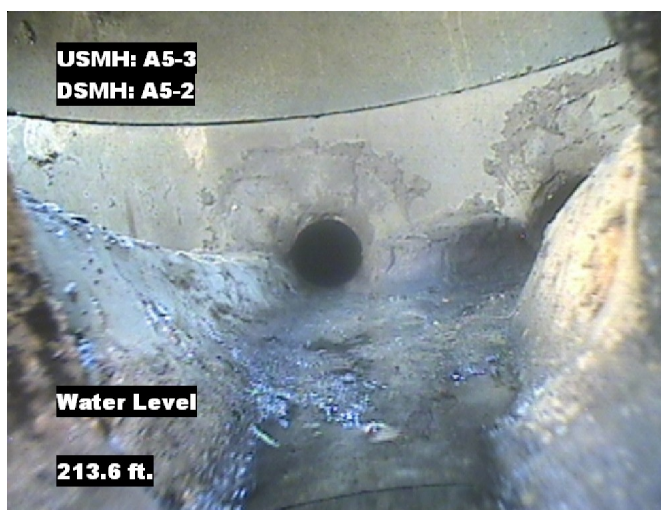
Distance: 213.5 ft. Grade: 0
Condition: Water Level
Remarks: N/A

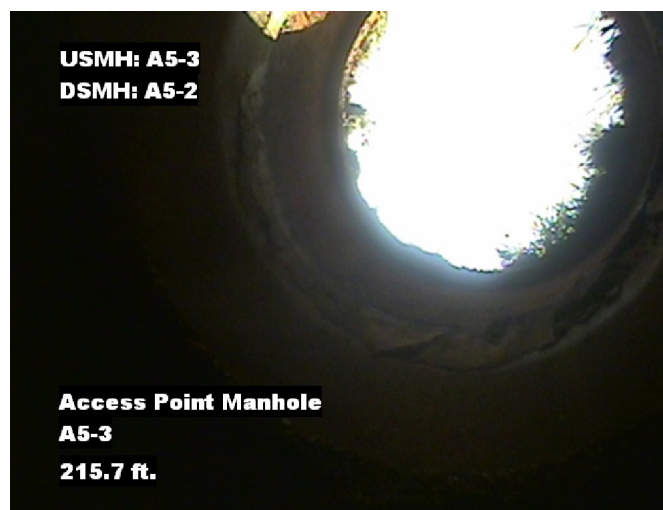
Distance: 215.7 ft. Grade: 0
Condition: Access Point Manhole
Remarks: A5-3
