Defect Listing

Pipe Segment Refere... A6-1_A-46	City Oliver Springs	Street Main St.	Material Fibreglass Reinforc...	Location C... Creek	Sewer Use Sanitary
Upstream MH A6-1	Total Length 11	Year Laid	Shape Circular	Location Details	
DS Manhole A-46	Length surveyed 11	Year Renewed	Height 8	Width 8	Pipe Joint... N/A

SPR N/A	MPR 4	PO Number 4397-03		Customer GRW	
SPRI N/A	MPRI 4	Work Order 4397-02		Purpose Pre-Rehabilitation Survey	
QSR N/A	QMR 4100				
OPR 4	Surveyed By Charlie_Gordon	Direction Downstream	Date 20150902	Media label	
OPRI 4	Certificate Number U-615-07000491	Pre-Cleaning No Pre-Cleaning	Time 07:07	Weather Dry	
Date Cleaned			End Time 07:12	Additional Info DEPOSITS UNDERWATER..

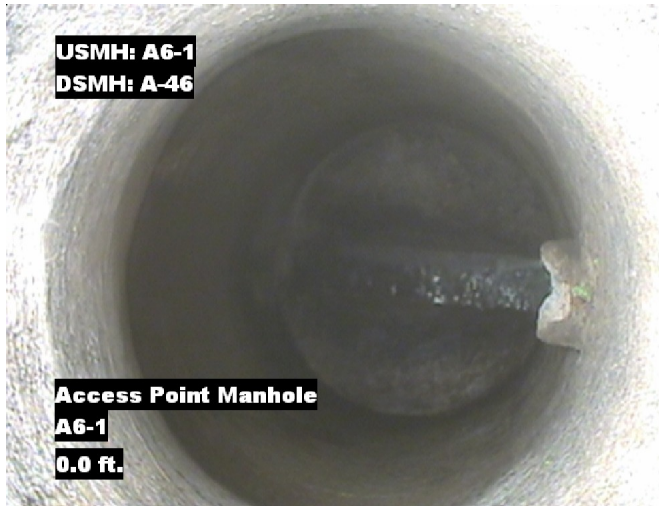
Distance: 0.0 ft. Grade: 0
Condition: Access Point Manhole
Remarks: A6-1

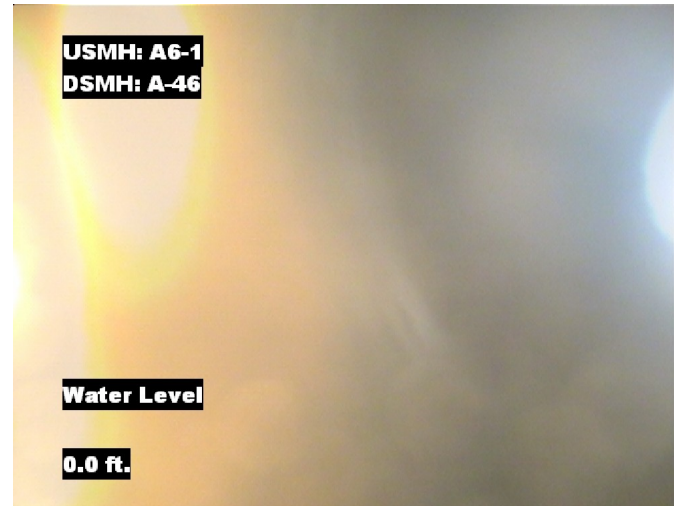
Distance: 0.0 ft. Grade: 0
Condition: Water Level
Remarks: N/A
