## Defect Listing

Pipe Segment Refere... <b>A6-10_A6-9</b>	City <b>Oliver Springs</b>	Street <b>61 Highway</b>	Material <b>Fibreglass Reinforc...</b>	Location C... <b>Main Highw...</b>	Sewer Use <b>Sanitary</b>
Upstream MH <b>A6-10</b>	Total Length <b>266.8</b>	Year Laid	Shape <b>Circular</b>	Location Details	
DS Manhole <b>A6-9</b>	Length surveyed <b>266.8</b>	Year Renewed	Height <b>8</b>	Width <b>8</b>	Pipe Joint... <b>N/A</b>

SPR <b>N/A</b>	MPR <b>N/A</b>	PO Number <b>4397-03</b>		Customer <b>GRW</b>	
SPRI <b>N/A</b>	MPRI <b>N/A</b>	Work Order <b>4397-02</b>		Purpose <b>Pre-Rehabilitation Survey</b>	
QSR <b>N/A</b>	QMR <b>N/A</b>				
OPR <b>N/A</b>	Surveyed By <b>Barry Rogers</b>	Direction <b>Downstream</b>	Date <b>20150810</b>	Media label	
OPRI <b>N/A</b>	Certificate Number <b>U-1012-16405</b>	Pre-Cleaning <b>Jetting</b>	Time <b>14:11</b>	Weather <b>Dry</b>	
Date Cleaned <b>20150810</b>			End Time <b>14:25</b>	Additional Info

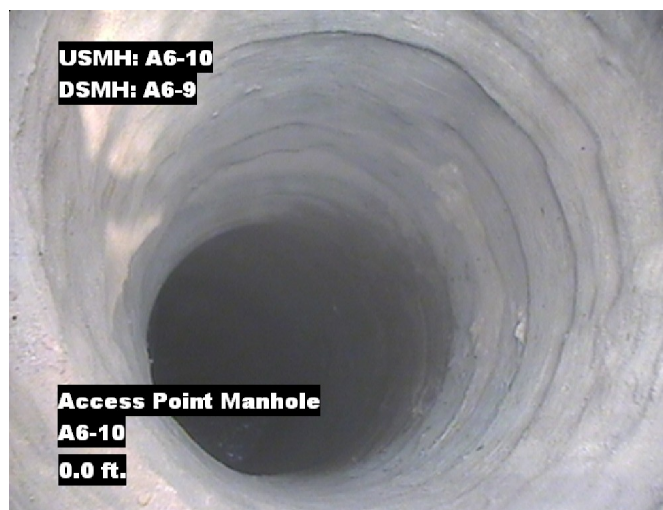
Distance: 0.0 ft. Grade: 0  
Condition: Access Point Manhole  
Remarks: A6-10

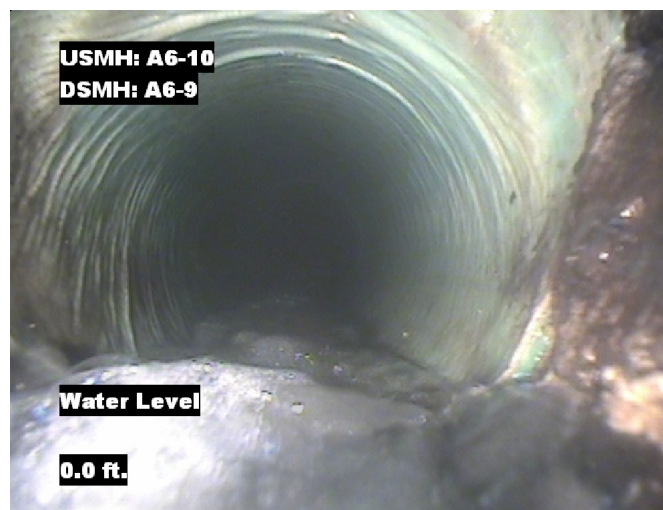
Distance: 0.0 ft. Grade: 0  
Condition: Water Level  
Remarks: N/A

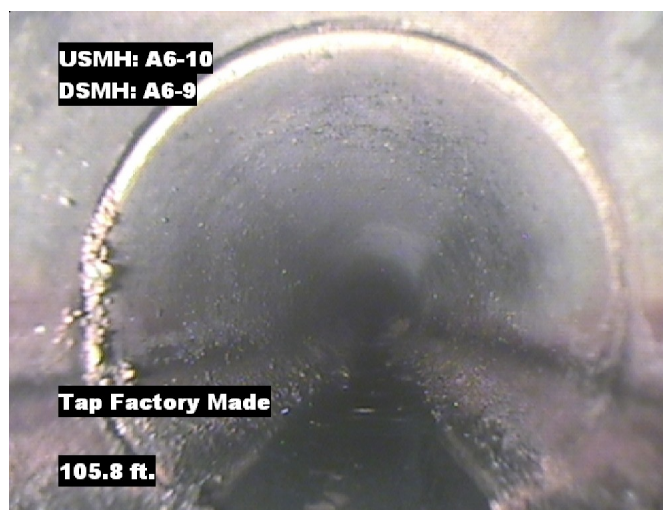
Distance: 105.8 ft. Grade: 0  
Condition: Tap Factory Made  
Remarks: N/A

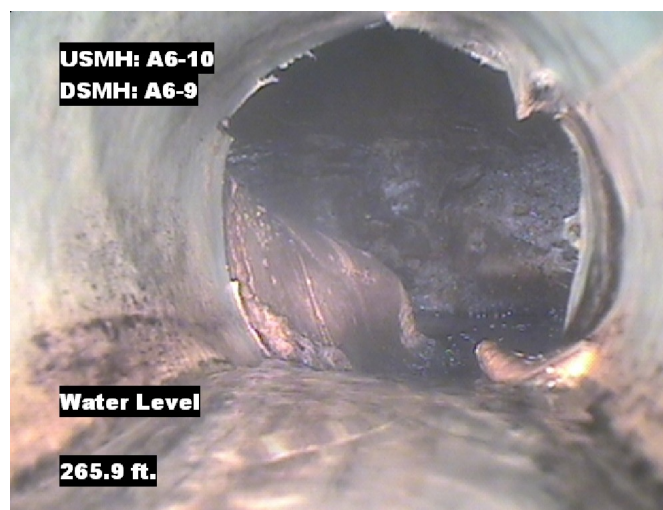
Distance: 265.9 ft. Grade: 0  
Condition: Water Level  
Remarks: N/A

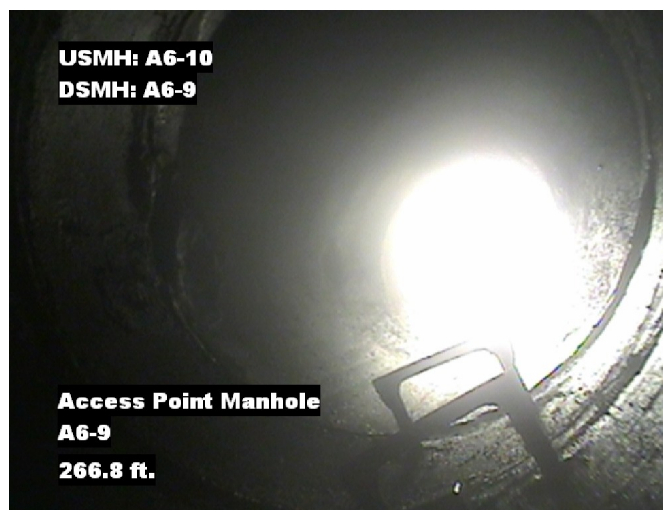
Distance: 266.8 ft.      Grade: 0  
Condition: Access Point Manhole  
Remarks: A6-9
