Defect Listing

Pipe Segment Refere... A6-11_A6-10	City Oliver Springs	Street Highway 61	Material Concrete Pipe (non-...	Location C... Main Highw...	Sewer Use Sanitary
Upstream MH A6-11	Total Length 251.4	Year Laid	Shape Circular	Location Details	
DS Manhole A6-10	Length surveyed 251.4	Year Renewed	Height 8	Width 8	Pipe Joint... 4

SPR 6	MPR 7	PO Number 4397-03	Customer GRW
SPRI 3	MPRI 3.5	Work Order 4397-02	Purpose Pre-Rehabilitation Survey
QSR 5111	QMR 4131		
OPR 13	Surveyed By Charlie Gordon	Direction Downstream	Date 20150820
OPRI 3.3	Certificate Number U-615-07000491	Pre-Cleaning Jetting	Time 10:44
	Date Cleaned 20150820	End Time 11:04	Weather Light Rain
			Media label
			Additional Info

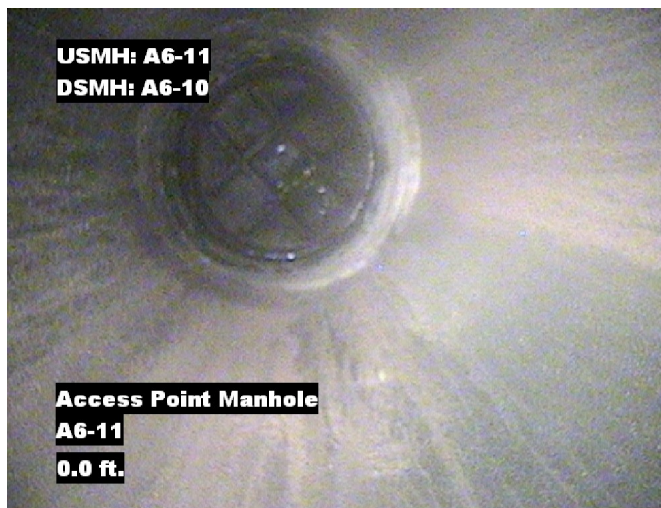
Distance: 0.0 ft. Grade: 0
Condition: Access Point Manhole
Remarks: A6-11

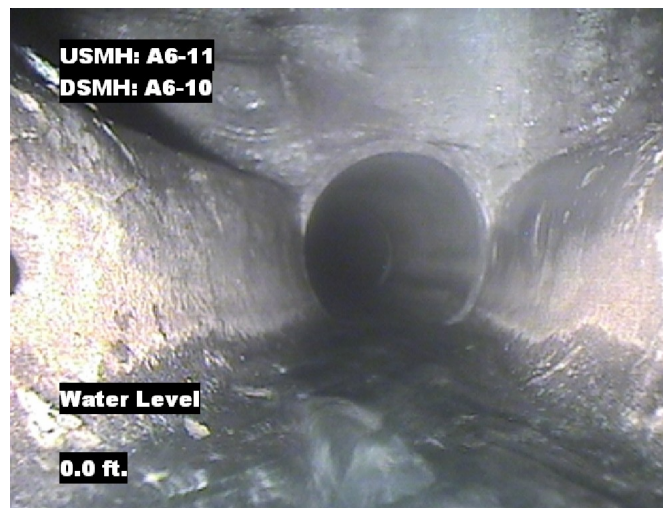
Distance: 0.0 ft. Grade: 0
Condition: Water Level
Remarks: N/A

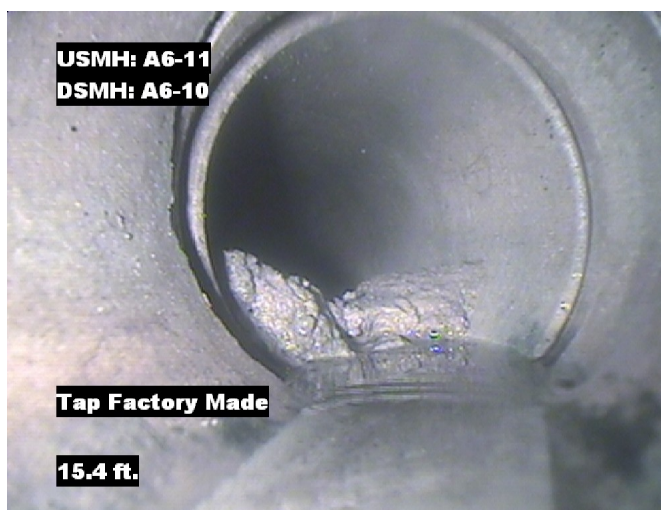
Distance: 15.4 ft. Grade: 0
Condition: Tap Factory Made
Remarks: N/A

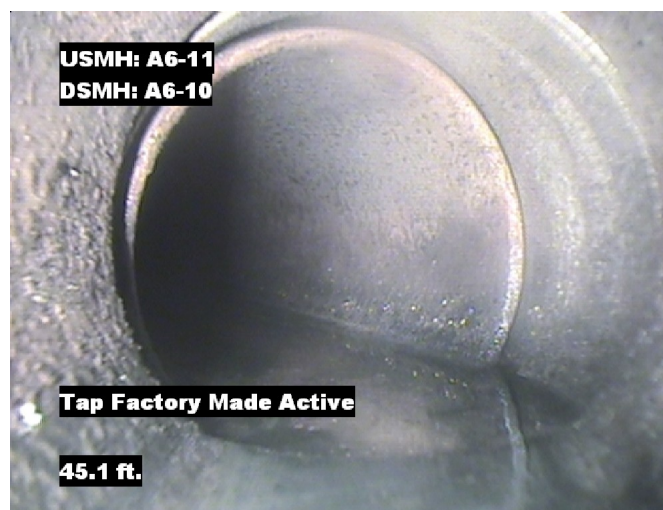
Distance: 45.1 ft. Grade: 0
Condition: Tap Factory Made Active
Remarks: N/A

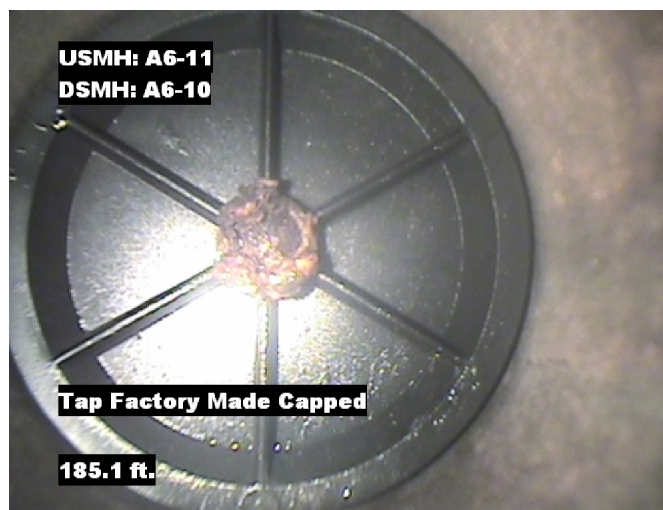
Distance: 185.1 ft. Grade: 0
Condition: Tap Factory Made Capped
Remarks: N/A

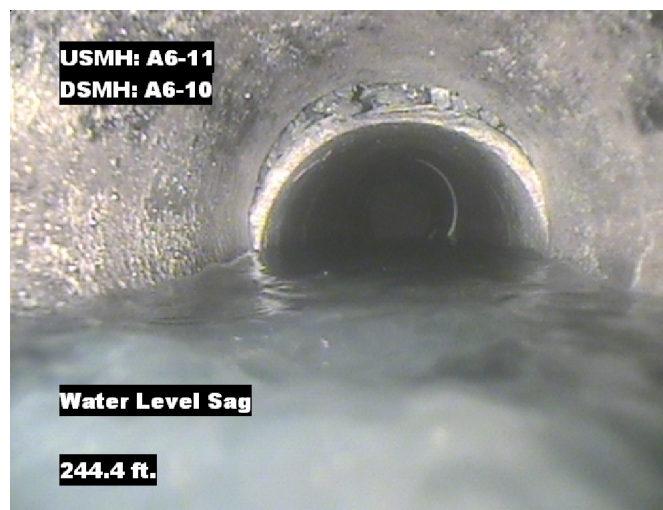
Distance: 244.4 ft. Grade: 3
Condition: Water Level Sag
Remarks: N/A

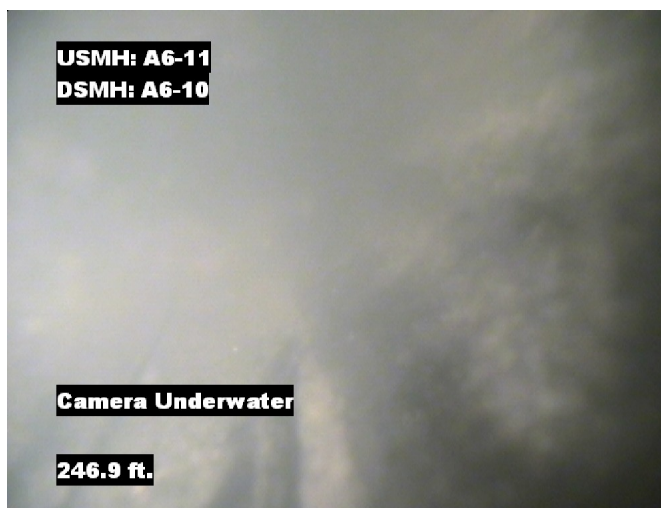
Distance: 246.9 ft. Grade: 4
Condition: Camera Underwater
Remarks: N/A

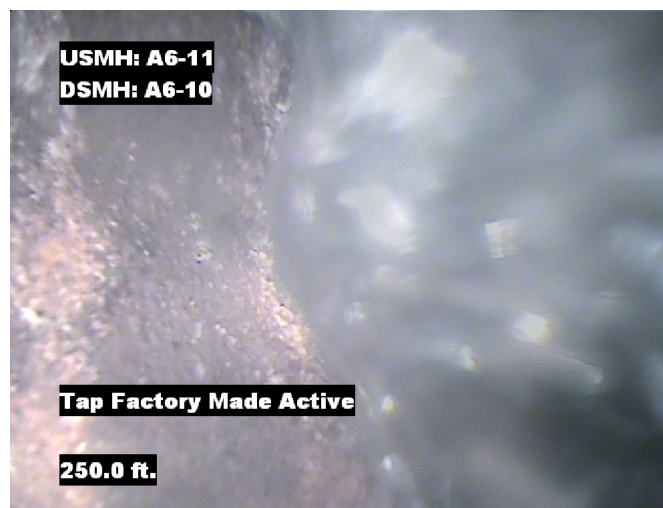
Distance: 250.0 ft. Grade: 0
Condition: Tap Factory Made Active
Remarks: N/A

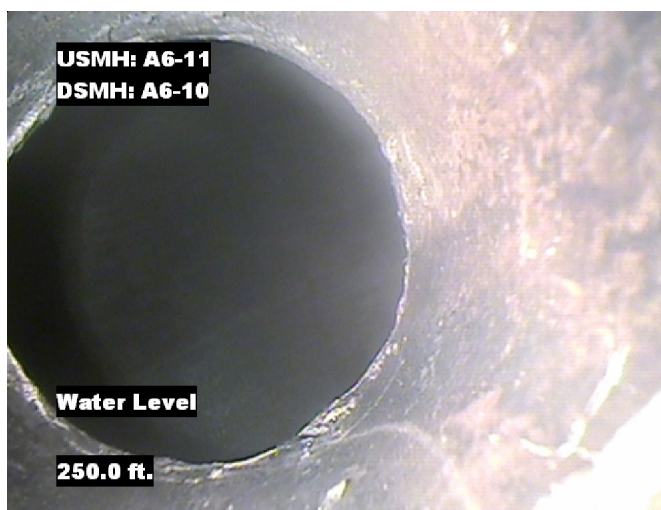
Distance: 250.0 ft. Grade: 0
Condition: Water Level
Remarks: N/A

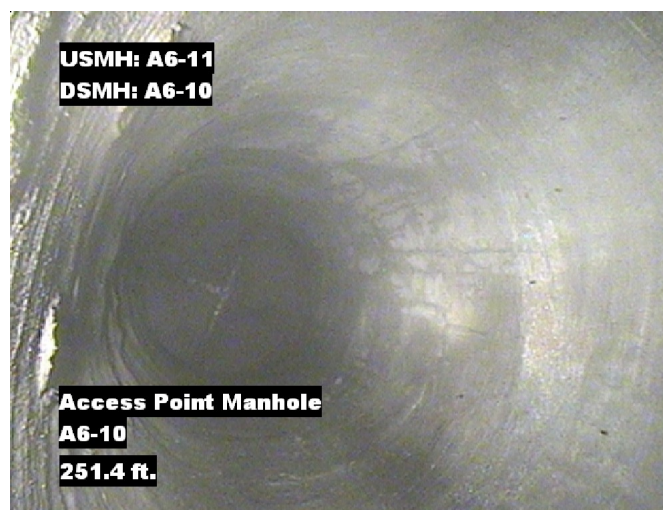
Distance: 251.4 ft. Grade: 0
Condition: Access Point Manhole
Remarks: A6-10
