## Defect Listing

Pipe Segment Refere... <b>A6-12_A6-11</b>	City <b>Oliver Springs</b>	Street <b>Highway 61</b>	Material <b>Concrete Pipe (non-...</b>	Location C... <b>Main Highw...</b>	Sewer Use <b>Sanitary</b>
Upstream MH <b>A6-12</b>	Total Length <b>253.7</b>	Year Laid	Shape <b>Circular</b>	Location Details	
DS Manhole <b>A6-11</b>	Length surveyed <b>253.7</b>	Year Renewed	Height <b>8</b>	Width <b>8</b>	Pipe Joint... <b>4</b>

SPR <b>N/A</b>	MPR <b>N/A</b>	PO Number <b>4397-03</b>	Customer <b>GRW</b>
SPRI <b>N/A</b>	MPRI <b>N/A</b>	Work Order <b>4397-02</b>	Purpose <b>Pre-Rehabilitation Survey</b>
QSR <b>N/A</b>	QMR <b>N/A</b>		
OPR <b>N/A</b>	Surveyed By <b>Charlie Gordon</b>	Direction <b>Downstream</b>	Date <b>20150820</b>
OPRI <b>N/A</b>	Certificate Number <b>U-615-07000491</b>	Pre-Cleaning <b>Jetting</b>	Time <b>10:28</b>
	Date Cleaned <b>20150820</b>	End Time <b>10:42</b>	Weather <b>Light Rain</b>
			Media label
			Additional Info

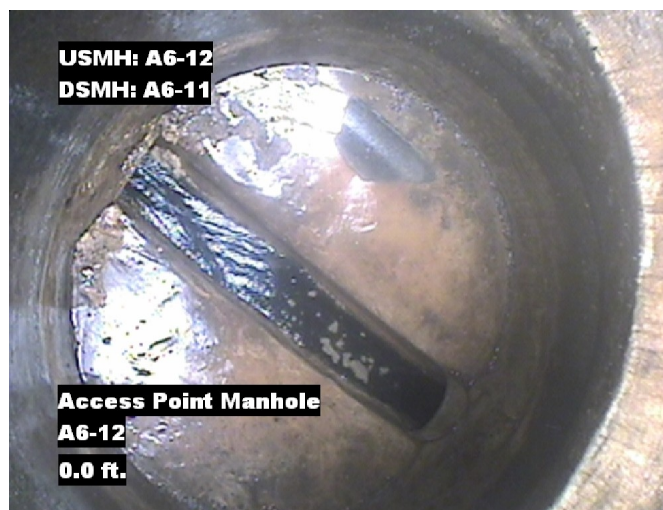
Distance: 0.0 ft. Grade: 0  
Condition: Access Point Manhole  
Remarks: A6-12

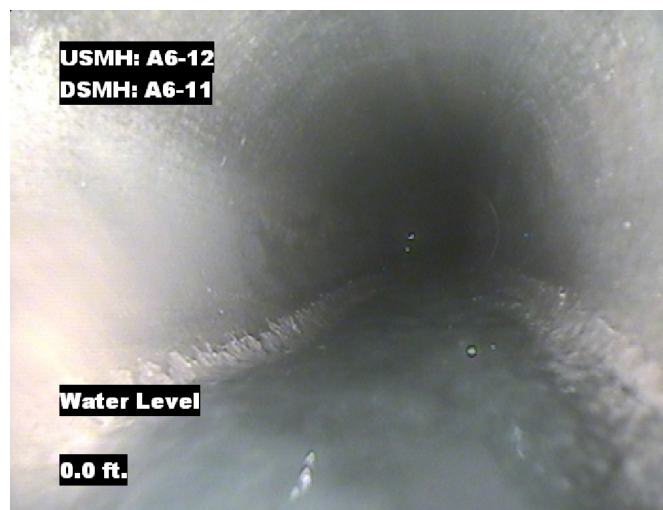
Distance: 0.0 ft. Grade: 0  
Condition: Water Level  
Remarks: N/A

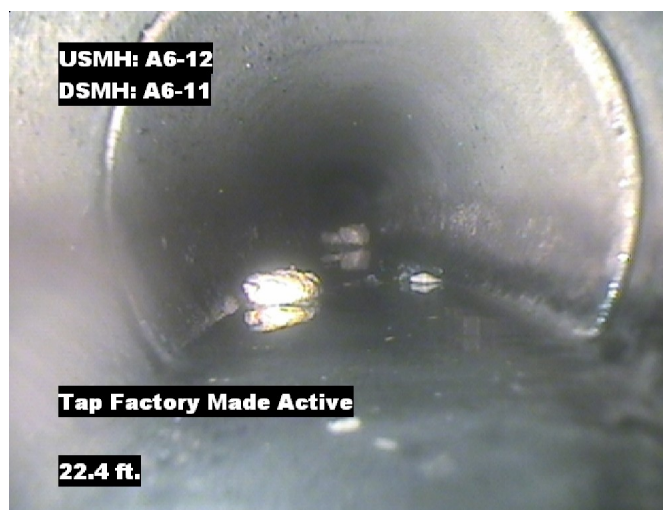
Distance: 22.4 ft. Grade: 0  
Condition: Tap Factory Made Active  
Remarks: N/A

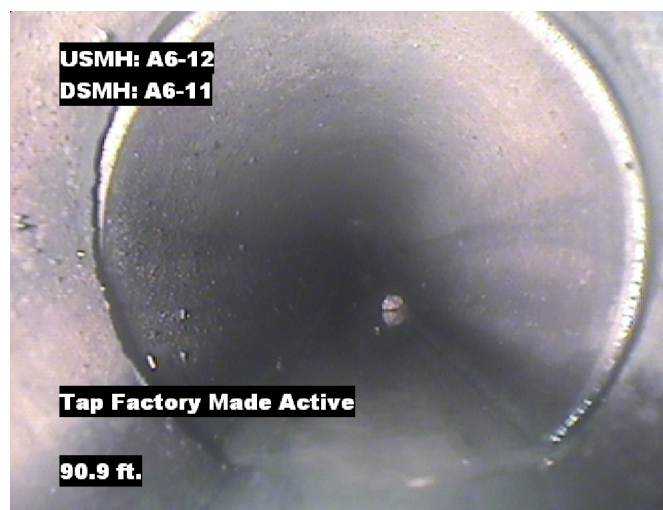
Distance: 90.9 ft. Grade: 0  
Condition: Tap Factory Made Active  
Remarks: N/A

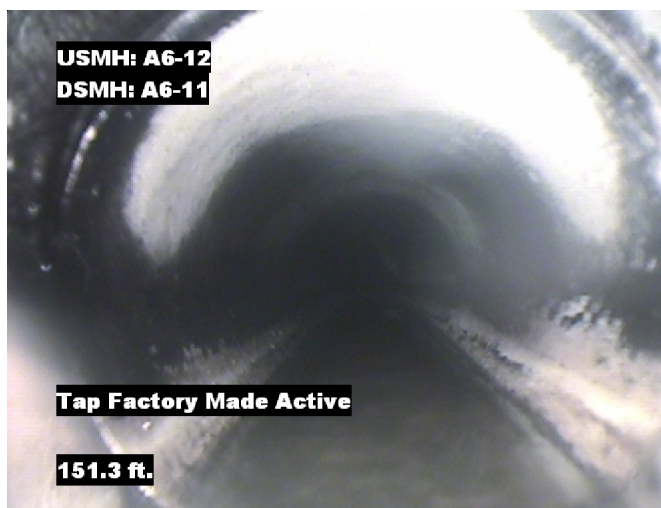
Distance: 151.3 ft. Grade: 0  
Condition: Tap Factory Made Active  
Remarks: N/A

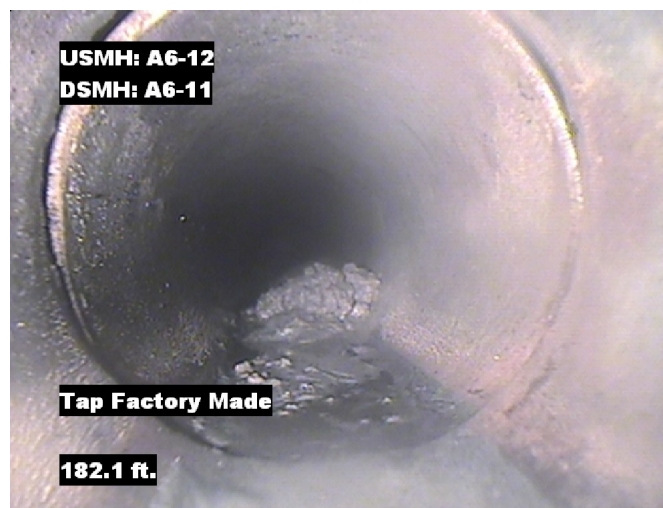
Distance: 182.1 ft. Grade: 0  
Condition: Tap Factory Made  
Remarks: N/A

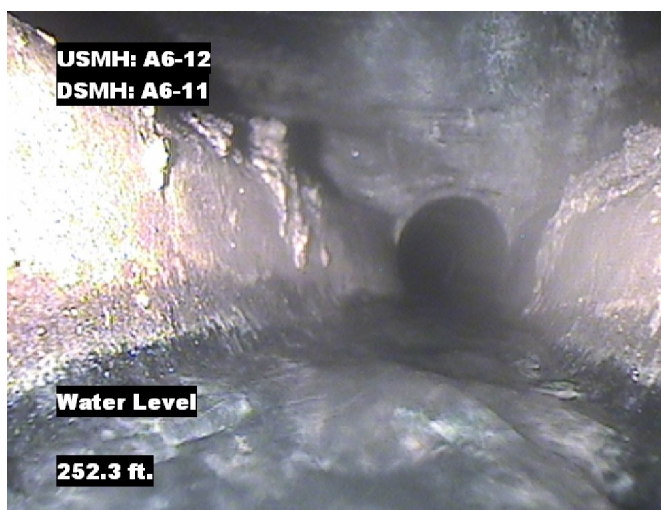
Distance: 252.3 ft. Grade: 0  
Condition: Water Level  
Remarks: N/A

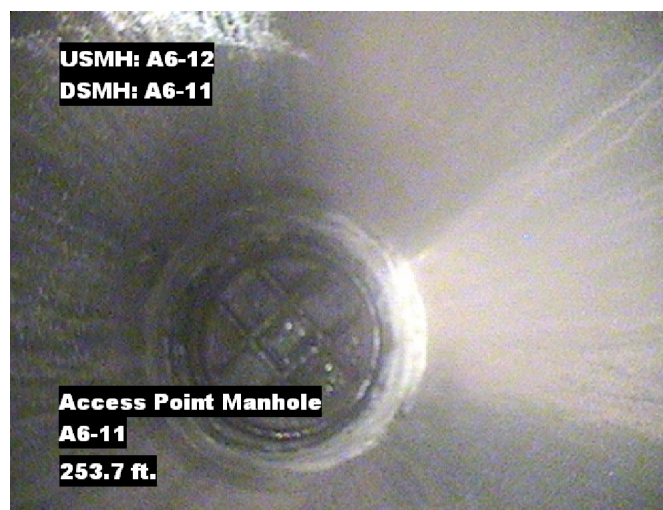
Distance: 253.7 ft. Grade: 0  
Condition: Access Point Manhole  
Remarks: A6-11
