Defect Listing

Pipe Segment Refere... A6-13_A6-12	City Oliver Springs	Street 61 highway	Material Concrete Pipe (non-...	Location C... Main Highw...	Sewer Use Sanitary
Upstream MH A6-13	Total Length 263.1	Year Laid	Shape Circular	Location Details	
DS Manhole A6-12	Length surveyed 263.1	Year Renewed	Height 8	Width 8	Pipe Joint... 4

SPR N/A	MPR 4	PO Number 4397-03	Customer GRW
SPRI N/A	MPRI 2	Work Order 4397-02	Purpose Pre-Rehabilitation Survey
QSR N/A	QMR 2200		
OPR 4	Surveyed By Barry Rogers	Direction Downstream	Date 20150810
OPRI 2	Certificate Number U-1012-16405	Pre-Cleaning Jetting	Time 13:23
	Date Cleaned 20150810	End Time 13:36	Weather Dry
			Additional Info

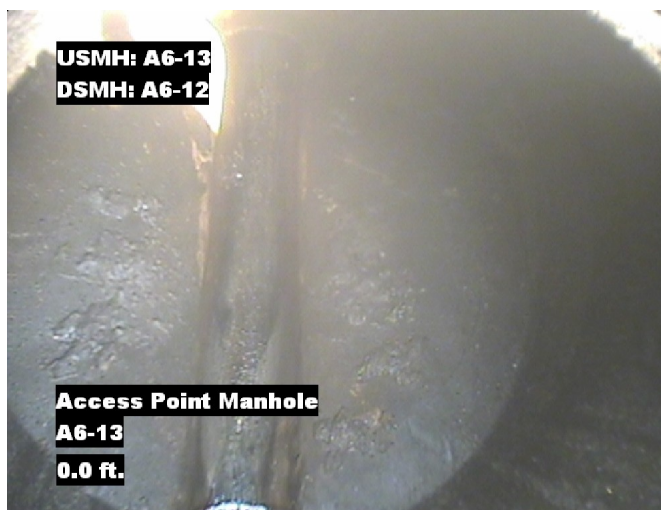
Distance: 0.0 ft. Grade: 0
Condition: Access Point Manhole
Remarks: A6-13

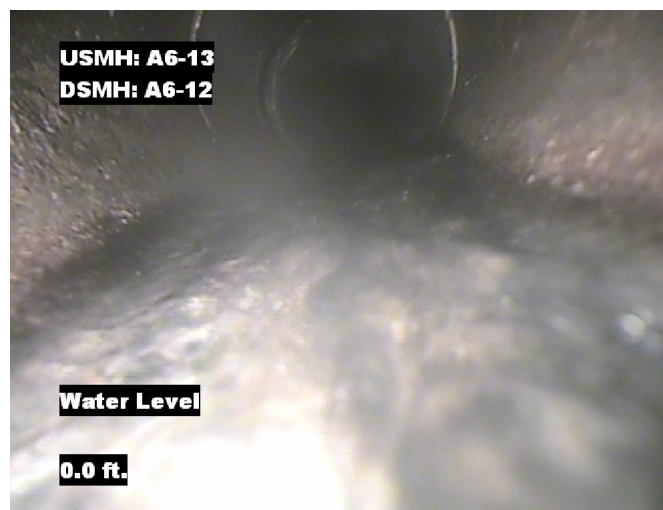
Distance: 0.0 ft. Grade: 0
Condition: Water Level
Remarks: N/A

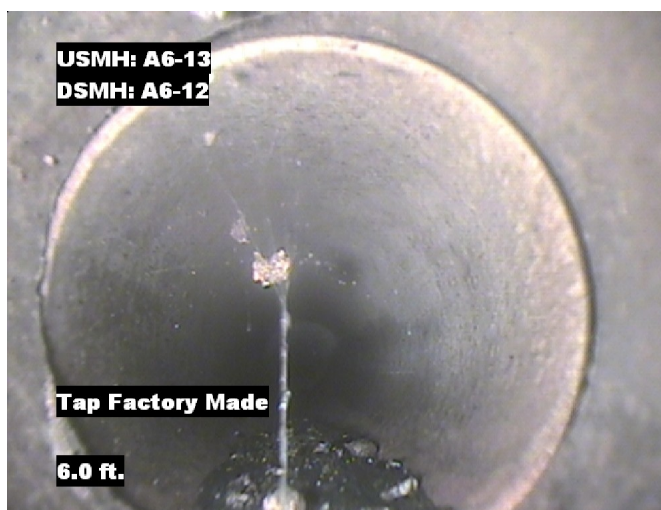
Distance: 6.0 ft. Grade: 0
Condition: Tap Factory Made
Remarks: N/A

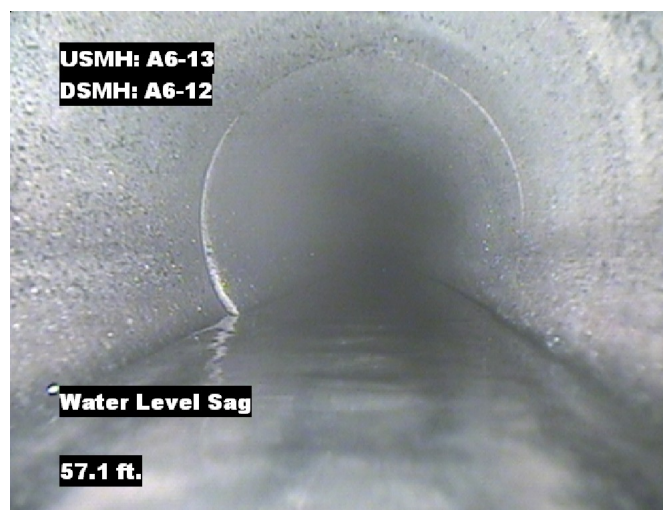
Distance: 57.1 ft. Grade: 2
Condition: Water Level Sag
Remarks: N/A

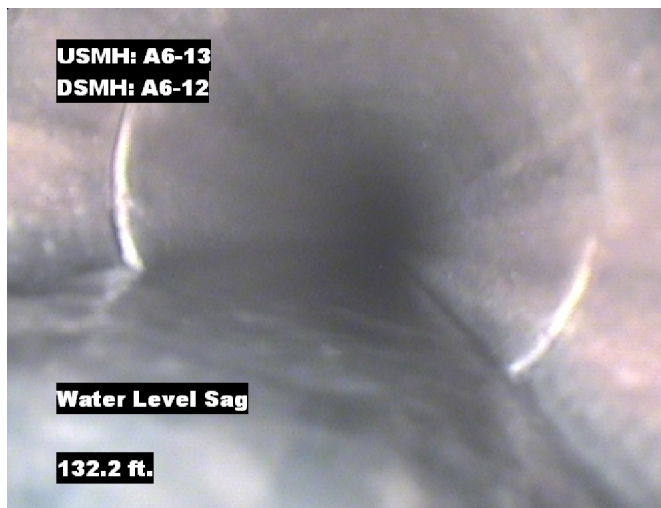
Distance: 132.2 ft. Grade: 2
Condition: Water Level Sag
Remarks: N/A

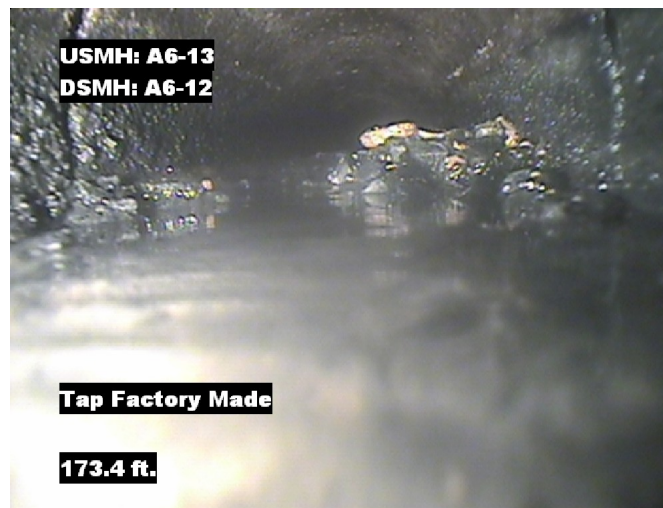
Distance: 173.4 ft. Grade: 0
Condition: Tap Factory Made
Remarks: N/A

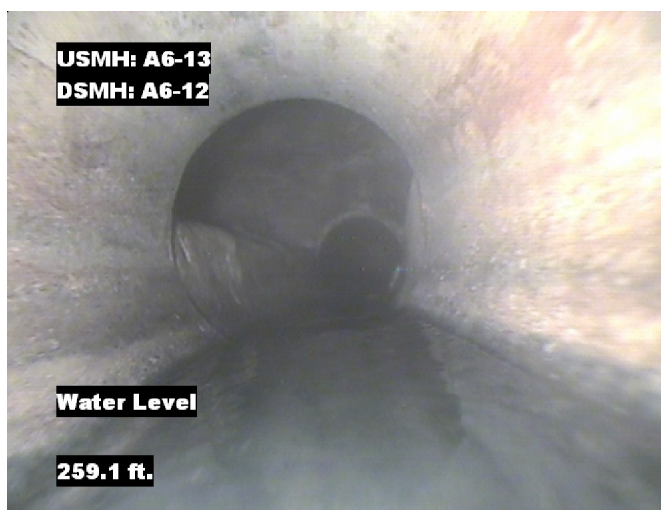
Distance: 259.0 ft. Grade: 0
Condition: Water Level
Remarks: N/A

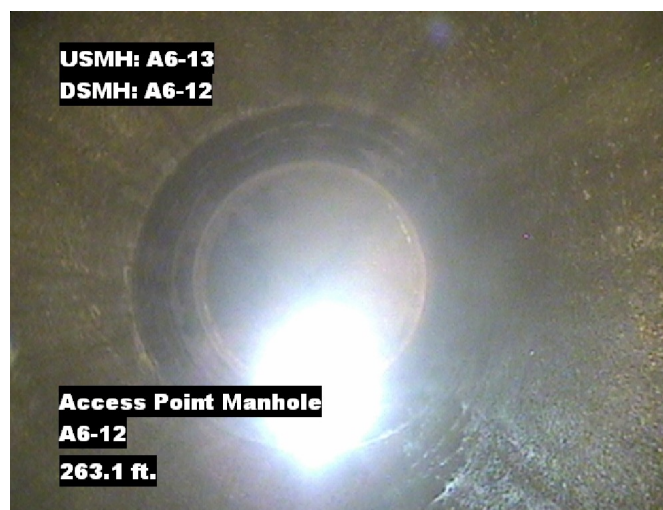
Distance: 263.1 ft. Grade: 0
Condition: Access Point Manhole
Remarks: A6-12
