## Defect Listing

Pipe Segment Refere... <b>A6-14_A6-13</b>	City <b>Oliver Springs</b>	Street <b>61 highway</b>	Material <b>Concrete Pipe (non-...</b>	Location C... <b>Main Highw...</b>	Sewer Use <b>Sanitary</b>
Upstream MH <b>A6-14</b>	Total Length <b>44.6</b>	Year Laid	Shape <b>Circular</b>	Location Details	
DS Manhole <b>A6-13</b>	Length surveyed <b>327.2</b>	Year Renewed	Height <b>8</b>	Width <b>8</b>	Pipe Joint... <b>4</b>

SPR <b>29</b>	MPR <b>7</b>	PO Number <b>4397-03</b>	Customer <b>GRW</b>
SPRI <b>2.9</b>	MPRI <b>3.5</b>	Work Order <b>4397-02</b>	Purpose <b>Pre-Rehabilitation Survey</b>
QSR <b>5241</b>	QMR <b>4131</b>		
OPR <b>36</b>	Surveyed By <b>Barry Rogers</b>	Direction <b>Upstream</b>	Date <b>20150810</b>
OPRI <b>3</b>	Certificate Number <b>U-1012-16405</b>	Pre-Cleaning <b>Jetting</b>	Time <b>12:44</b>
	Date Cleaned <b>20150810</b>	End Time <b>13:15</b>	Weather <b>Dry</b>
			Media label
			Additional Info

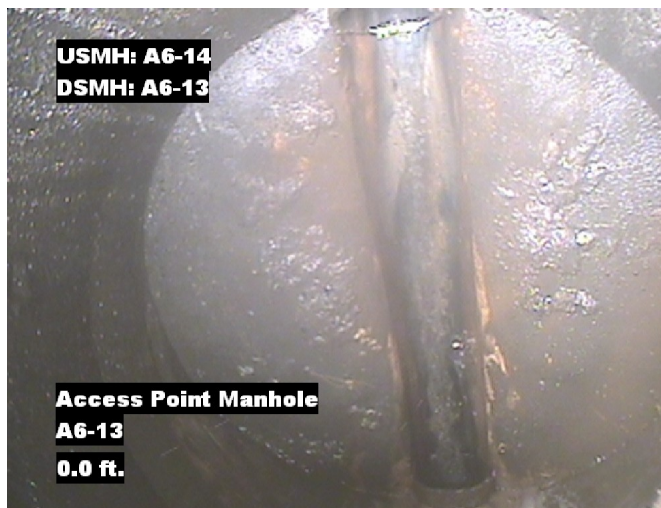
Distance: 0.0 ft. Grade: 0  
Condition: Access Point Manhole  
Remarks: A6-13

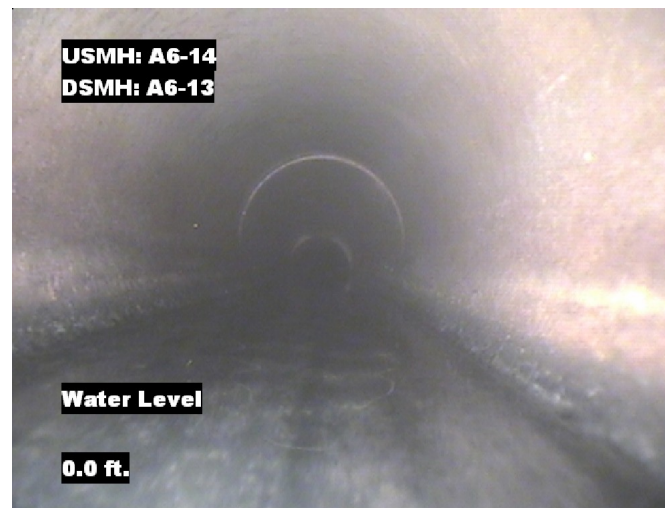
Distance: 0.0 ft. Grade: 0  
Condition: Water Level  
Remarks: N/A

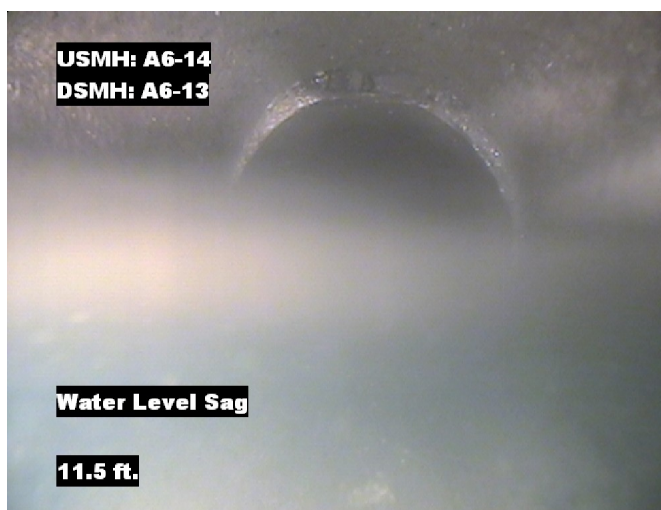
Distance: 11.5 ft. Grade: 3  
Condition: Water Level Sag  
Remarks: N/A

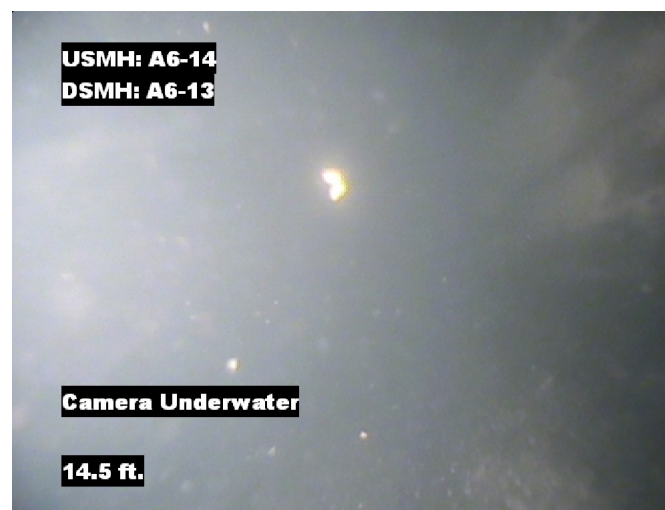
Distance: 14.5 ft. Grade: 4  
Condition: Camera Underwater  
Remarks: N/A

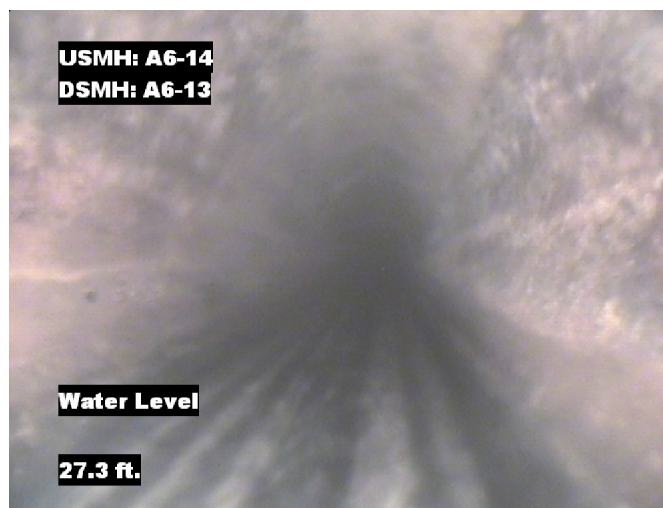
Distance: 27.3 ft. Grade: 0  
Condition: Water Level  
Remarks: N/A

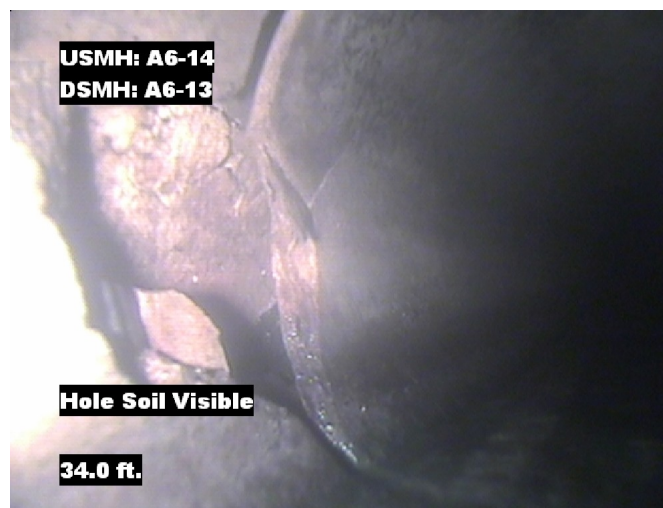
Distance: 34.0 ft. Grade: 5  
Condition: Hole Soil Visible  
Remarks: N/A

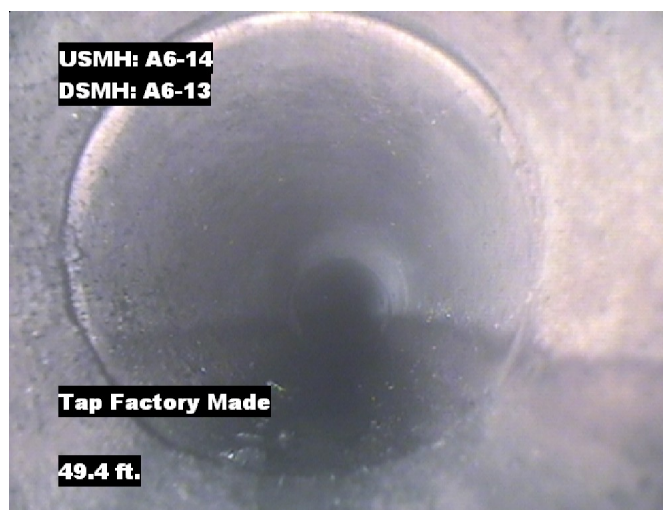
Distance: 49.4 ft. Grade: 0  
Condition: Tap Factory Made  
Remarks: N/A

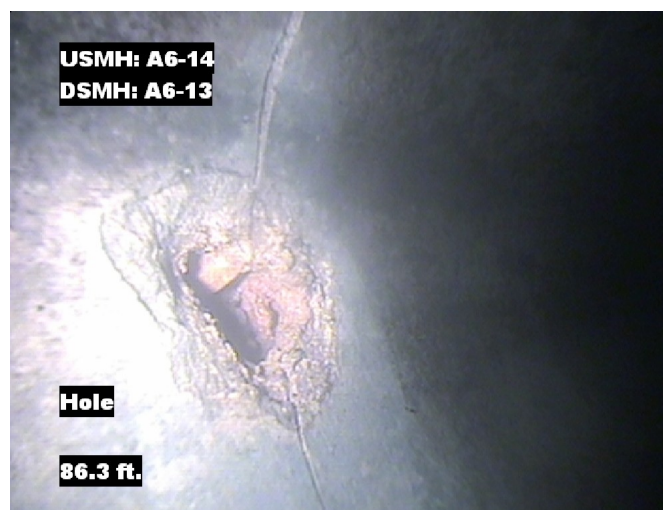
Distance: 86.3 ft. Grade: 3  
Condition: Hole  
Remarks: N/A

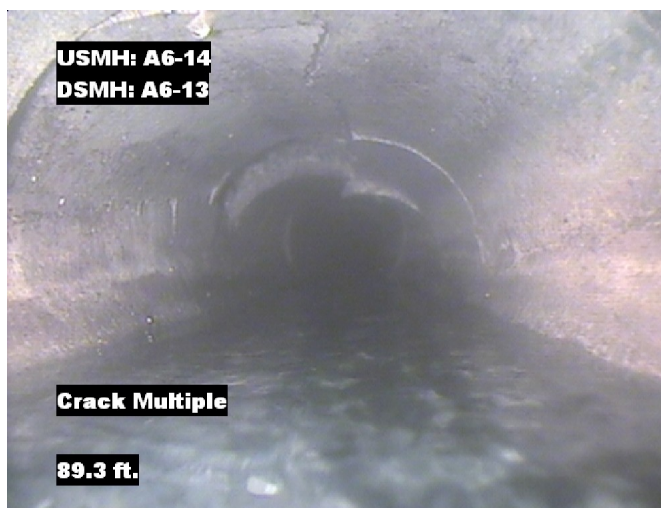
Distance: 89.3 ft. Grade: 3  
Condition: Crack Multiple  
Remarks: N/A

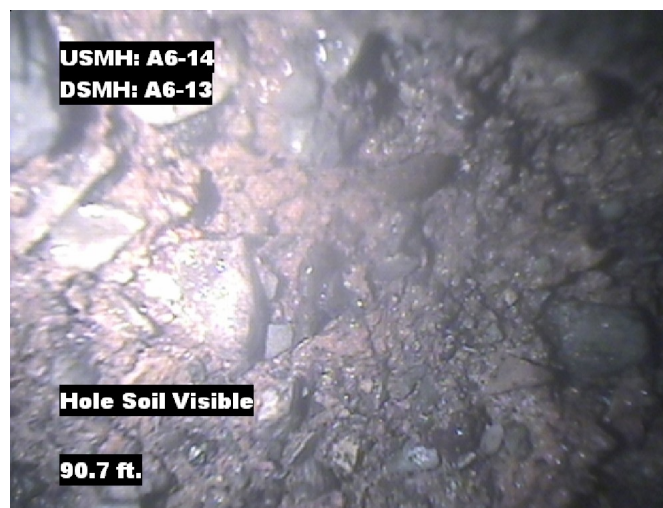
Distance: 90.7 ft. Grade: 5  
Condition: Hole Soil Visible  
Remarks: N/A

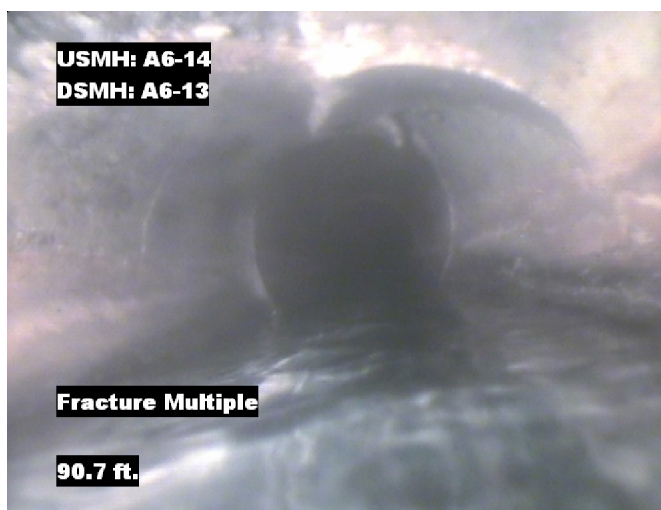
Distance: 90.7 ft. Grade: 4  
Condition: Fracture Multiple  
Remarks: N/A

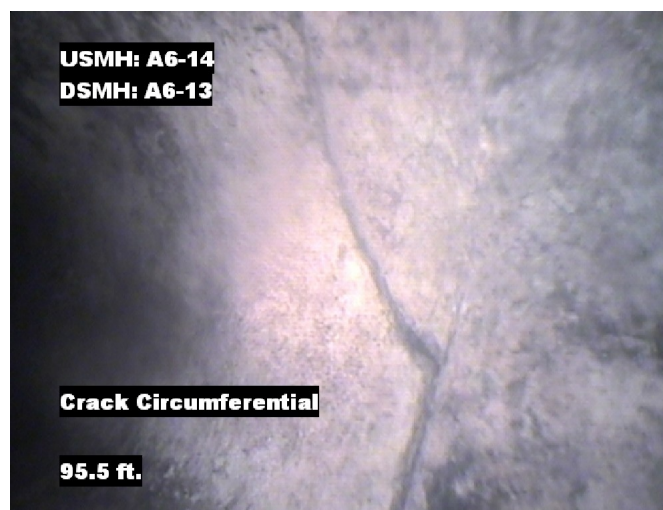
Distance: 95.5 ft. Grade: 1  
Condition: Crack Circumferential  
Remarks: N/A

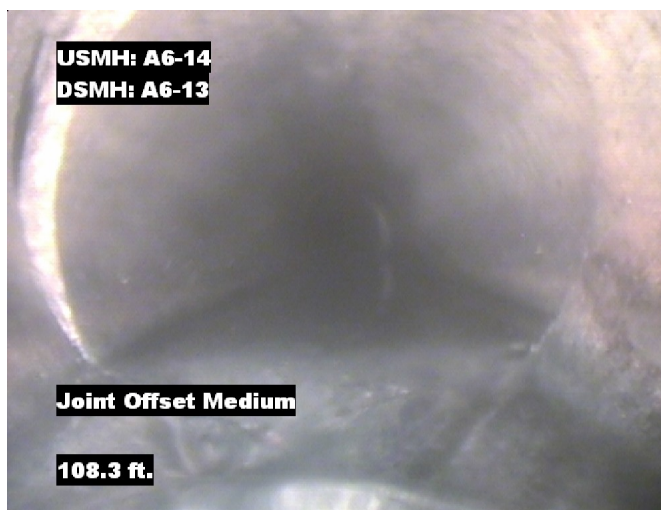
Distance: 108.3 ft. Grade: 1  
Condition: Joint Offset Medium  
Remarks: N/A

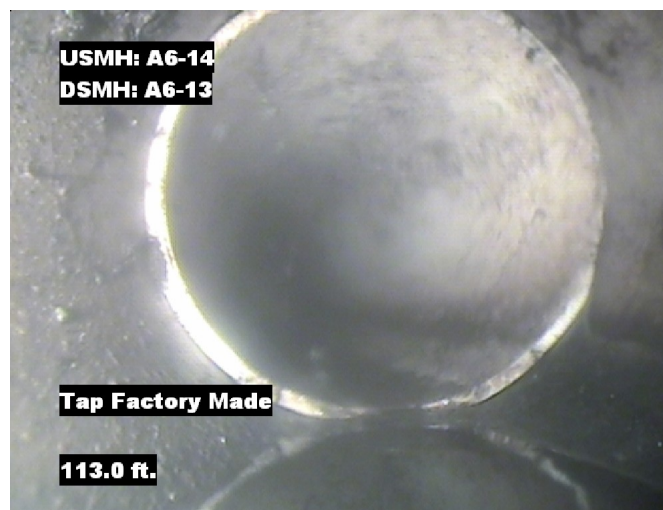
Distance: 113.0 ft. Grade: 0  
Condition: Tap Factory Made  
Remarks: N/A

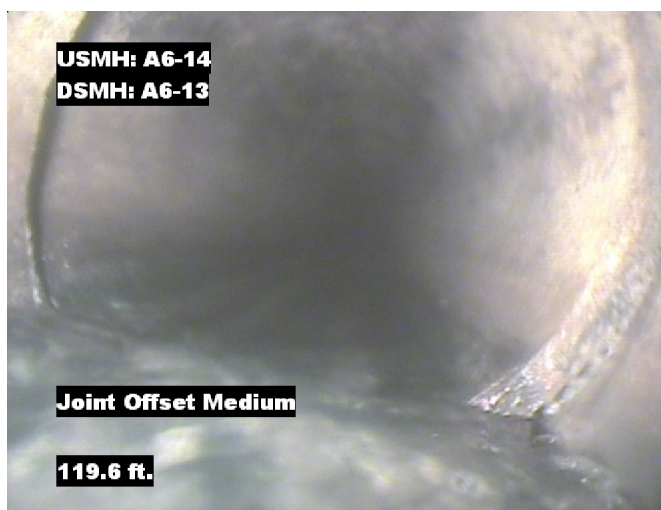
Distance: 119.6 ft. Grade: 1  
Condition: Joint Offset Medium  
Remarks: N/A

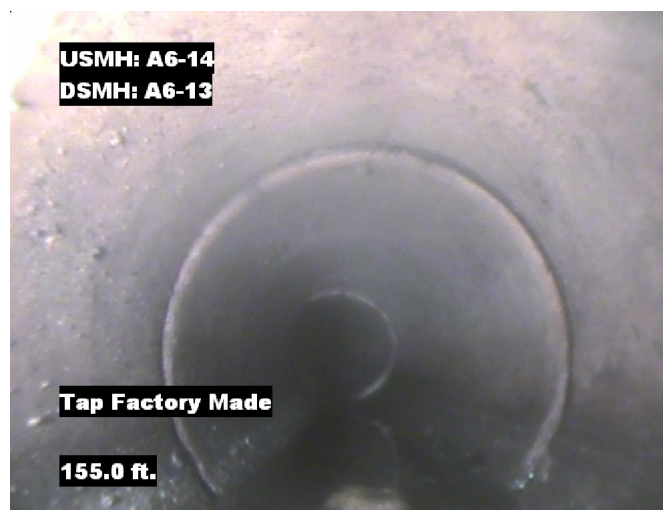
Distance: 155.0 ft. Grade: 0  
Condition: Tap Factory Made  
Remarks: N/A

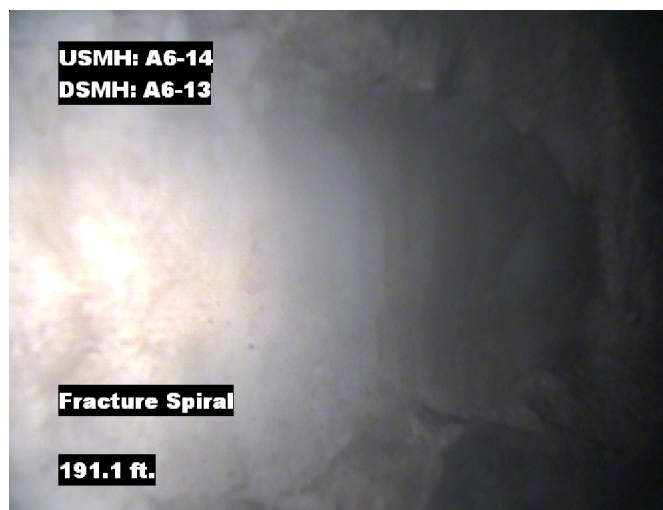
Distance: 191.1 ft. Grade: 3  
Condition: Fracture Spiral  
Remarks: N/A

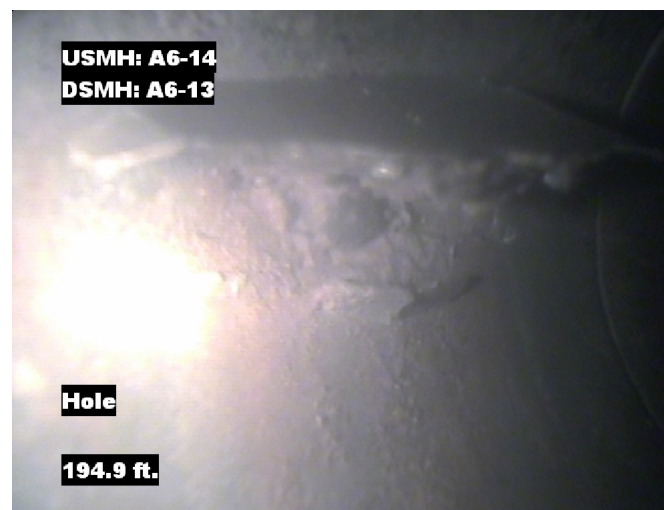
Distance: 194.9 ft. Grade: 3  
Condition: Hole  
Remarks: N/A

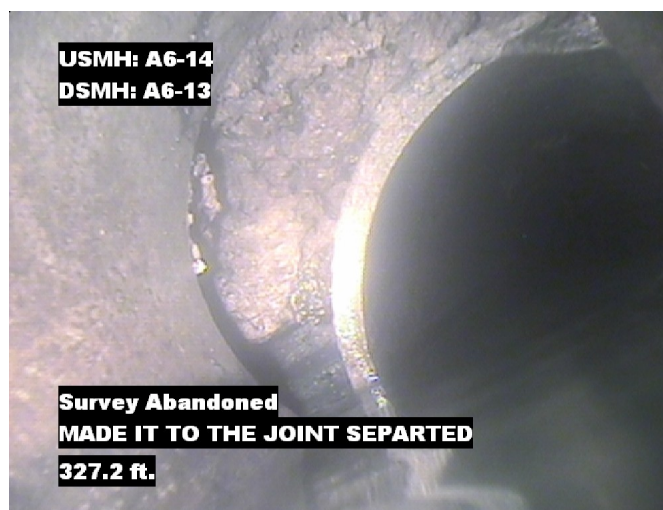
Distance: 327.2 ft. Grade: 0  
Condition: Survey Abandoned  
Remarks: MADE IT TO THE JOINT SEPARTED
