Defect Listing

Pipe Segment Refere... A6-15_A6-14	City Oliver Springs	Street 61 highway	Material Concrete Pipe (non-...	Location C... Main Highw...	Sewer Use Sanitary
Upstream MH A6-15	Total Length 190.5	Year Laid	Shape Circular	Location Details	
DS Manhole A6-14	Length surveyed 190.5	Year Renewed	Height 8	Width 8	Pipe Joint... 4

Image Report 4/Page

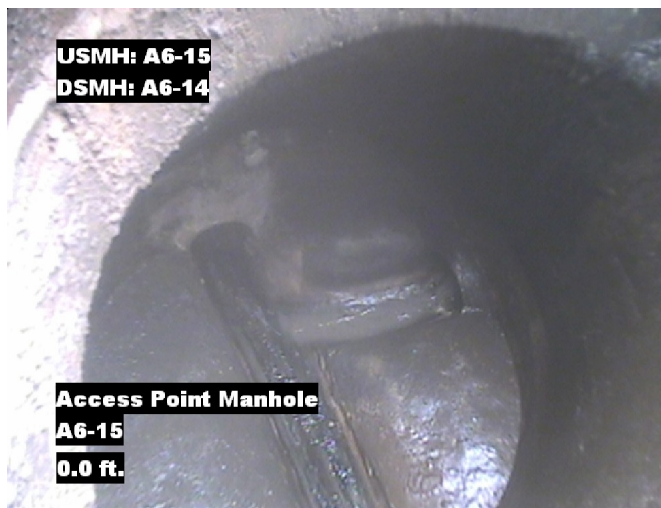
Distance: 0.0 ft. Grade: 0
Condition: Access Point Manhole
Remarks: A6-15

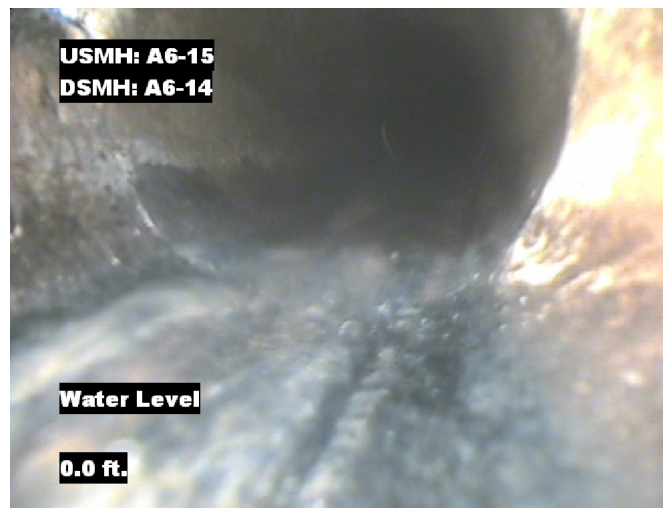
Distance: 0.0 ft. Grade: 0
Condition: Water Level
Remarks: N/A

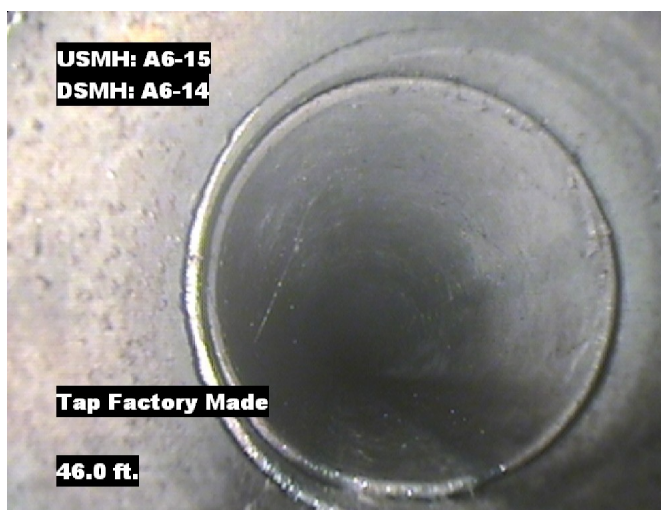
Distance: 46.0 ft. Grade: 0
Condition: Tap Factory Made
Remarks: N/A

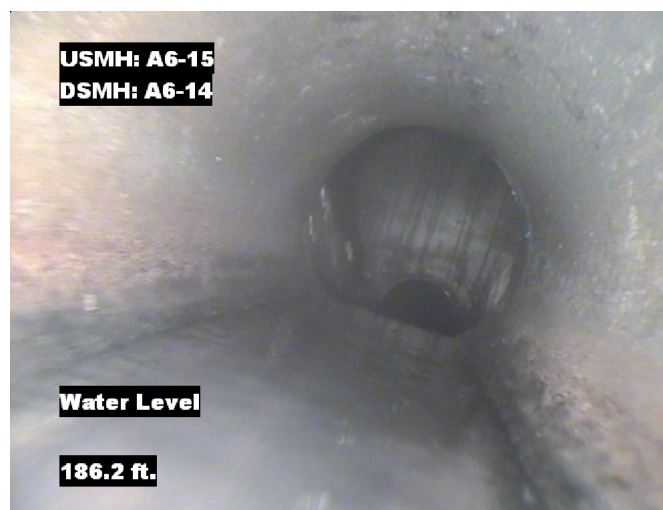
Distance: 186.2 ft. Grade: 0
Condition: Water Level
Remarks: N/A

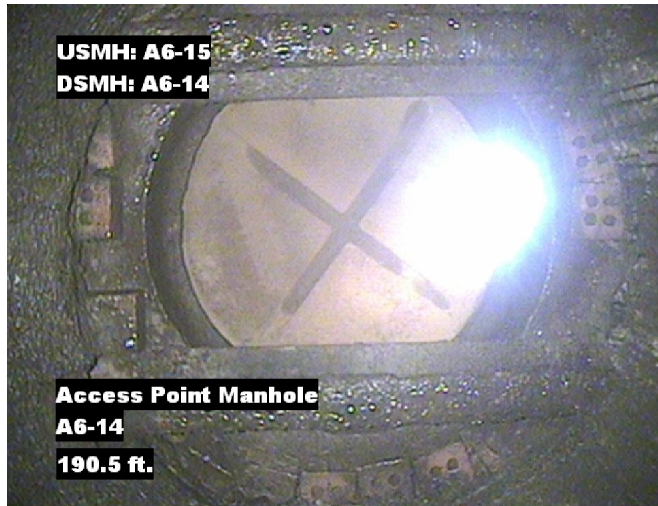
Distance: 190.5 ft. Grade: 0
Condition: Access Point Manhole
Remarks: A6-14
