## Defect Listing

| Pipe Segment Refere...<br><b>A6-16_A6-16A</b> | City<br><b>Oliver Springs</b> | Street<br><b>61 HIGHWAY</b> | Material<br><b>Fibreglass Reinforc...</b> | Location C...<br><b>Main Highw...</b> | Sewer Use<br><b>Sanitary</b> |

| SPRI<br><b>N/A</b> | MPRI<br><b>2</b> | Work Order<br><b>4397-02</b> | Purpose<br><b>Pre-Rehabilitation Survey</b> |

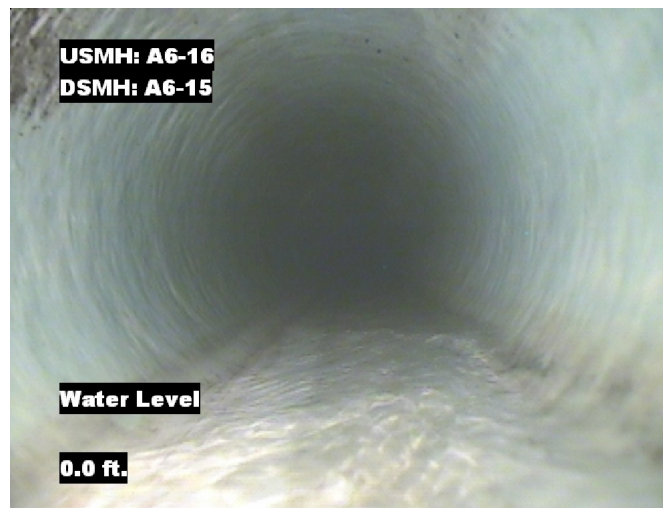
| Distance | Condition | Cont. Dfct. | Values | | | Joint | Clock Position | | Grade |
|---|---|---|---|---|---|---|---|---|---|
| 0.0 ft. | Water Level | | | | 10 | <input type="checkbox"/> | | | |

Distance: 0.0 ft. Grade: 0  
Condition: Water Level  
Remarks: N/A

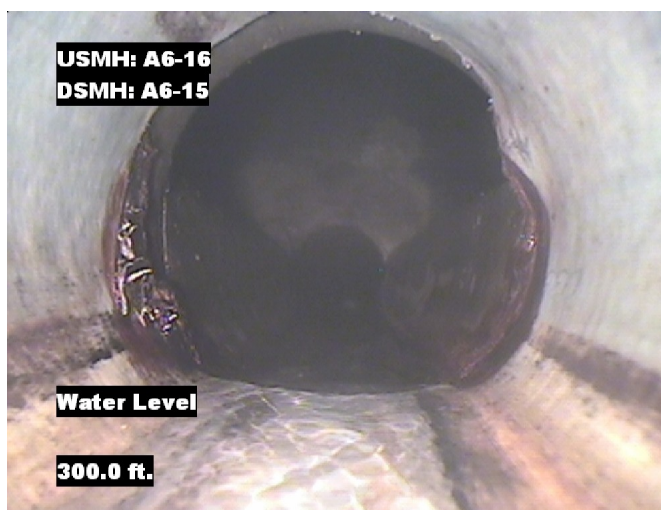
| Distance | Condition | Cont. Dfct. | Values | | | Joint | Clock Position | | Grade |
|---|---|---|---|---|---|---|---|---|---|
| 300.0 ft. | Water Level | | | | 5 | <input type="checkbox"/> | | | |

Distance: 300.0 ft. Grade: 0  
Condition: Water Level  
Remarks: N/A

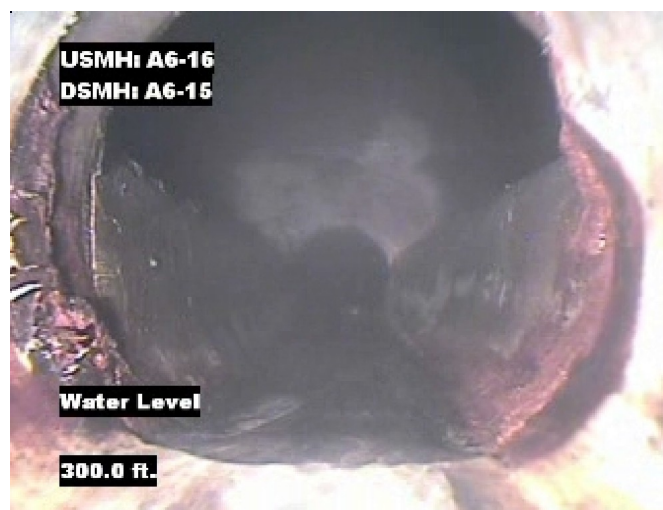
| Distance | Condition | Cont. Dfct. | Values | | | Joint | Clock Position | | Grade |
|---|---|---|---|---|---|---|---|---|---|
| 300.1 ft. | Roots Fine Barrell | | | | | <input type="checkbox"/> | 7 | 10 | 2 |

Distance: 300.1 ft. Grade: 2  
Condition: Roots Fine Barrell  
Remarks: N/A

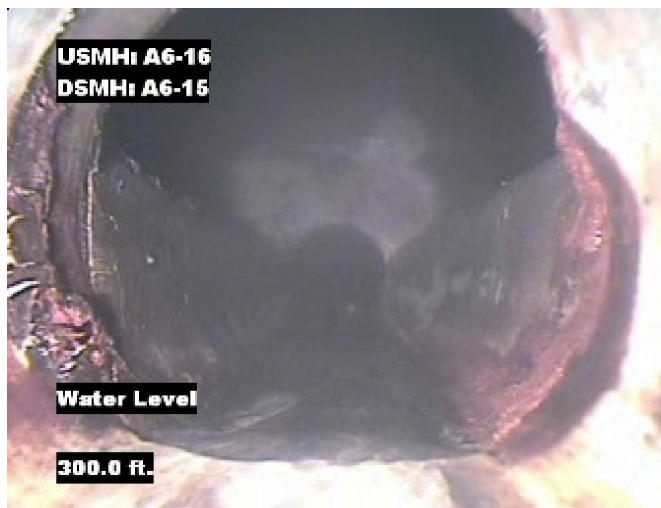
| Distance | Condition | Cont. Dfct. | Values | | | Joint | Clock Position | | Grade |
|---|---|---|---|---|---|---|---|---|---|
| 300.1 ft. | Infiltration Stain | | | | | <input type="checkbox"/> | 2 | 5 | |

Distance: 300.1 ft. Grade: 0  
Condition: Infiltration Stain  
Remarks: N/A

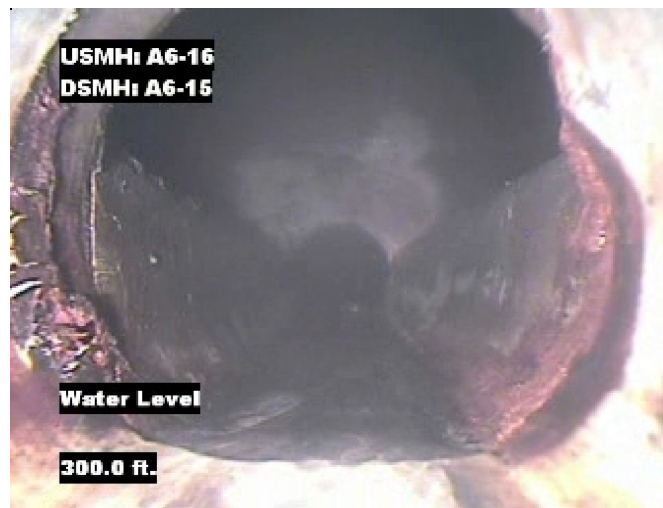
| Distance | Condition | Cont. Dfct. | Values | | | Joint | Clock Position | | Grade |
|---|---|---|---|---|---|---|---|---|---|
| 300.1 ft. | Infiltration Stain | | | | | <input type="checkbox"/> | 8 | 10 | |

Distance: 300.1 ft. Grade: 0  
Condition: Infiltration Stain  
Remarks: N/A
