Defect Listing

Pipe Segment Refere...	City	Street	Material	Location C...	Sewer Use
A6-16A_A6-15	Oliver Springs	61 highway	Concrete Pipe (non-...	Main Highw...	Sanitary
Upstream MH	Total Length	Year Laid	Shape	Location Details	
A6-16A	161.7		Circular		
DS Manhole	Length surveyed	Year Renewed	Height	Width	Pipe Joint...
A6-15	161.7		8	8	4

SPR	3	MPR	2	PO Number	Customer
SPRI	3	MPRI	2	4397-03	GRW
QSR	3100	QMR	2100	Work Order	Purpose
				4397-02	Pre-Rehabilitation Survey
OPR		Surveyed By	Direction	Date	Media label
5		Barry Rogers	Downstream	20150810	
OPRI		Certificate Number	Pre-Cleaning	Time	Weather
2.5		U-1012-16405	Jetting	10:10	Dry
Date Cleaned				End Time	Additional Info
20150810				10:29

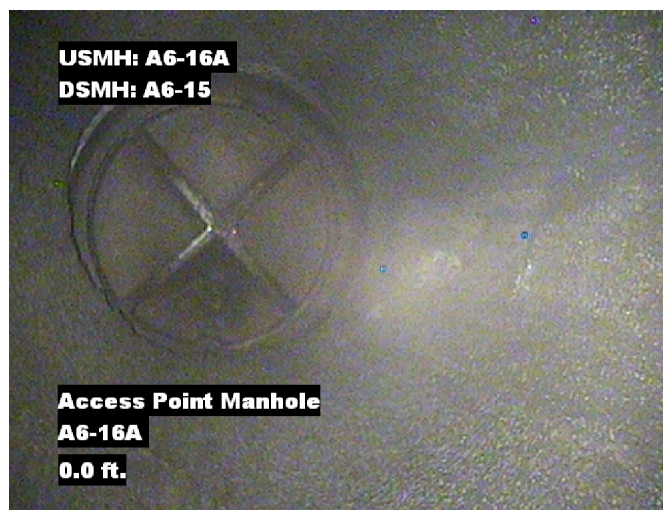
Distance: 0.0 ft. Grade: 0
Condition: Access Point Manhole
Remarks: A6-16A

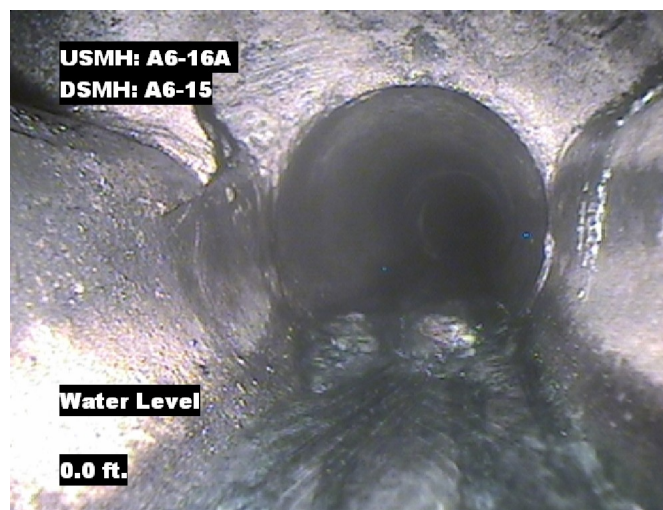
Distance: 0.0 ft. Grade: 0
Condition: Water Level
Remarks: N/A

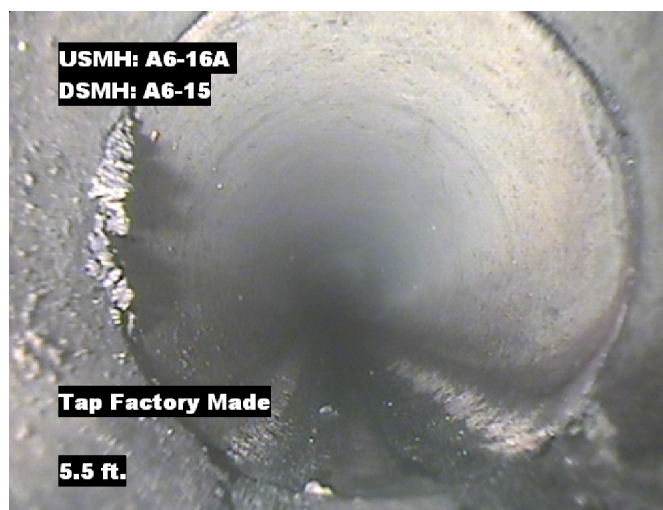
Distance: 5.5 ft. Grade: 0
Condition: Tap Factory Made
Remarks: N/A

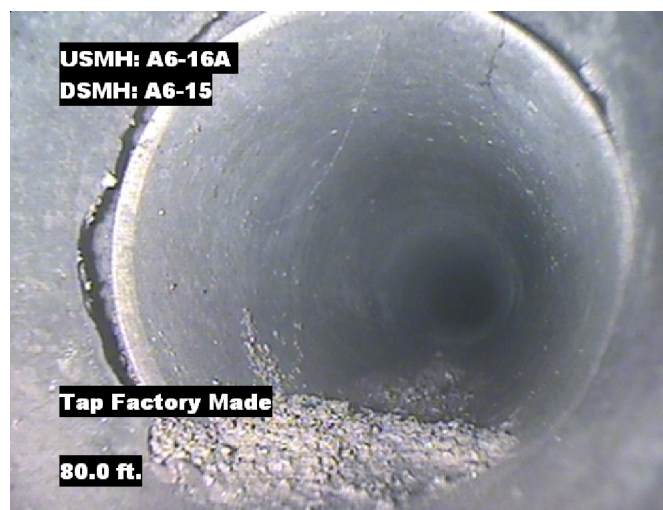
Distance: 80.0 ft. Grade: 0
Condition: Tap Factory Made
Remarks: N/A

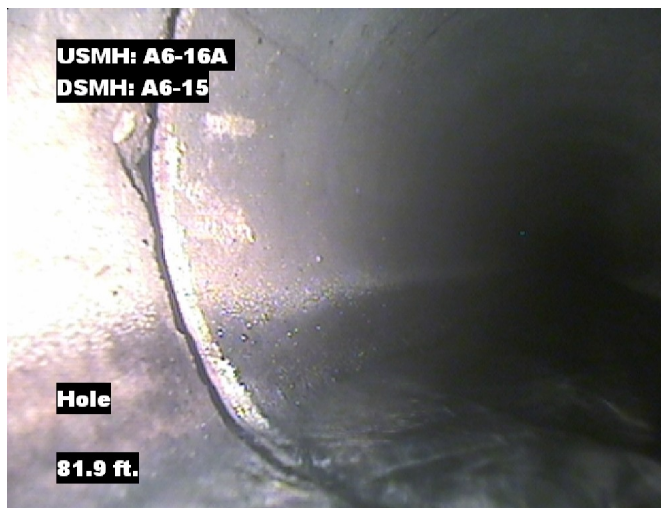
Distance: 81.9 ft. Grade: 3
Condition: Hole
Remarks: N/A

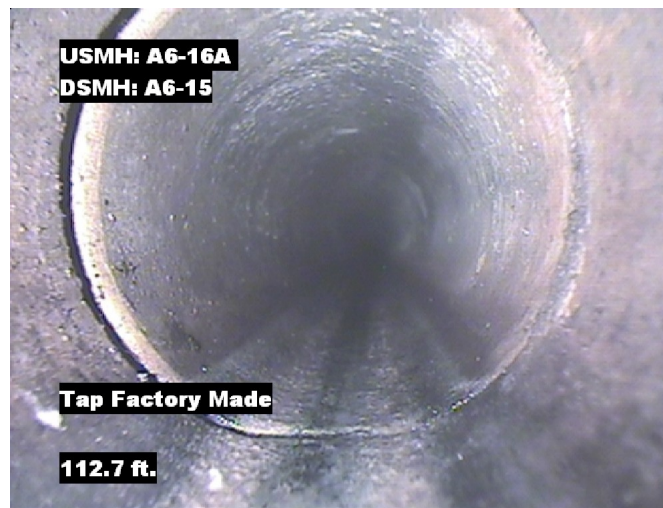
Distance: 112.7 ft. Grade: 0
Condition: Tap Factory Made
Remarks: N/A

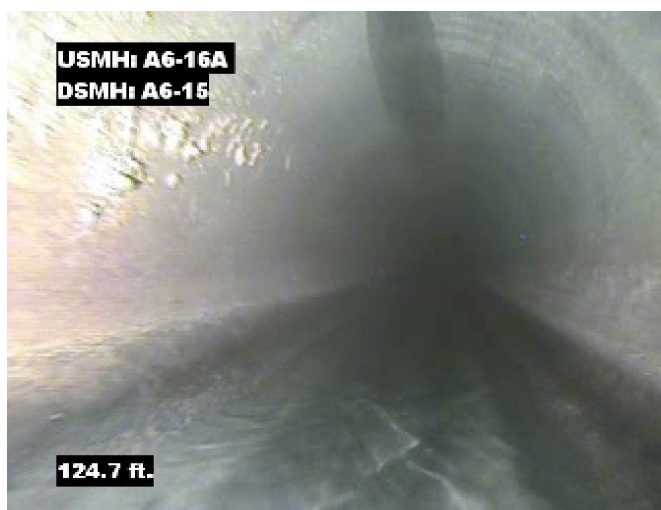
Distance: 124.8 ft. Grade: 2
Condition: Deposits Attached Grease
Remarks: N/A

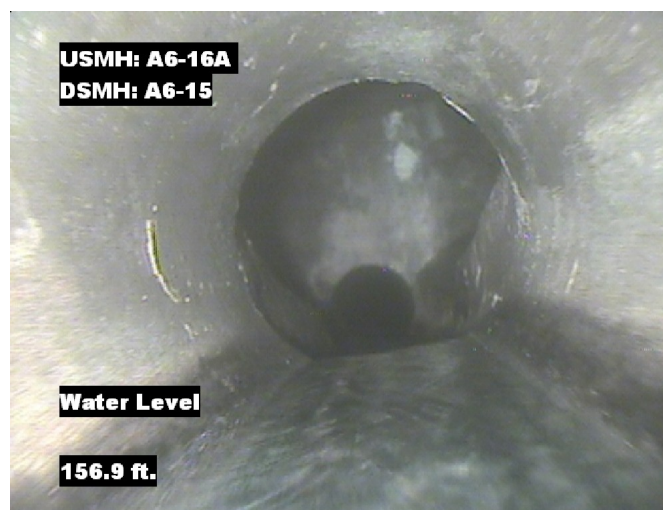
Distance: 156.8 ft. Grade: 0
Condition: Water Level
Remarks: N/A

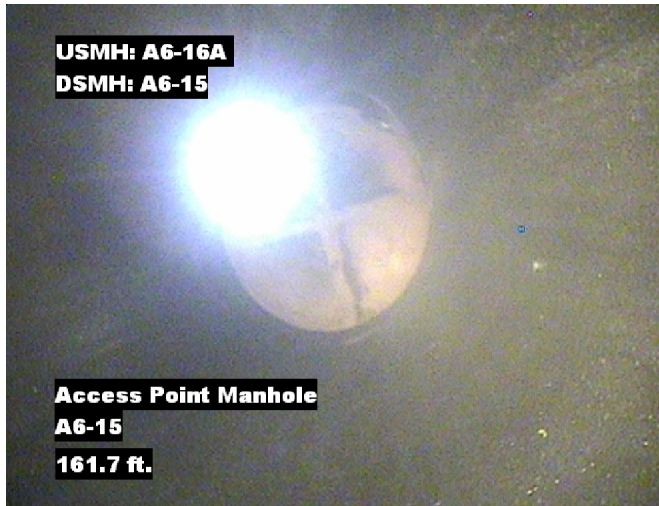
Distance: 161.7 ft. Grade: 0
Condition: Access Point Manhole
Remarks: A6-15
