Defect Listing

Pipe Segment Refere... A6-19_A6-19A	City Oliver Springs	Street Highway 61	Material Concrete Pipe (non-...	Location C... Main Highw...	Sewer Use Sanitary
Upstream MH A6-19	Total Length 48.7	Year Laid	Shape Circular	Location Details	
DS Manhole A6-19A	Length surveyed 48.7	Year Renewed	Height 8	Width 8	Pipe Joint... 4

SPR N/A	MPR N/A	PO Number 4397-03		Customer GRW	
SPRI N/A	MPRI N/A	Work Order 4397-02		Purpose Pre-Rehabilitation Survey	
QSR N/A	QMR N/A				
OPR N/A	Surveyed By Charlie Gordon	Direction Downstream	Date 20150820	Media label	
OPRI N/A	Certificate Number U-615-07000491	Pre-Cleaning Jetting	Time 13:20	Weather Damp	
Date Cleaned 20150820			End Time 13:24	Additional Info

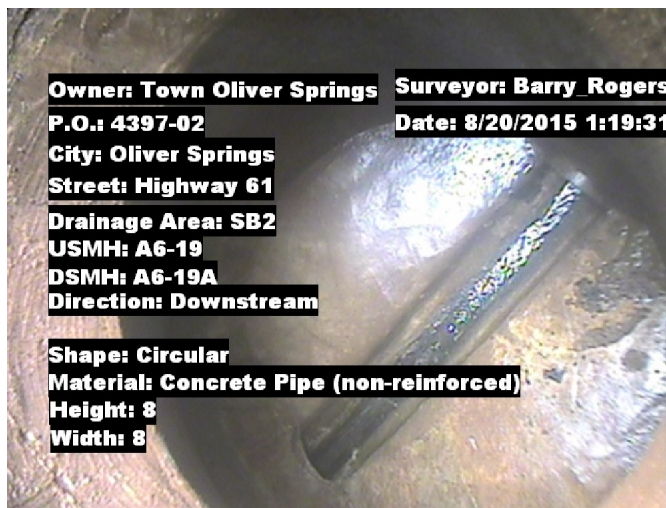
Distance: 0.0 ft. Grade: 0
Condition: Access Point Manhole
Remarks: A6-19A

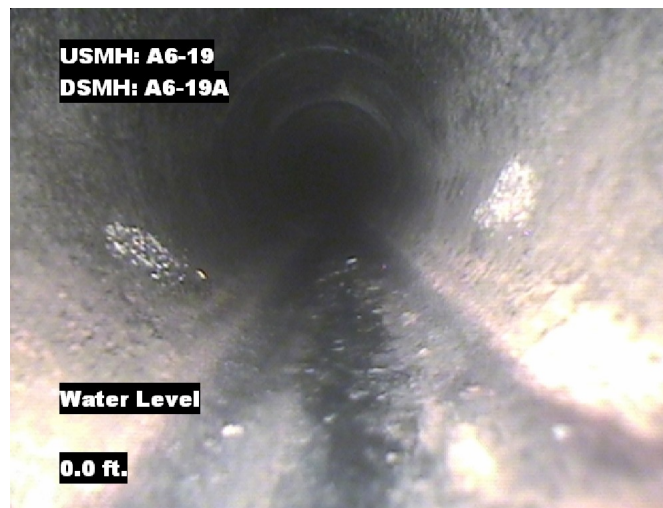
Distance: 0.0 ft. Grade: 0
Condition: Water Level
Remarks: N/A

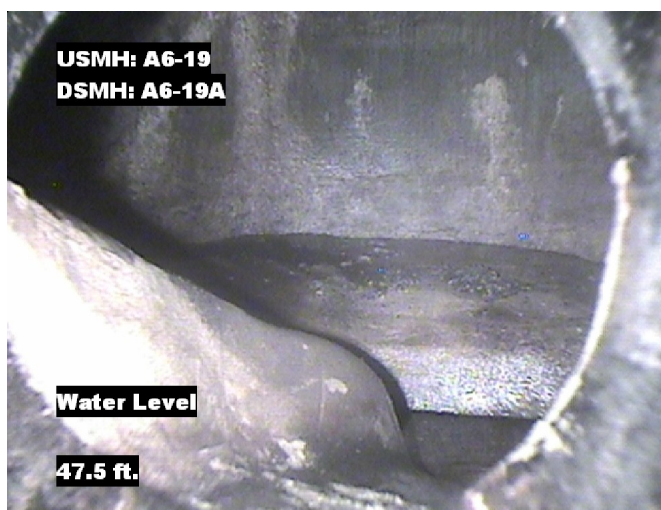
Distance: 47.4 ft. Grade: 0
Condition: Water Level
Remarks: N/A

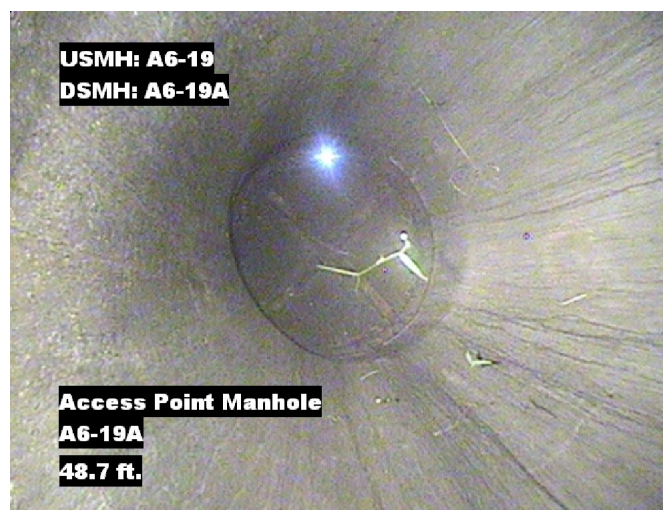
Distance: 48.7 ft. Grade: 0
Condition: Access Point Manhole
Remarks: A6-19
