Defect Listing

Pipe Segment Refere... A6-19A_A6-17	City Oliver Springs	Street Highway 61	Material Concrete Pipe (non-...	Location C... Main Highw...	Sewer Use Sanitary
Upstream MH A6-19A	Total Length 300	Year Laid	Shape Circular	Location Details	
DS Manhole A6-17	Length surveyed 300	Year Renewed	Height 8	Width 8	Pipe Joint... 4

SPR N/A	MPR 7	PO Number 4397-03	Customer GRW
SPRI N/A	MPRI 2.3	Work Order 4397-02	Purpose Pre-Rehabilitation Survey
QSR N/A	QMR 3122		
OPR 7	Surveyed By Charlie Gordon	Direction Downstream	Date 20150901
OPRI 2.3	Certificate Number U-615-07000491	Pre-Cleaning Jetting	Time 11:20
	Date Cleaned 20150901	End Time 11:23	Weather Dry
			Additional Info MH A6-18 DNE

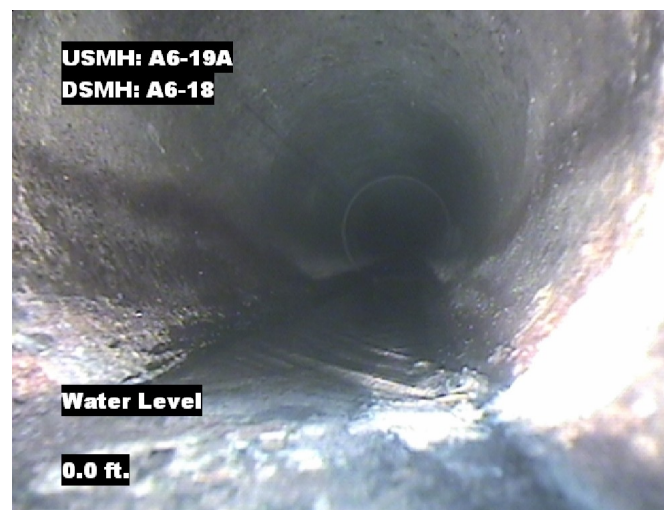
Distance: 0.0 ft. Grade: 0
Condition: Water Level
Remarks: N/A

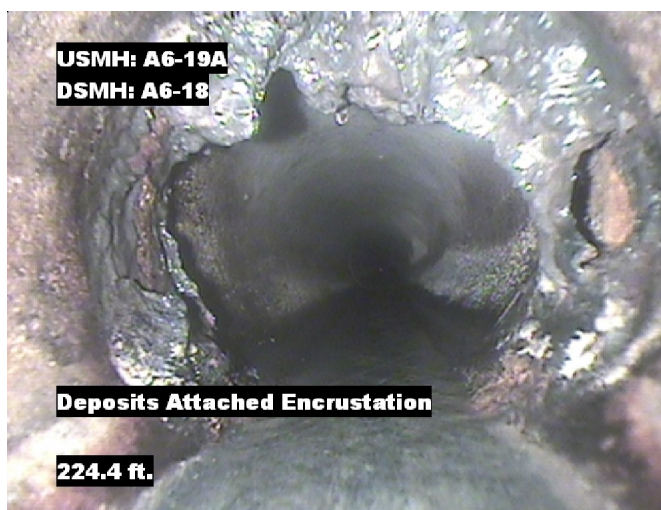
Distance: 224.4 ft. Grade: 2
Condition: Deposits Attached Encrustation
Remarks: N/A

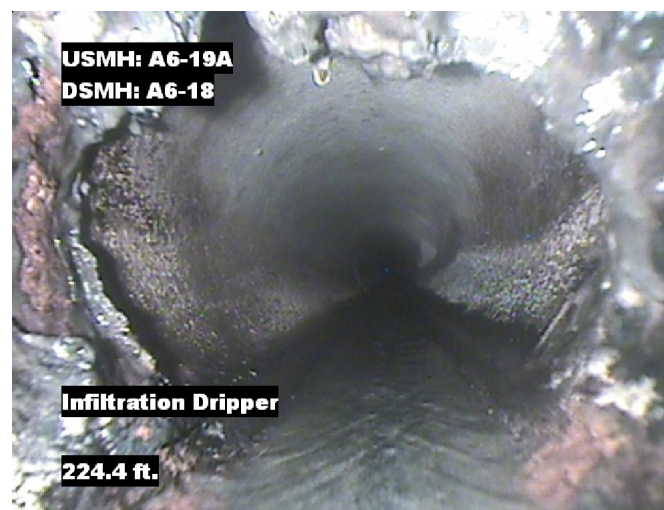
Distance: 224.4 ft. Grade: 3
Condition: Infiltration Dripper
Remarks: N/A

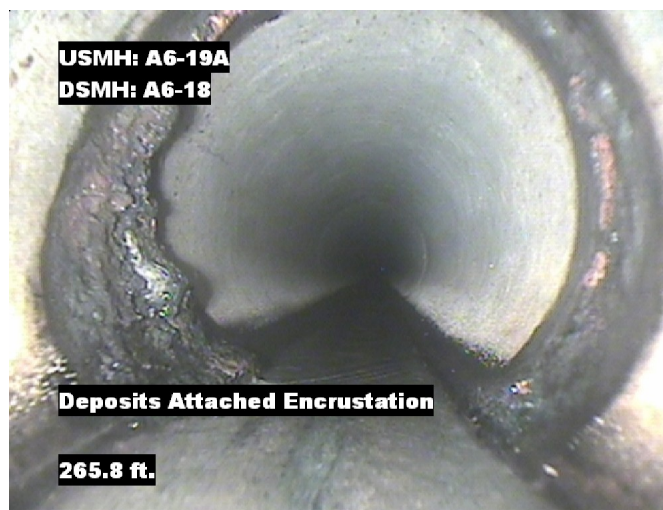
Distance: 265.8 ft. Grade: 2
Condition: Deposits Attached Encrustation
Remarks: N/A

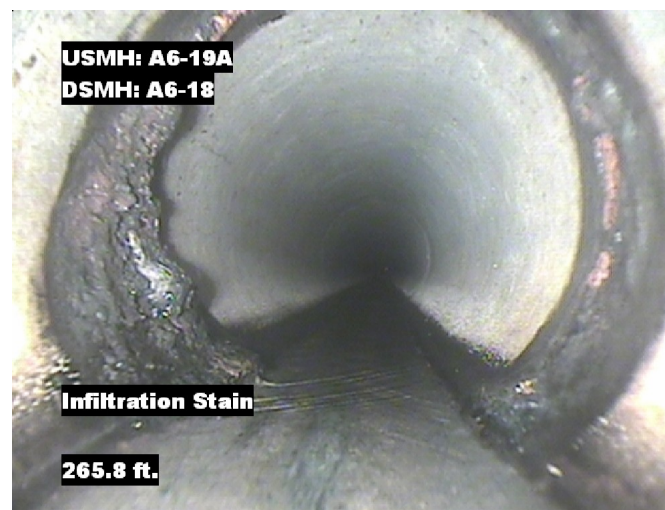
Distance: 265.8 ft. Grade: 0
Condition: Infiltration Stain
Remarks: N/A

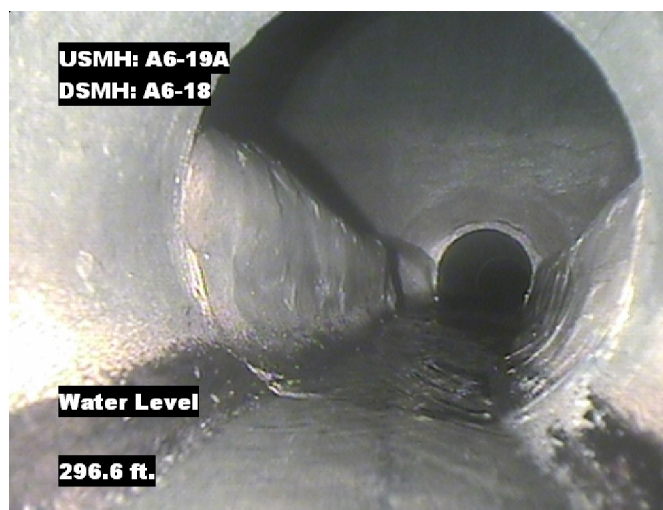
Distance: 296.6 ft. Grade: 0
Condition: Water Level
Remarks: N/A
