Defect Listing

Pipe Segment Refere... A6-2_A6-1	City Oliver Springs	Street Main St	Material Concrete Pipe (non-...	Location C... Yard	Sewer Use Sanitary
Upstream MH A6-2	Total Length 177.1	Year Laid	Shape Circular	Location Details	
DS Manhole A6-1	Length surveyed 177.1	Year Renewed	Height 8	Width 8	Pipe Joint... 4

SPR 7	MPR 12	PO Number 4397-03	Customer GRW
SPRI 3.5	MPRI 3	Work Order 4397-02	Purpose Pre-Rehabilitation Survey
QSR 5121	QMR 4132		
OPR 19	Surveyed By Charlie Gordon	Direction Downstream	Date 20150827
OPRI 3.2	Certificate Number U-615-07000491	Pre-Cleaning Jetting	Time 12:25
	Date Cleaned 20150827	End Time 12:37	Weather Dry
		Additional Info

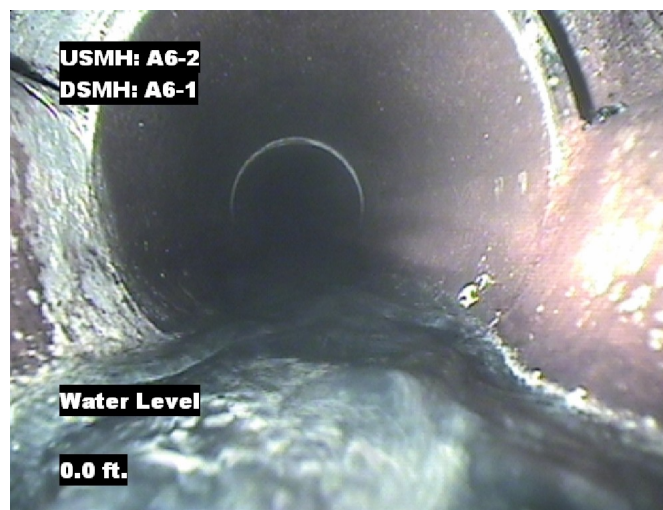
Distance: 0.0 ft. Grade: 0
Condition: Water Level
Remarks: N/A

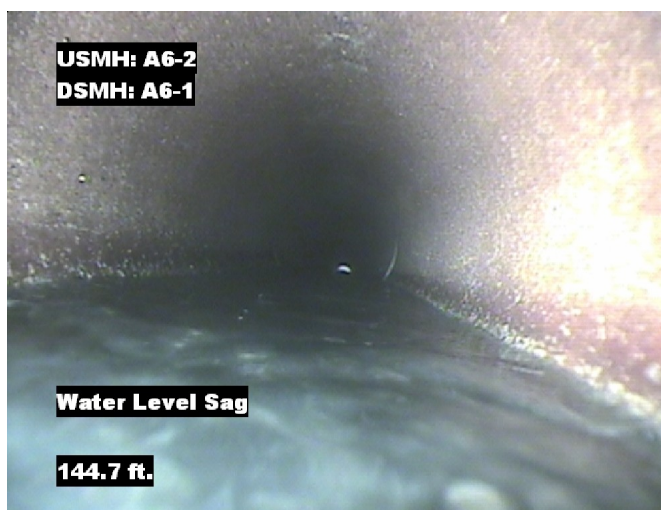
Distance: 144.7 ft. Grade: 2
Condition: Water Level Sag
Remarks: N/A

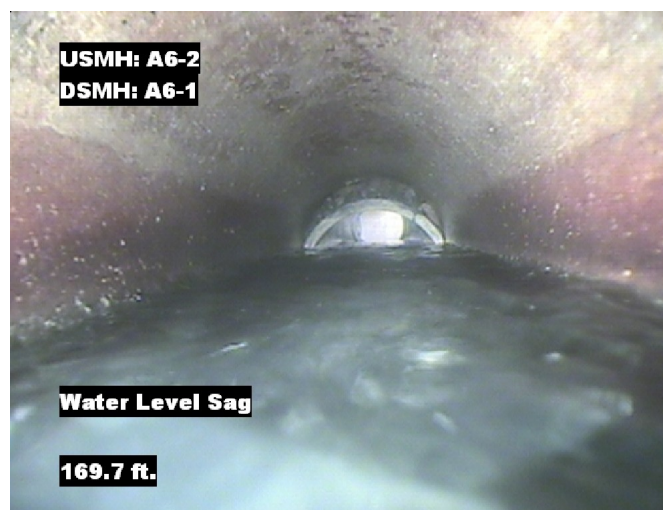
Distance: 169.7 ft. Grade: 3
Condition: Water Level Sag
Remarks: N/A

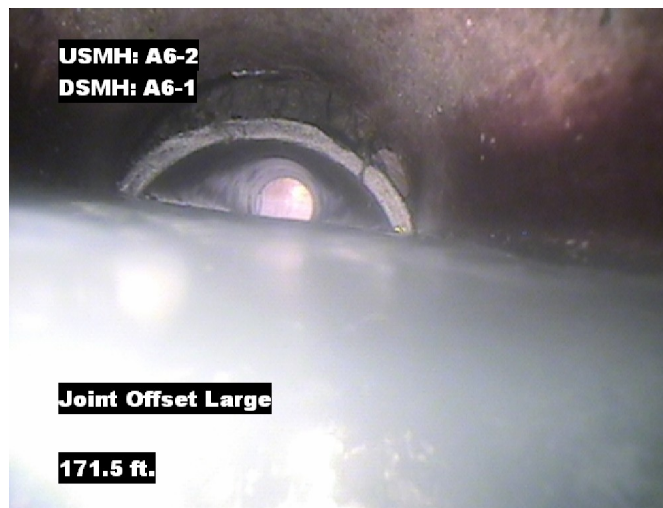
Distance: 171.5 ft. Grade: 2
Condition: Joint Offset Large
Remarks: N/A

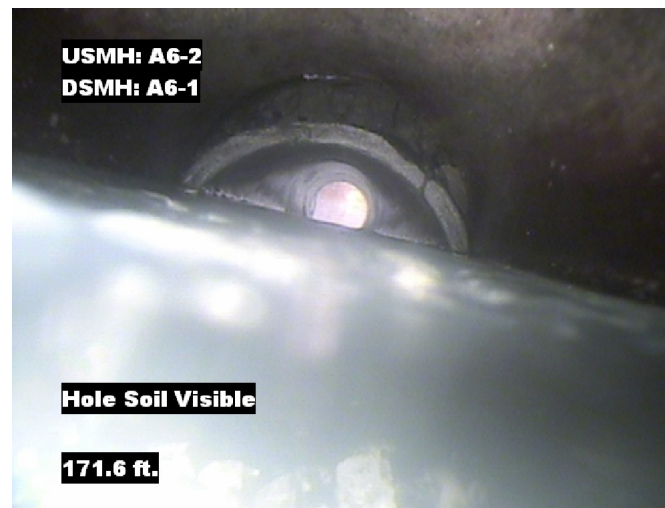
Distance: 171.6 ft. Grade: 5
Condition: Hole Soil Visible
Remarks: N/A

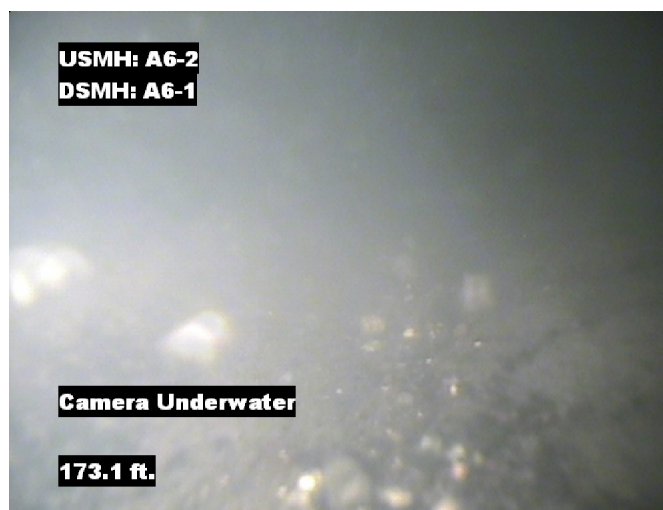
Distance: 173.1 ft. Grade: 4
Condition: Camera Underwater
Remarks: N/A

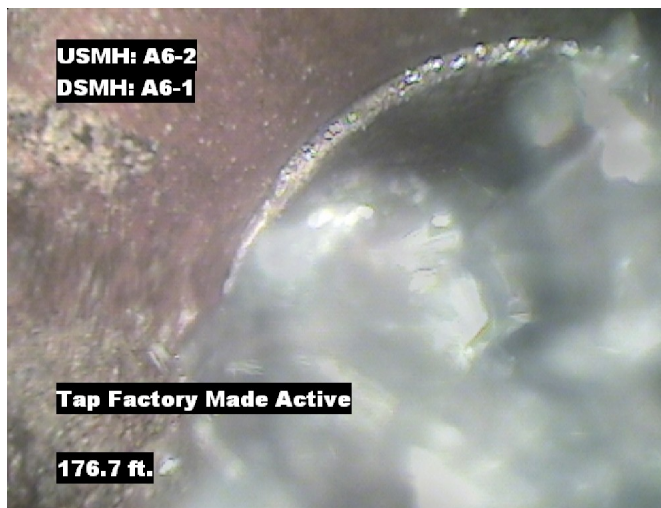
Distance: 176.7 ft. Grade: 0
Condition: Tap Factory Made Active
Remarks: N/A

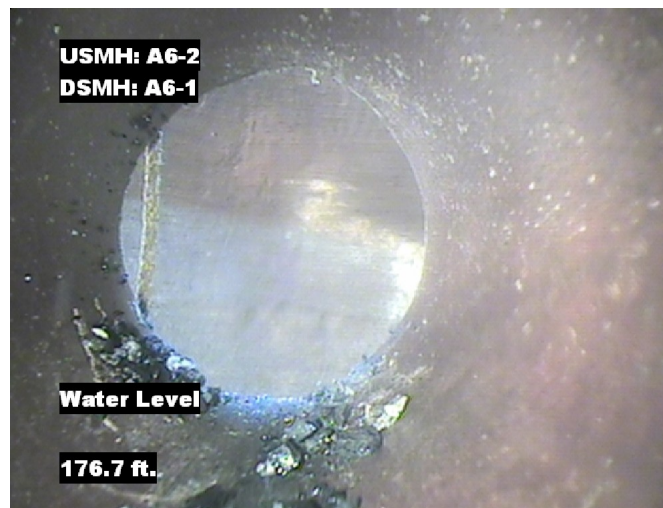
Distance: 176.7 ft. Grade: 0
Condition: Water Level
Remarks: N/A
