# **Defect Listing**

Pipe Segment Refere		City		Street	Mat	erial	Location C	Sewer Use		
A6-20_A44-1		Oliver Springs		Hen valley	Concrete F	ipe (non	Light High	Sanitary		
Upstream MH		Total Length		Year Laid	Shape		Location Details			
A6-20		340.4			Circ	ular				
DS Manhole A44-1		Length surveyed 340.4		Year Renewed	Height	Width	Pipe Joint			
					8	8	4			
SPR	8	MPR	4	PO Number		Customer				
				4397-03				GRW		
SPRI	2.7	MPRI	2	Work Order	Pre-Reha		Purpose			
QSR	5121	QMR	2200	4397-02			Rehabilitation S	ehabilitation Survey		
Ol	PR	Surve	yed By	Direction	Date		Media label			
1	2	Charlie	Gordon	Downstream	20150828					
OF	PRI	Certificate Number		Pre-Cleaning	Time		Weather			
2.4		U-615-07000491		Jetting	08:52		Dry			
		Date C	End Time		Additional Info					
		2015	0828	09:21		Both mhs are buried

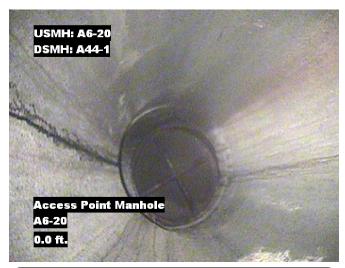
Distance: 0.0 ft. Grade: (

Condition: Access Point Manhole

Remarks: A6-20

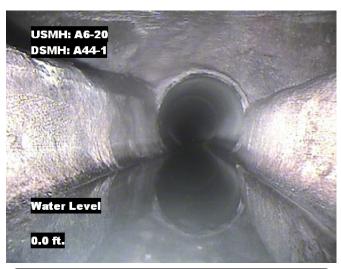
Distance: 0.0 ft. Grade: 0

Condition: Water Level

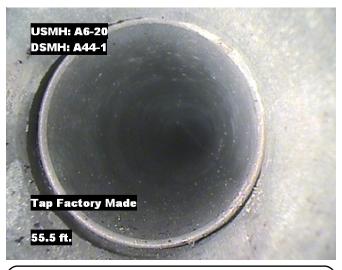
Distance: 55.5 ft. Grade: 0

Condition: Tap Factory Made

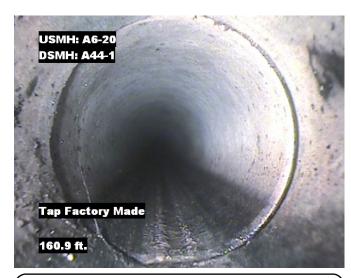
Distance: 160.9 ft. Grade: 0

Condition: Tap Factory Made

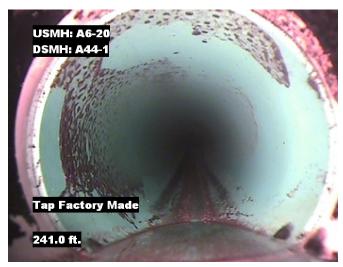
Distance: 241.0 ft. Grade: 0

Condition: Tap Factory Made

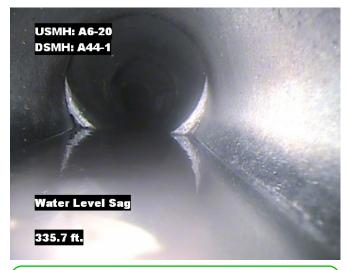
Distance: 335.7 ft. Grade: 2

Condition: Water Level Sag

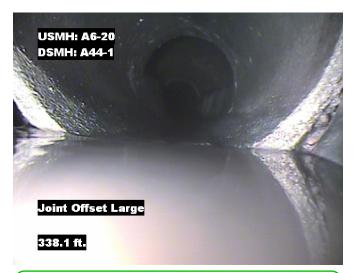
Distance: 338.1 ft. Grade:

Condition: Joint Offset Large

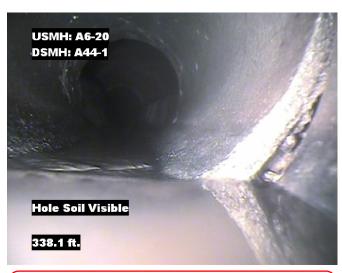
Distance: 338.1 ft. Grade: 5

Condition: Hole Soil Visible

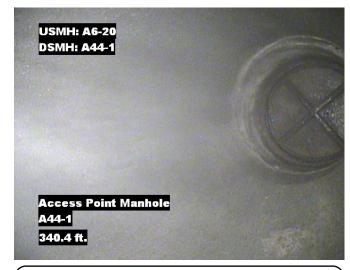
Distance: 340.4 ft. Grade: 0

Condition: Access Point Manhole

Remarks: A44-1
