Defect Listing

Pipe Segment Refere... A6-21_A6-20	City Oliver Springs	Street Hen valley	Material Concrete Pipe (non-...	Location C... Light High...	Sewer Use Sanitary
Upstream MH A6-21	Total Length 257.8	Year Laid	Shape Circular	Location Details	
DS Manhole A6-20	Length surveyed 257.8	Year Renewed	Height 8	Width 8	Pipe Joint... 4

SPR N/A	MPR 11	PO Number 4397-03	Customer GRW
SPRI N/A	MPRI 2.2	Work Order 4397-02	Purpose Pre-Rehabilitation Survey
QSR N/A	QMR 4123		
OPR 11	Surveyed By Charlie Gordon	Direction Downstream	Date 20150828
OPRI 2.2	Certificate Number U-615-07000491	Pre-Cleaning Jetting	Time 08:41
	Date Cleaned 20150828	End Time 08:44	Weather Dry
			Additional Info MANHOLE A6-20 is bu...

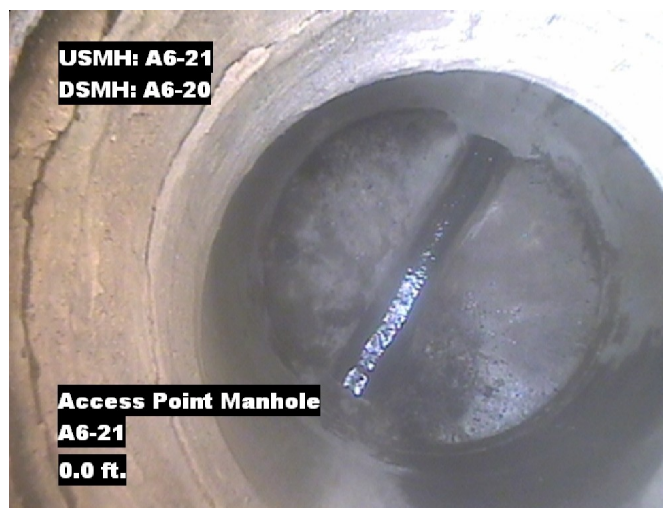
Distance: 0.0 ft. Grade: 0
Condition: Access Point Manhole
Remarks: A6-21

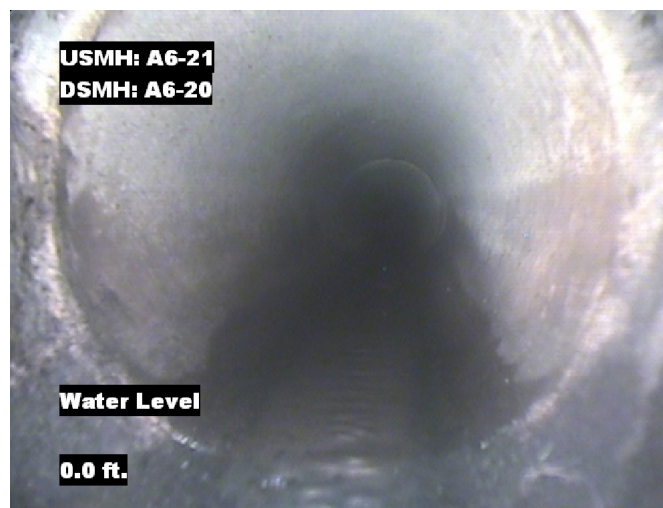
Distance: 0.0 ft. Grade: 0
Condition: Water Level
Remarks: N/A

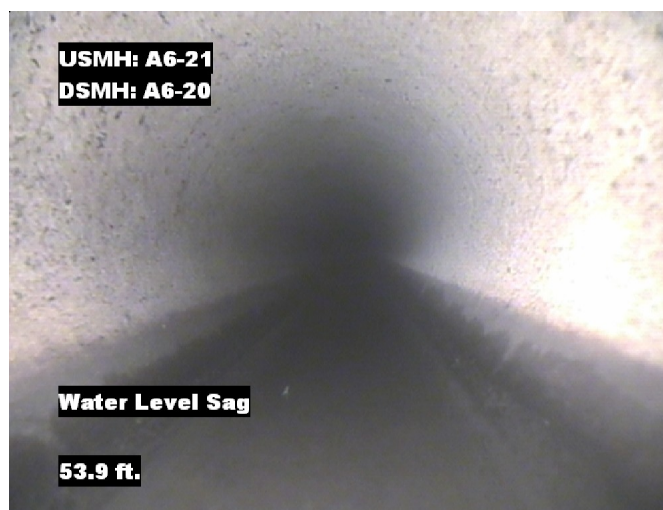
Distance: 53.9 ft. Grade: 2
Condition: Water Level Sag
Remarks: N/A

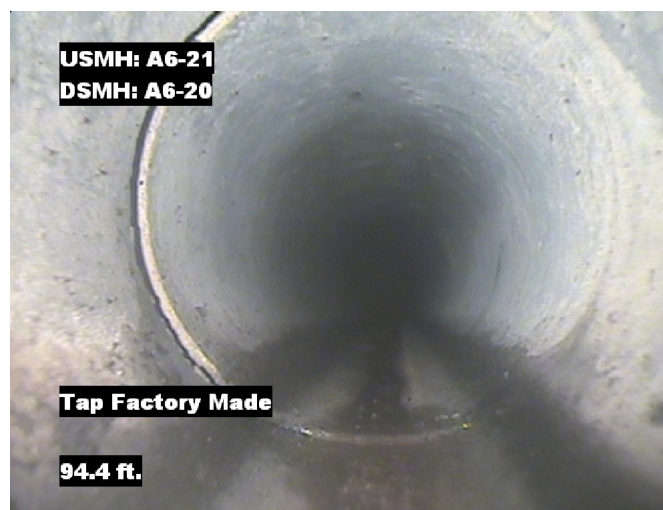
Distance: 94.4 ft. Grade: 0
Condition: Tap Factory Made
Remarks: N/A

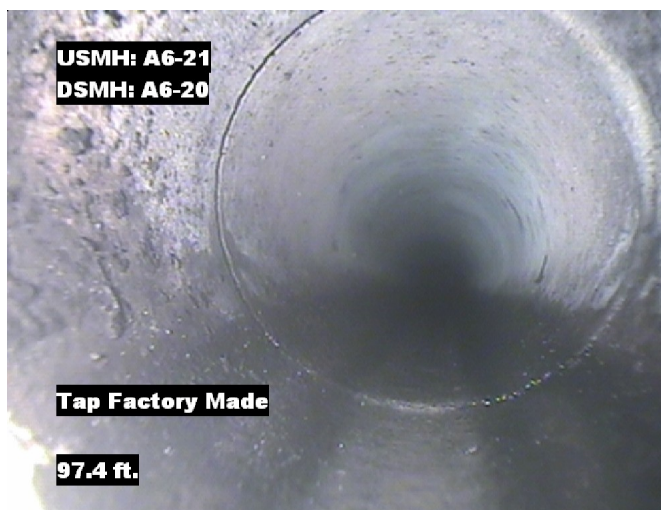
Distance: 97.4 ft. Grade: 0
Condition: Tap Factory Made
Remarks: N/A

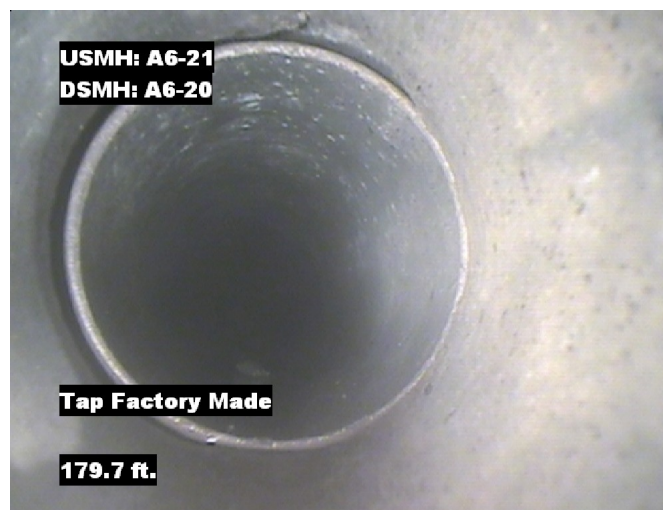
Distance: 179.7 ft. Grade: 0
Condition: Tap Factory Made
Remarks: N/A

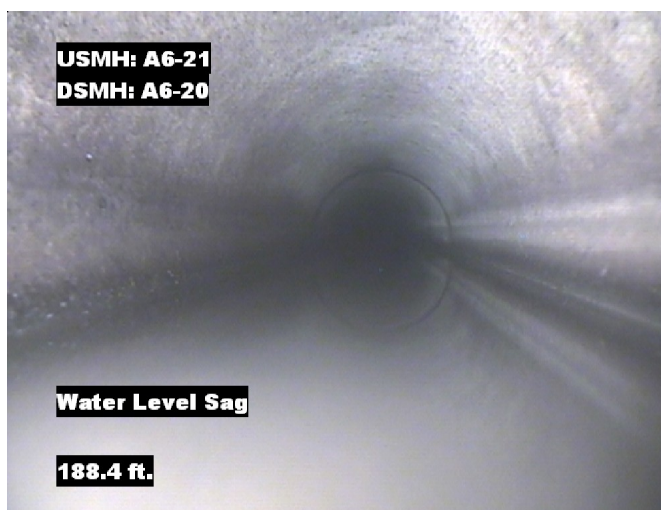
Distance: 188.4 ft. Grade: 2
Condition: Water Level Sag
Remarks: N/A

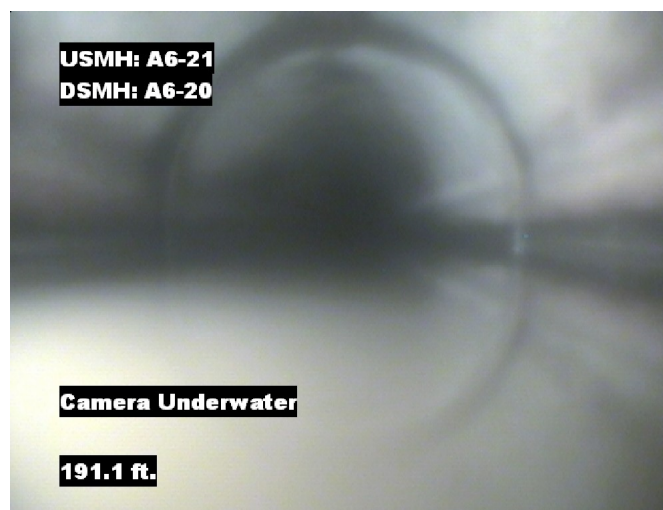
Distance: 191.1 ft. Grade: 4
Condition: Camera Underwater
Remarks: N/A

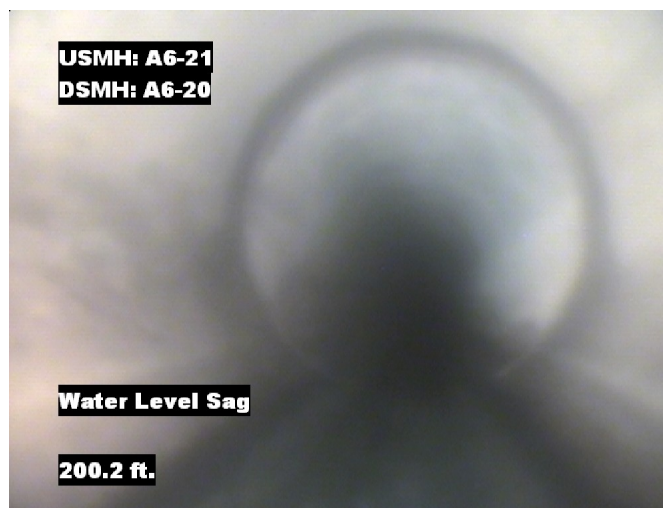
Distance: 200.2 ft. Grade: 2
Condition: Water Level Sag
Remarks: N/A

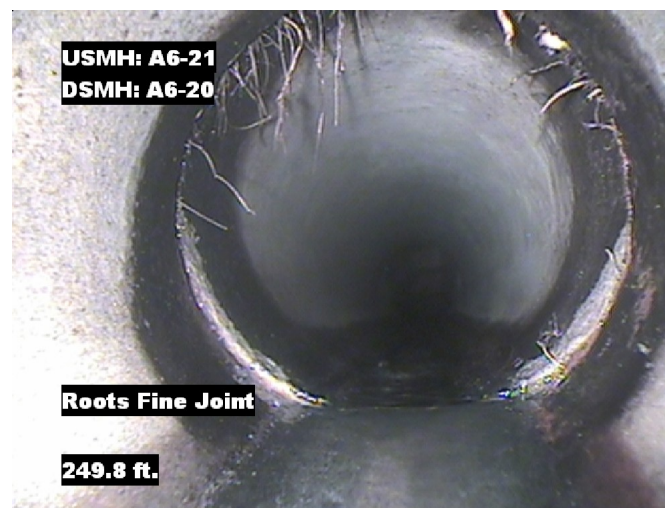
Distance: 249.8 ft. Grade: 1
Condition: Roots Fine Joint
Remarks: N/A

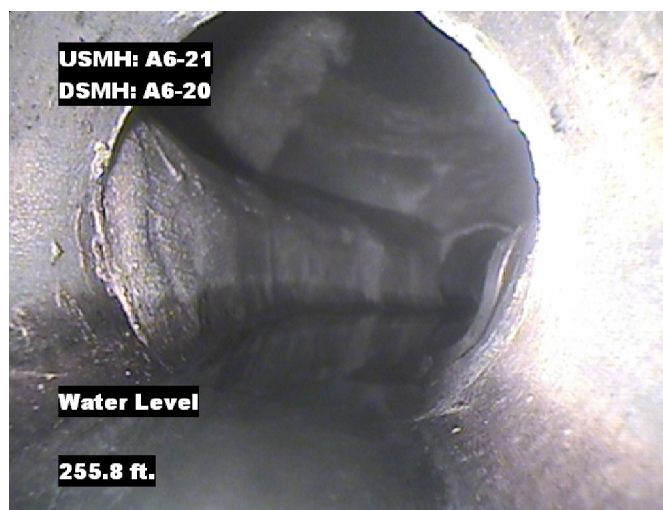
Distance: 255.7 ft. Grade: 0
Condition: Water Level
Remarks: N/A

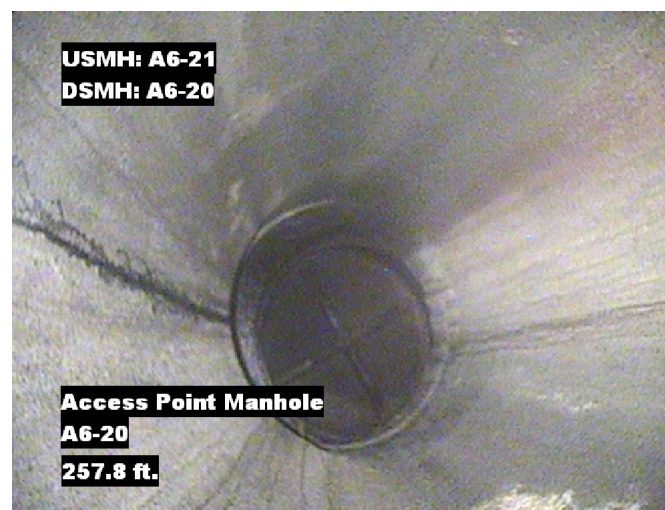
Distance: 257.8 ft. Grade: 0
Condition: Access Point Manhole
Remarks: A6-20
