Defect Listing

Pipe Segment Refere		City		Street	Ma	terial	Location C	Sewer Use	
A6-23_A6-22		Oliver Springs		708 Hen Valley Rd.	Concrete I	Concrete Pipe (non		Sanitary	
Upstream MH T		Total I	_ength	Year Laid	Sh	ape	Location	n Details	
A6-	23	20)3		Circ	cular	Middle of road		
DS Ma	inhole	Length s	surveyed	Year Renewed	Height	Width	Pipe Joint		
A6-	A6-22)3		8	8	4		
SPR	N/A	MPR	1	PO Number		Customer			
0001	-			4397-03		GRW			
SPRI	N/A	MPRI	1	Work Order			Purpose		
QSR	N/A	QMR	1100	4397-02		Pre-Rehabilitation Survey			
OF	PR	Survey	ed By	Direction	Date		Media label		
1	1 Dustin		stin	Downstream	20150807				
OPRI		Certificate Number		Pre-Cleaning	Time		Weather		
1		U-214-06020262		Jetting	13:57		Dry		
	Date Cleaned					End Time		Additional Info	
		2015	0807	14:12

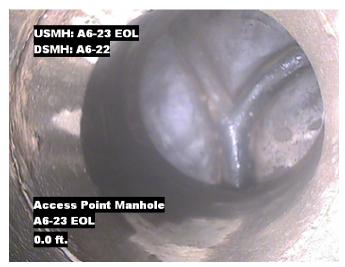
Distance: 0.0 ft. Grade: (

Condition: Access Point Manhole

Remarks: A6-23 EOL

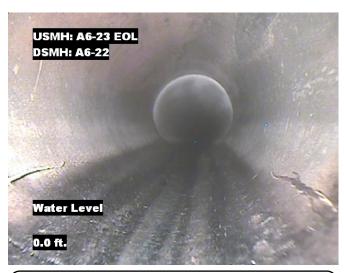
Distance: 0.0 ft. Grade: 0

Condition: Water Level

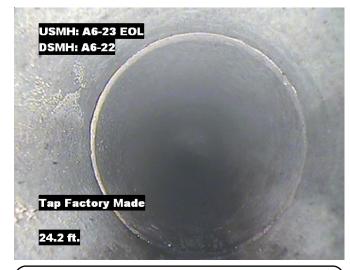
Distance: 24.2 ft. Grade: 0

Condition: Tap Factory Made

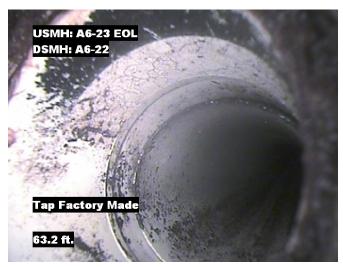
Distance: 63.2 ft. Grade: 0

Condition: Tap Factory Made

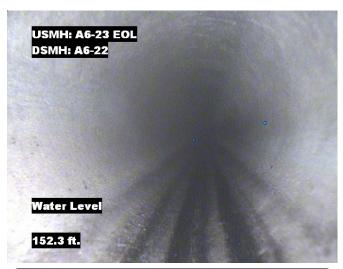
Distance: 152.3 ft. Grade: 0

Condition: Water Level

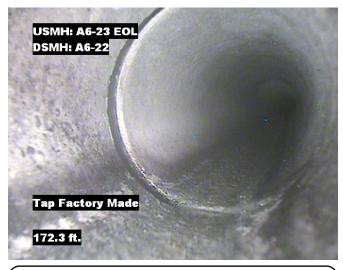
Distance: 172.3 ft. Grade: 0

Condition: Tap Factory Made

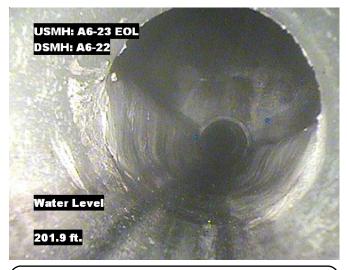
Distance: 201.9 ft. Grade: 0

Condition: Water Level

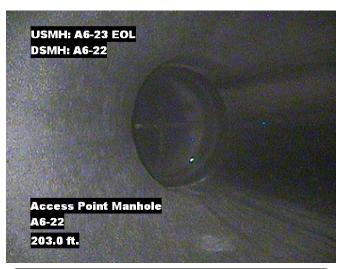
Distance: 203.0 ft. Grade: 0

Condition: Access Point Manhole

Remarks: A6-22
