## Defect Listing

Pipe Segment Refere...	City	Street	Material	Location C...	Sewer Use
<b>A6-3_A6-2</b>	<b>Oliver Springs</b>	<b>Main St</b>	<b>Concrete Pipe (non-...</b>	<b>Yard</b>	<b>Sanitary</b>
Upstream MH	Total Length	Year Laid	Shape	Location Details	
<b>A6-3</b>	<b>264.8</b>		<b>Circular</b>		
DS Manhole	Length surveyed	Year Renewed	Height	Width	Pipe Joint...
<b>A6-2</b>	<b>264.8</b>		<b>8</b>	<b>8</b>	<b>4</b>

SPR	N/A	MPR	41	PO Number	Customer
SPRI	N/A	MPRI	2.3	<b>4397-03</b>	<b>GRW</b>
QSR	N/A	QMR	4231	Work Order	Purpose
			<b>4397-02</b>	<b>Pre-Rehabilitation Survey</b>	
OPR	Surveyed By	Direction	Date	Media label	
<b>41</b>	<b>Charlie Gordon</b>	<b>Downstream</b>	<b>20150827</b>		
OPRI	Certificate Number	Pre-Cleaning	Time	Weather	
<b>2.3</b>	<b>U-615-07000491</b>	<b>Jetting</b>	<b>11:25</b>	<b>Damp</b>	
Date Cleaned			End Time	Additional Info	
<b>20150827</b>			<b>11:30</b>

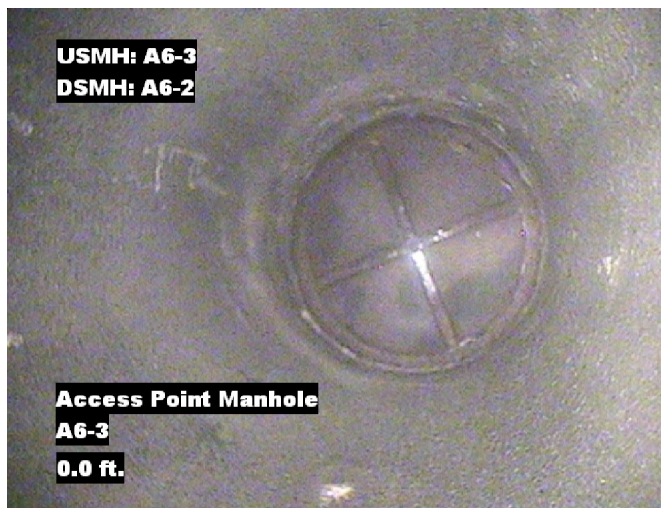
Distance: 0.0 ft. Grade: 0  
Condition: Access Point Manhole  
Remarks: A6-3

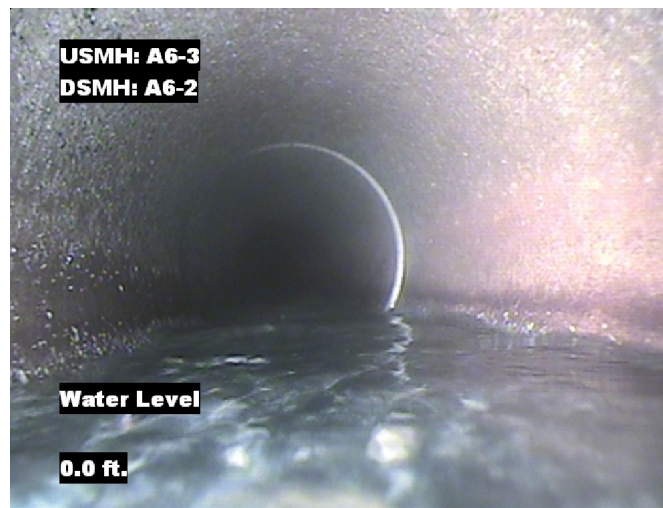
Distance: 0.0 ft. Grade: 0  
Condition: Water Level  
Remarks: N/A

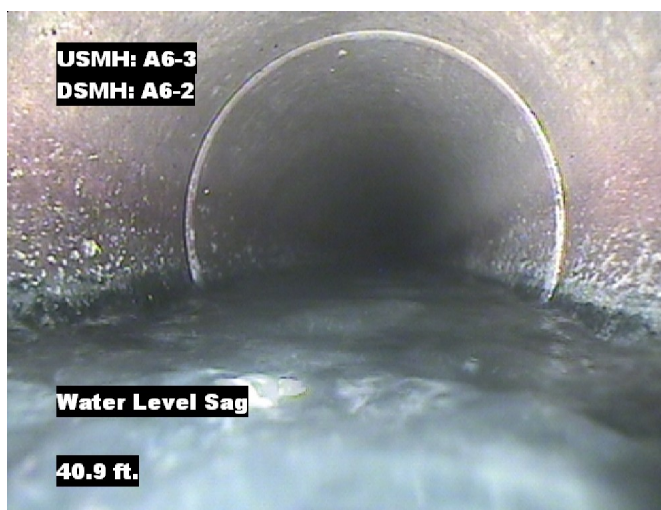
Distance: 40.9 ft. Grade: 2  
Condition: Water Level Sag  
Remarks: N/A

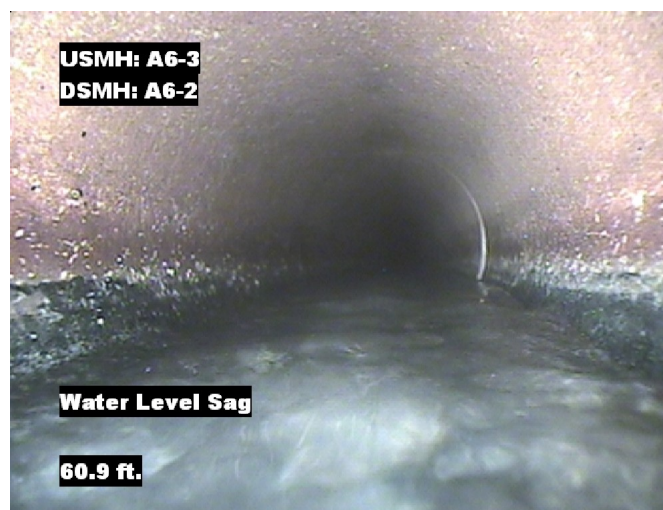
Distance: 60.9 ft. Grade: 2  
Condition: Water Level Sag  
Remarks: N/A

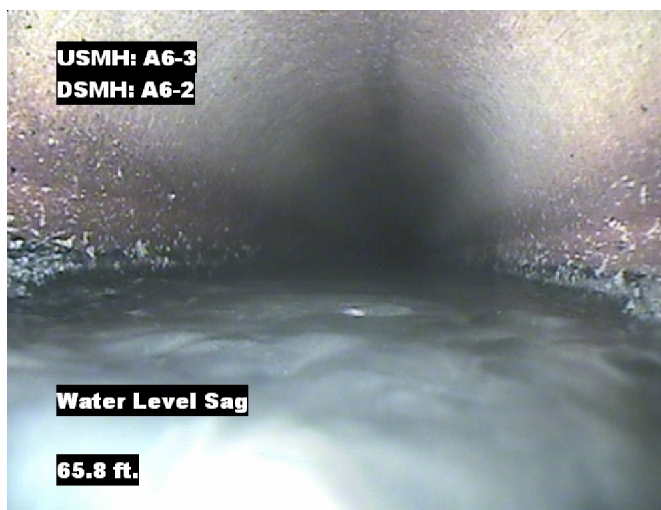
Distance: 65.8 ft. Grade: 2  
Condition: Water Level Sag  
Remarks: N/A

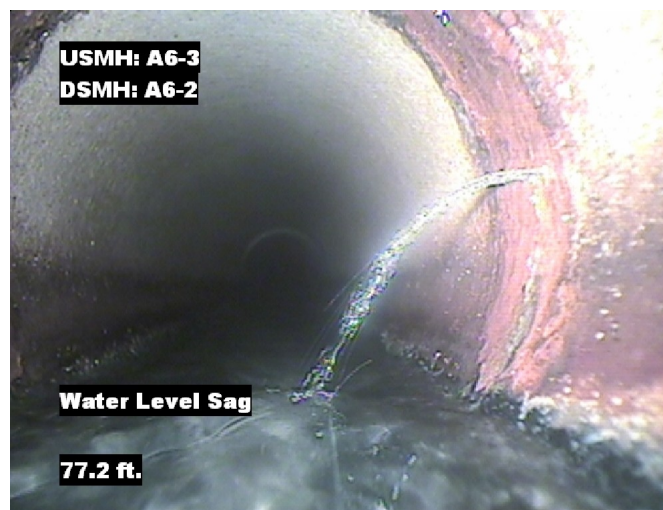
Distance: 77.2 ft. Grade: 2  
Condition: Water Level Sag  
Remarks: N/A

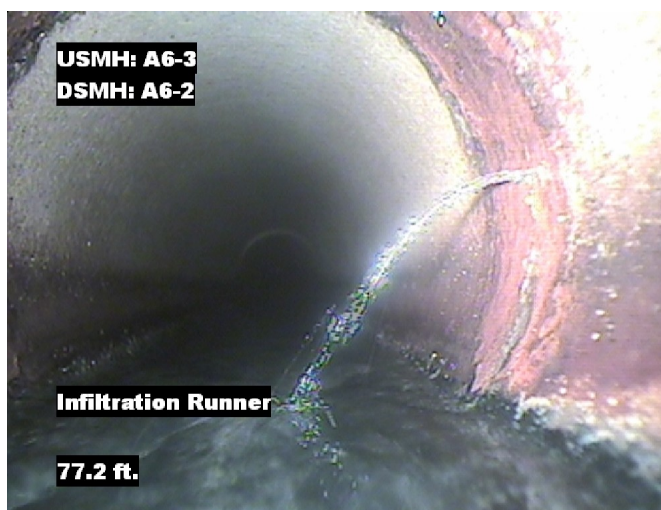
Distance: 77.2 ft. Grade: 4  
Condition: Infiltration Runner  
Remarks: N/A

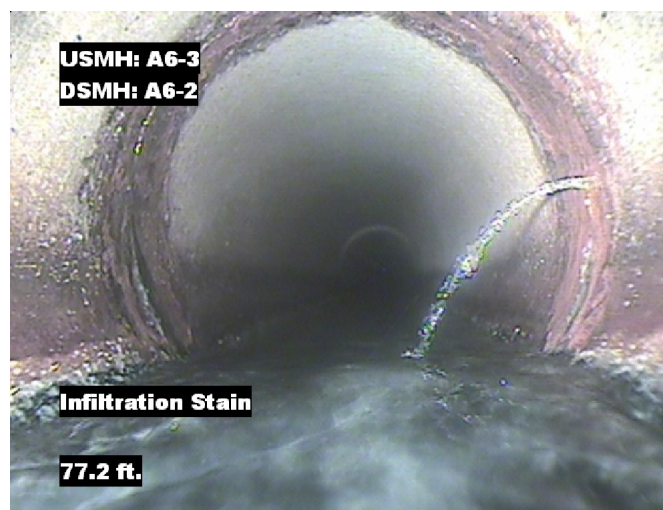
Distance: 77.2 ft. Grade: 0  
Condition: Infiltration Stain  
Remarks: N/A

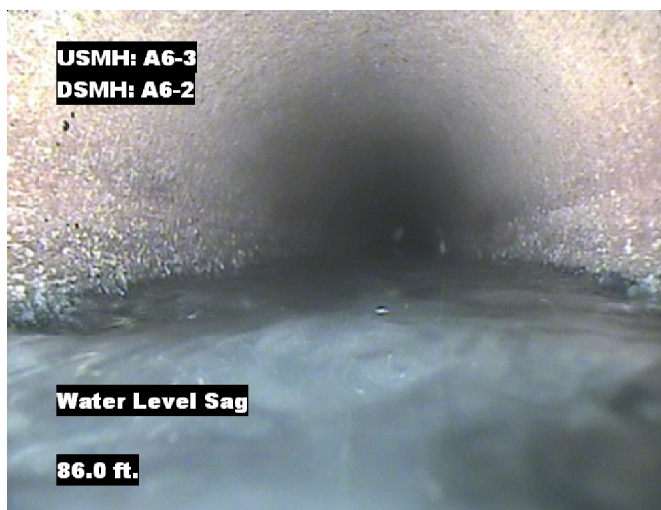
Distance: 86.0 ft. Grade: 2  
Condition: Water Level Sag  
Remarks: N/A

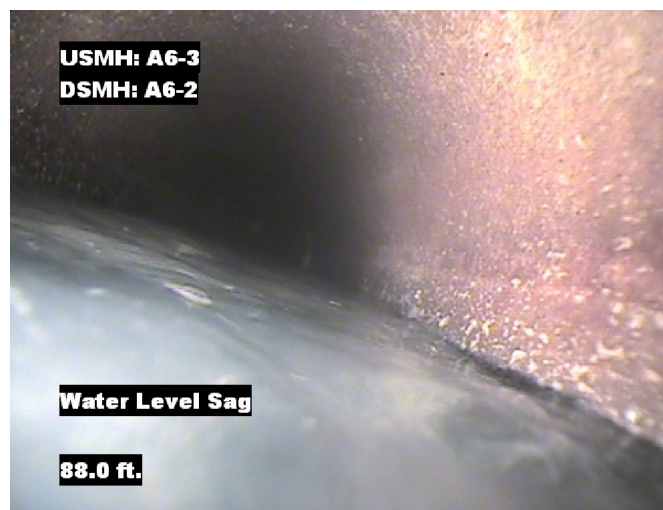
Distance: 88.0 ft. Grade: 2  
Condition: Water Level Sag  
Remarks: N/A

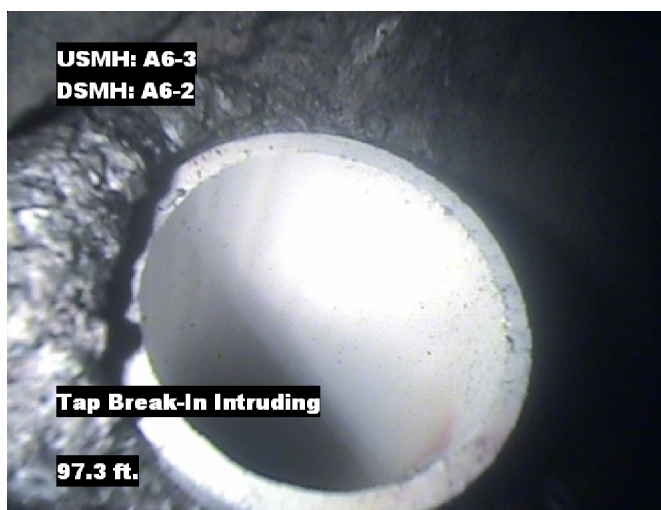
Distance: 97.3 ft. Grade: 2  
Condition: Tap Break-In Intruding  
Remarks: N/A

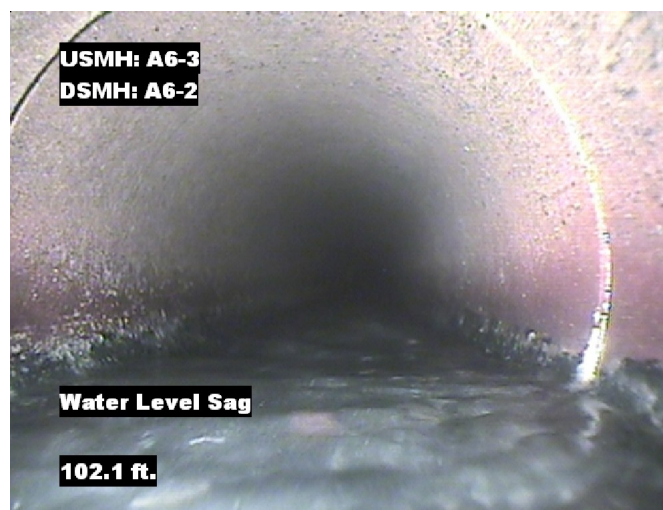
Distance: 102.1 ft. Grade: 2  
Condition: Water Level Sag  
Remarks: N/A

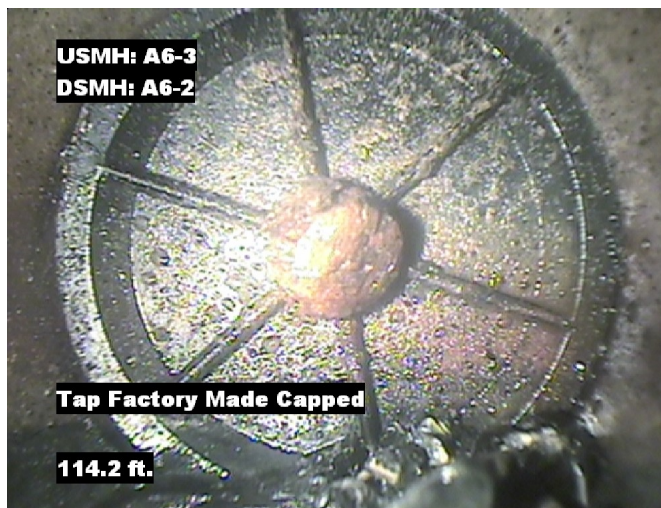
Distance: 114.2 ft. Grade: 0  
Condition: Tap Factory Made Capped  
Remarks: N/A

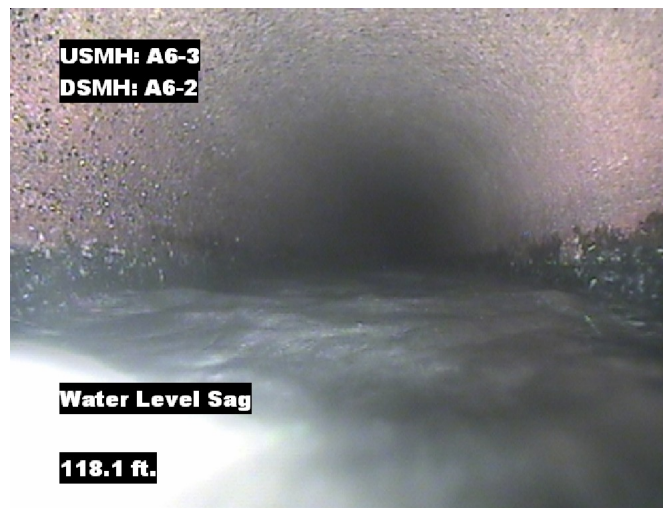
Distance: 118.1 ft. Grade: 2  
Condition: Water Level Sag  
Remarks: N/A

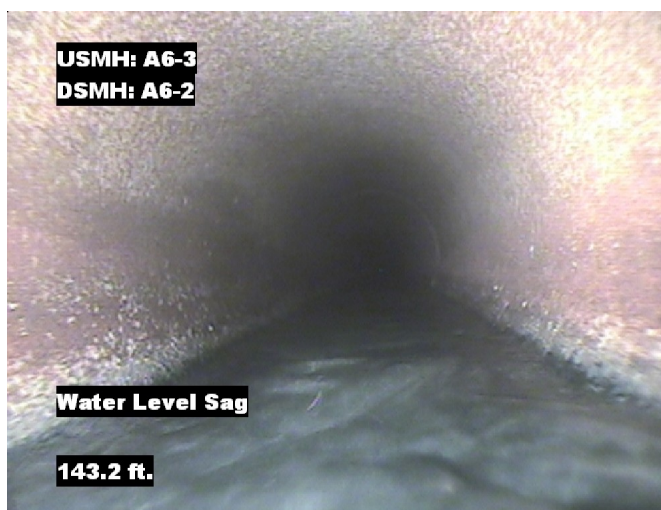
Distance: 143.0 ft. Grade: 2  
Condition: Water Level Sag  
Remarks: N/A

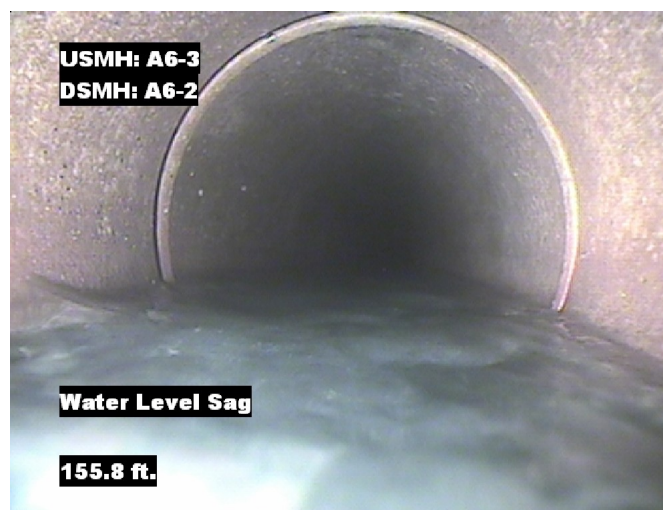
Distance: 155.8 ft. Grade: 2  
Condition: Water Level Sag  
Remarks: N/A

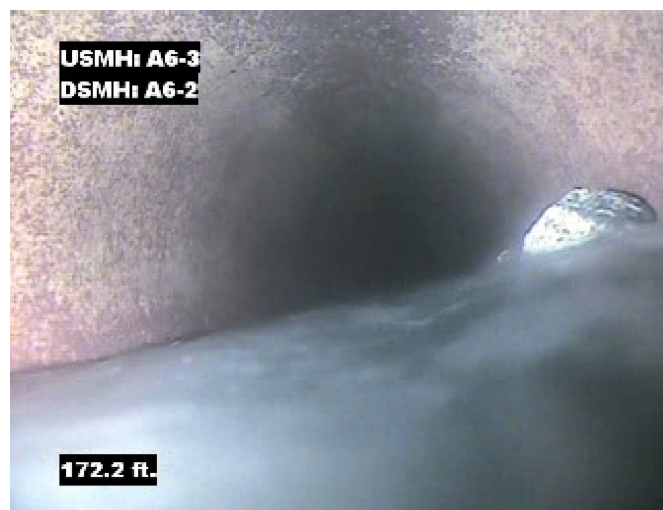
Distance: 171.0 ft. Grade: 3  
Condition: Obstacles Brick  
Remarks: N/A

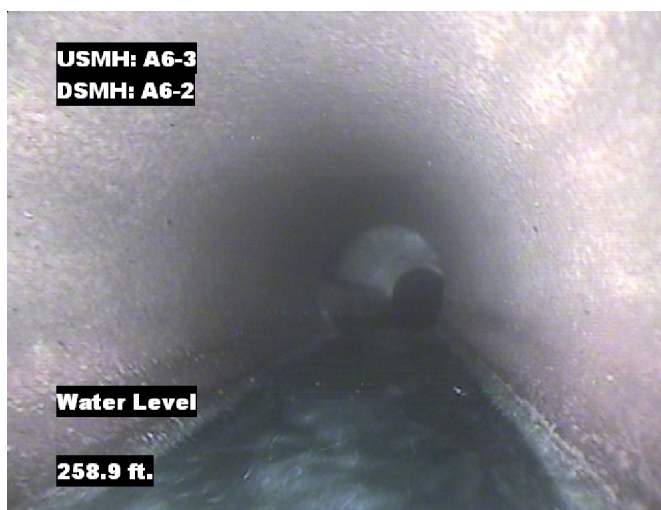
Distance: 258.9 ft. Grade: 0  
Condition: Water Level  
Remarks: N/A

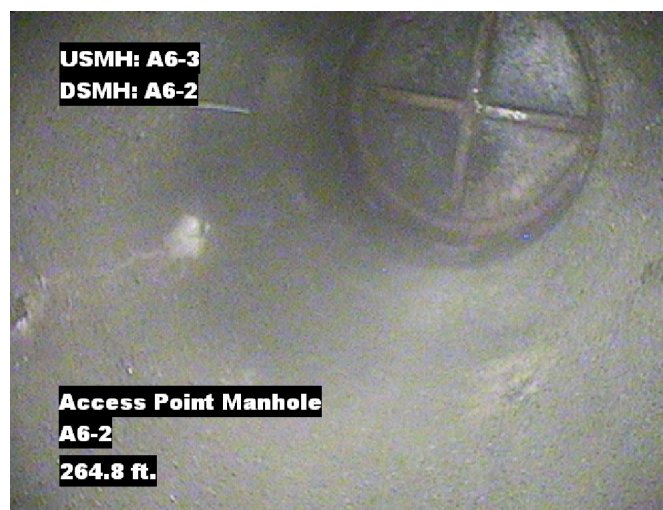
Distance: 264.8 ft. Grade: 0  
Condition: Access Point Manhole  
Remarks: A6-2
