## Defect Listing

Pipe Segment Refere...	City	Street	Material	Location C...	Sewer Use
<b>A6-4_A6-3</b>	<b>Oliver Springs</b>	<b>Main St</b>	<b>Concrete Pipe (non-...</b>	<b>Yard</b>	<b>Sanitary</b>
Upstream MH	Total Length	Year Laid	Shape	Location Details	
<b>A6-4</b>	<b>254.3</b>		<b>Circular</b>		
DS Manhole	Length surveyed	Year Renewed	Height	Width	Pipe Joint...
<b>A6-3</b>	<b>254.3</b>		<b>8</b>	<b>8</b>	<b>4</b>

## Image Report 4/Page

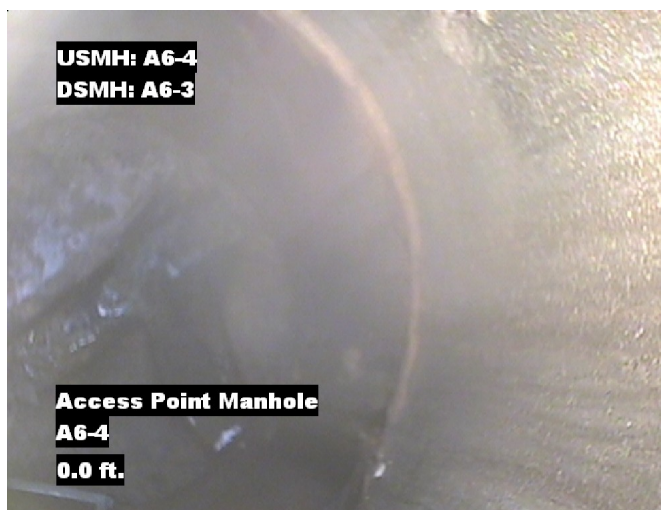
Distance: 0.0 ft. Grade: 0  
Condition: Access Point Manhole  
Remarks: A6-4

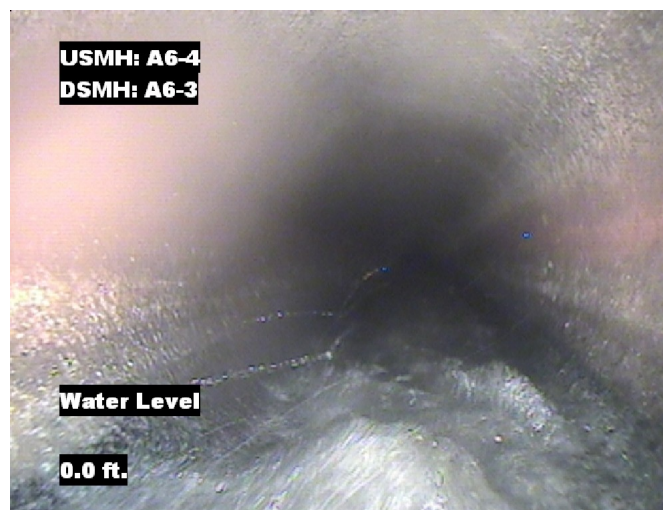
Distance: 0.0 ft. Grade: 0  
Condition: Water Level  
Remarks: N/A

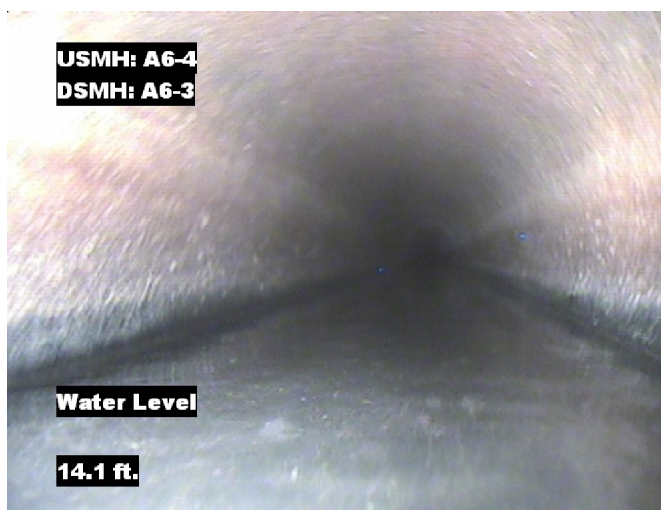
Distance: 14.0 ft. Grade: 0  
Condition: Water Level  
Remarks: N/A

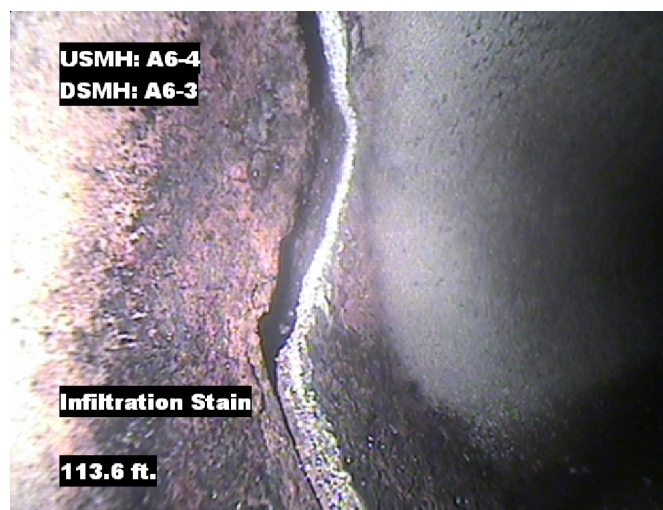
Distance: 113.6 ft. Grade: 0  
Condition: Infiltration Stain  
Remarks: N/A

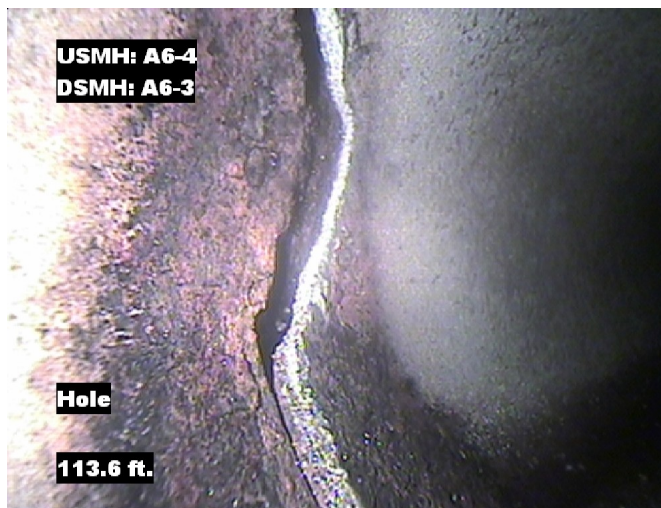
Distance: 113.6 ft. Grade: 3  
Condition: Hole  
Remarks: N/A

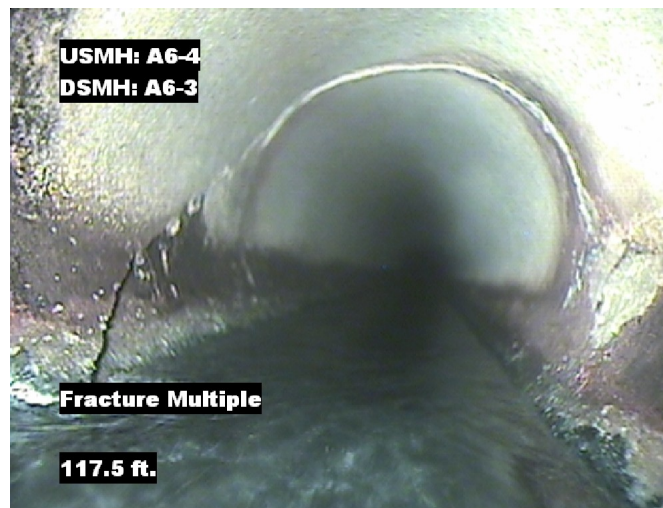
Distance: 117.5 ft. Grade: 4  
Condition: Fracture Multiple  
Remarks: N/A

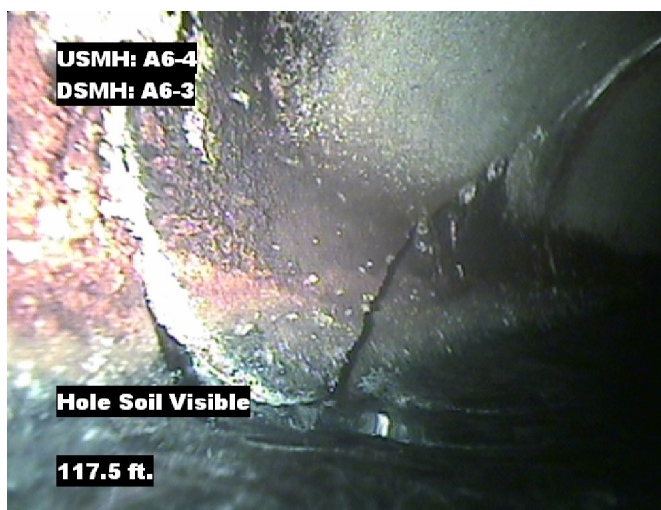
Distance: 117.5 ft. Grade: 5  
Condition: Hole Soil Visible  
Remarks: N/A

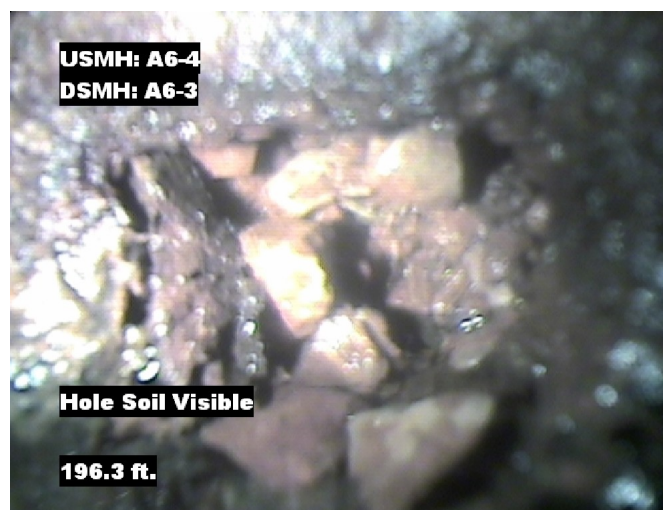
Distance: 196.3 ft. Grade: 5  
Condition: Hole Soil Visible  
Remarks: N/A

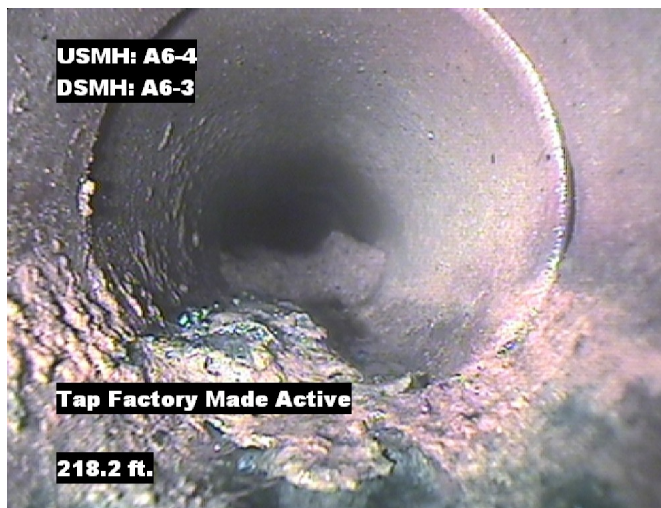
Distance: 218.2 ft. Grade: 0  
Condition: Tap Factory Made Active  
Remarks: N/A

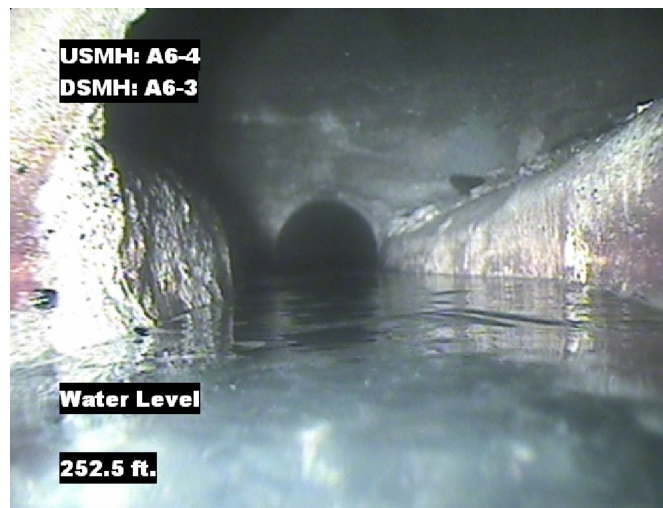
Distance: 252.5 ft. Grade: 0  
Condition: Water Level  
Remarks: N/A

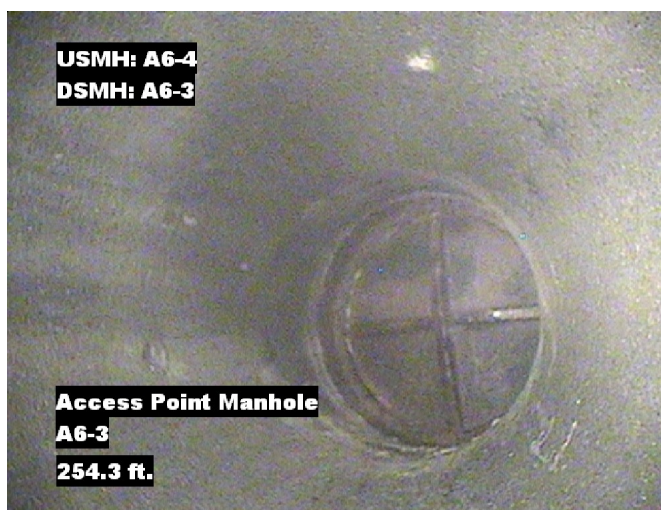
Distance: 254.3 ft. Grade: 0  
Condition: Access Point Manhole  
Remarks: A6-3
