## **Defect Listing**

Pipe Segment Refere		City		Street	Mat	Material		Sewer Use		
A6-5_A6-4		Oliver Springs		Main St	Ductile	<b>Ductile Iron Pipe</b>		Sanitary		
Upstream MH		Total Length		Year Laid	Shape		Location	n Details		
A6-5		69.8			Circ	cular				
DS Manhole		Length surveyed		Year Renewed	Height	Width	Pipe Joint			
A6-4		69.8			8	8	13			
SPR	N/A	MPR	N/A	PO Number	Customer					
0001			-	4397-03				GRW		
SPRI	N/A	MPRI	N/A	Work Order				Purpose		
QSR	N/A	QMR	N/A	4397-02		Pre	Pre-Rehabilitation Survey			
OF	PR	Surveyed By		Direction	Date		Media label			
N/	N/A		Gordon	Downstream	20150826					
OPRI		Certificate Number		Pre-Cleaning	Time		Weather			
N/A		U-615-07000491		Jetting	14:10		Dry			
Date Cleaned						End Time		Additional Info		
20150826						14:15

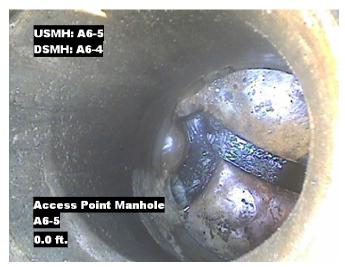
Distance: 0.0 ft. Grade: (

Condition: Access Point Manhole

Remarks: A6-5

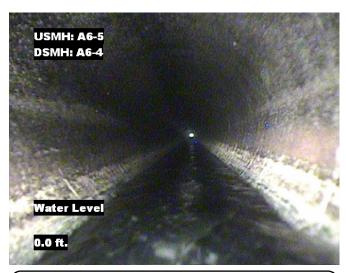
Distance: 0.0 ft. Grade: (

Condition: Water Level

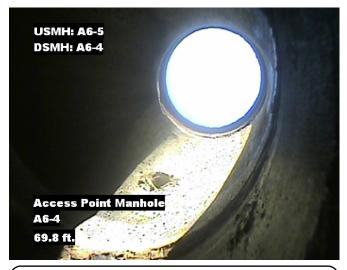
Distance: 69.8 ft. Grade: 0

Condition: Access Point Manhole

Remarks: A6-4
