## Defect Listing

Pipe Segment Refere...	City	Street	Material	Location C...	Sewer Use
<b>A6-6_A6-5</b>	<b>Oliver Springs</b>	<b>Main St</b>	<b>Fibreglass Reinforc...</b>	<b>Yard</b>	<b>Sanitary</b>
Upstream MH	Total Length	Year Laid	Shape	Location Details	
<b>A6-6</b>	<b>376</b>		<b>Circular</b>		
DS Manhole	Length surveyed	Year Renewed	Height	Width	Pipe Joint...
<b>A6-5</b>	<b>376</b>		<b>8</b>	<b>8</b>	<b>N/A</b>

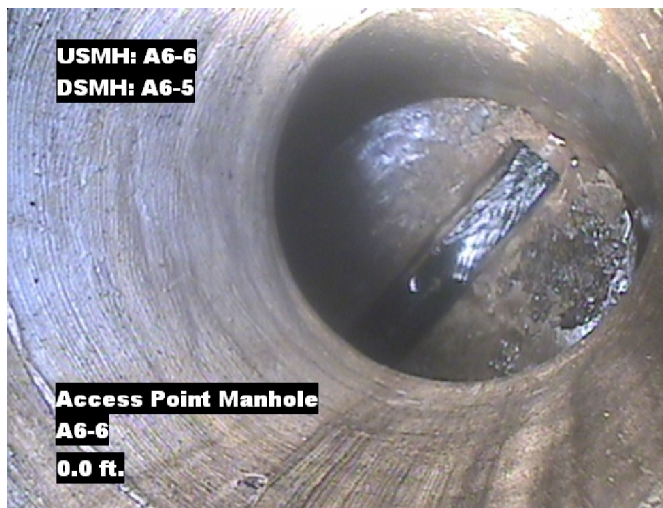
Distance: 0.0 ft. Grade: 0  
Condition: Access Point Manhole  
Remarks: A6-6

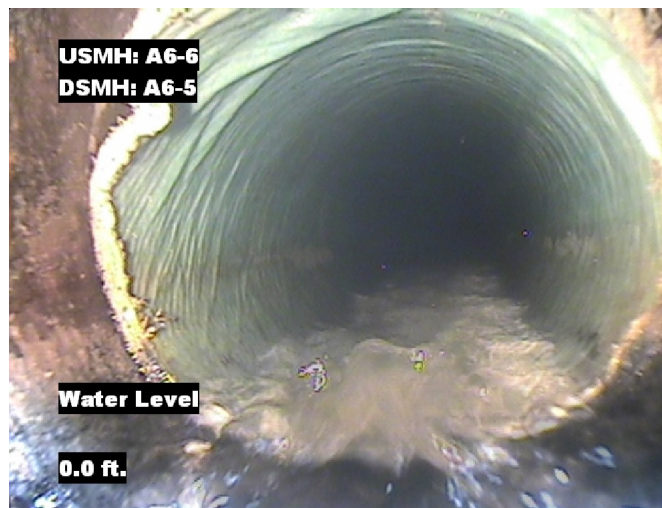
Distance: 0.0 ft. Grade: 0  
Condition: Water Level  
Remarks: N/A

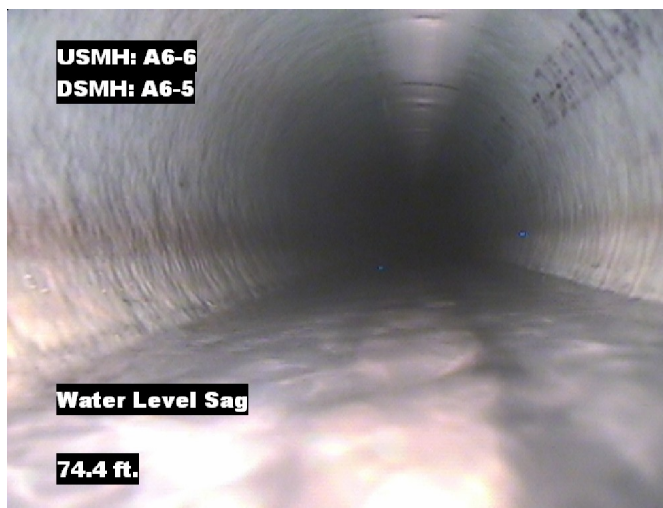
Distance: 74.4 ft. Grade: 2  
Condition: Water Level Sag  
Remarks: N/A

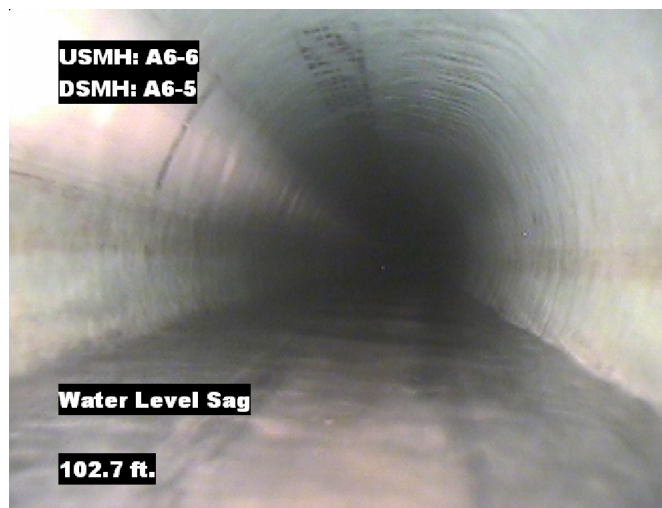
Distance: 102.7 ft. Grade: 2  
Condition: Water Level Sag  
Remarks: N/A

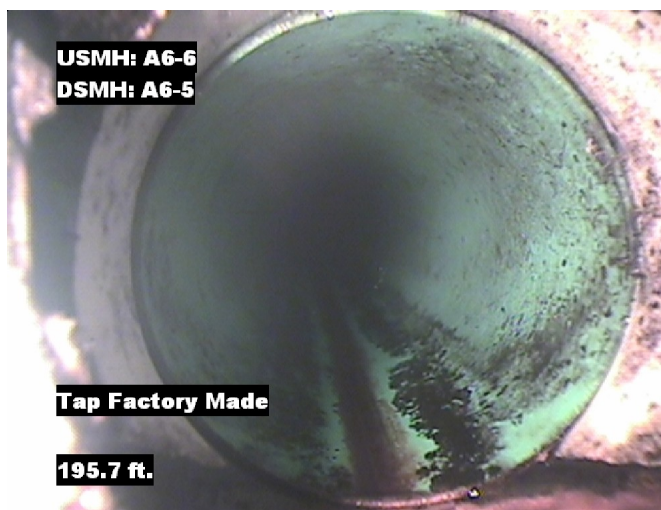
Distance: 195.7 ft. Grade: 0  
Condition: Tap Factory Made  
Remarks: N/A

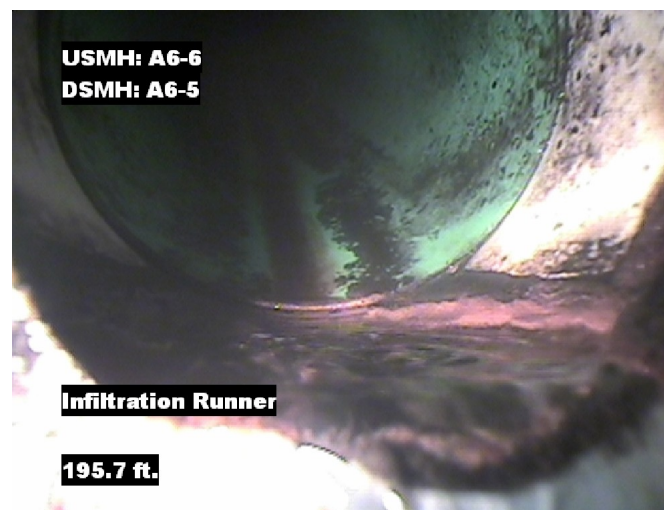
Distance: 195.7 ft. Grade: 4  
Condition: Infiltration Runner  
Remarks: N/A

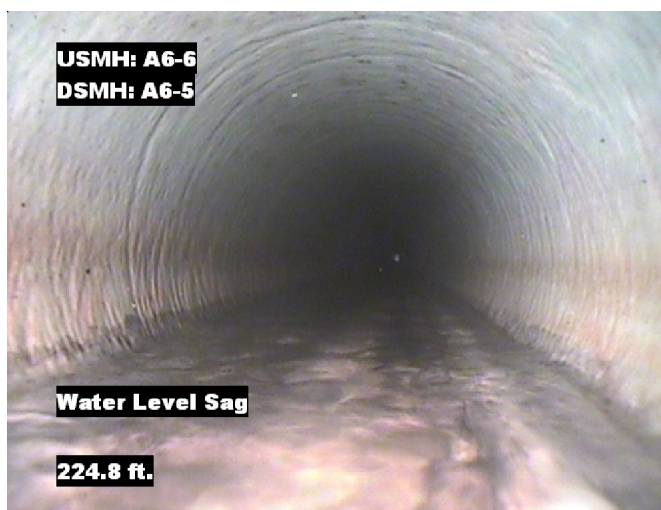
Distance: 224.8 ft. Grade: 2  
Condition: Water Level Sag  
Remarks: N/A

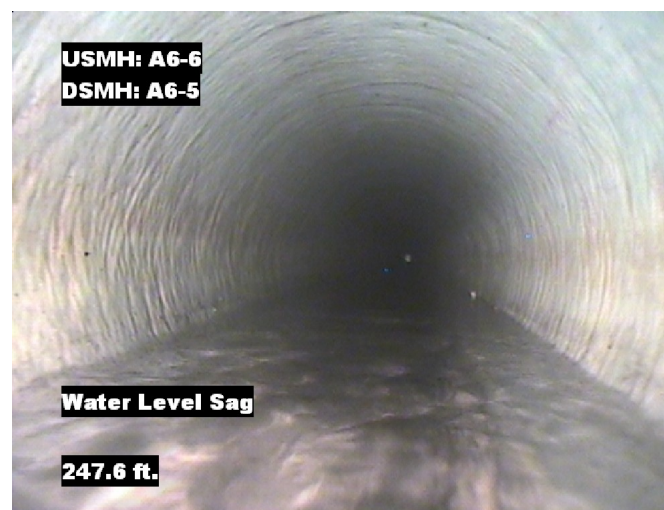
Distance: 247.6 ft. Grade: 2  
Condition: Water Level Sag  
Remarks: N/A

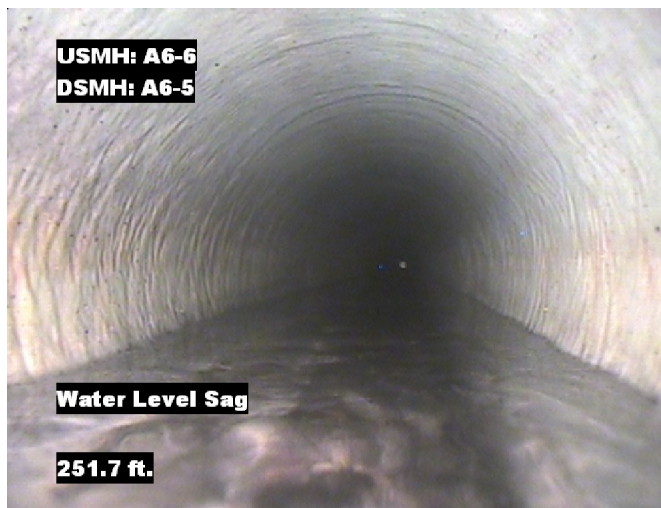
Distance: 251.7 ft. Grade: 2  
Condition: Water Level Sag  
Remarks: N/A

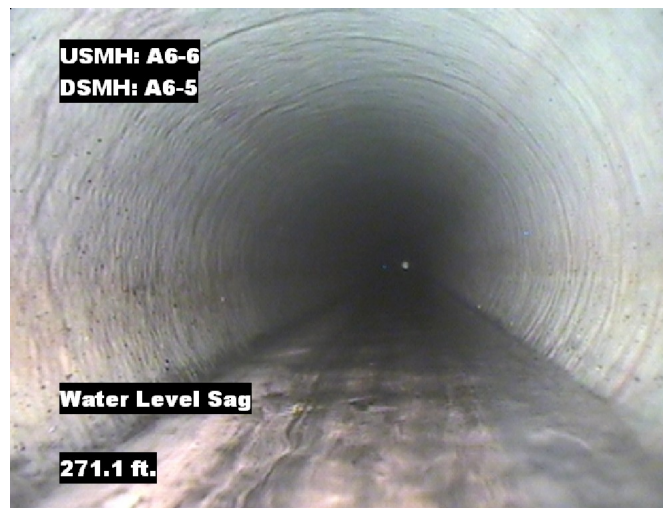
Distance: 271.1 ft. Grade: 2  
Condition: Water Level Sag  
Remarks: N/A

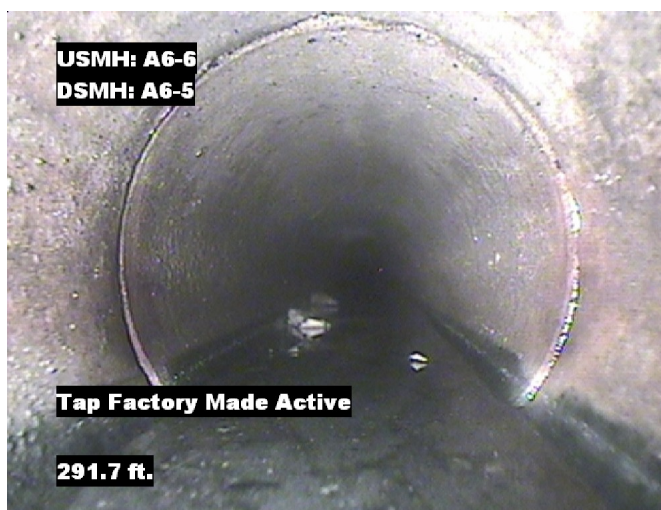
Distance: 291.7 ft. Grade: 0  
Condition: Tap Factory Made Active  
Remarks: N/A

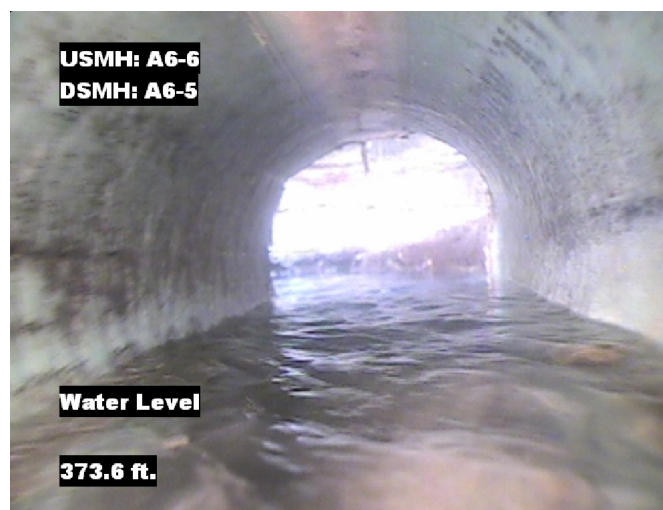
Distance: 373.5 ft. Grade: 0  
Condition: Water Level  
Remarks: N/A

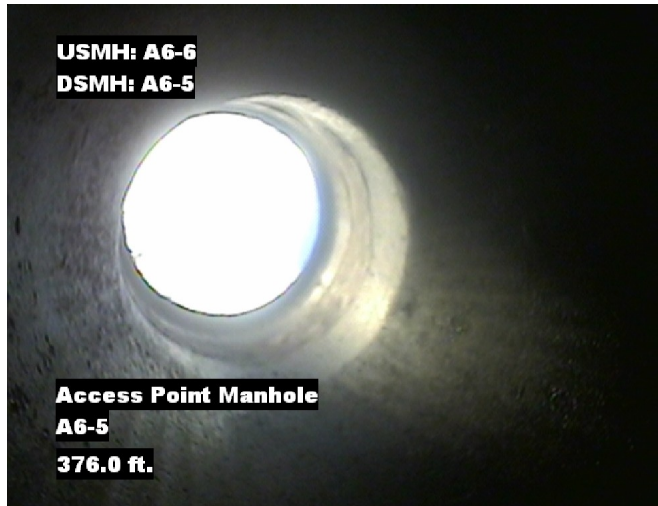
Distance: 376.0 ft. Grade: 0  
Condition: Access Point Manhole  
Remarks: A6-5
