Defect Listing

Pipe Segment Refere... A6-6A_A6-6	City Oliver Springs	Street Tri county boulevard...	Material Concrete Pipe (non-...	Location C... Easement/R...	Sewer Use Sanitary
Upstream MH A6-6A	Total Length 115.7	Year Laid	Shape Circular	Location Details	
DS Manhole A6-6	Length surveyed 115.7	Year Renewed	Height 8	Width 8	Pipe Joint... 4

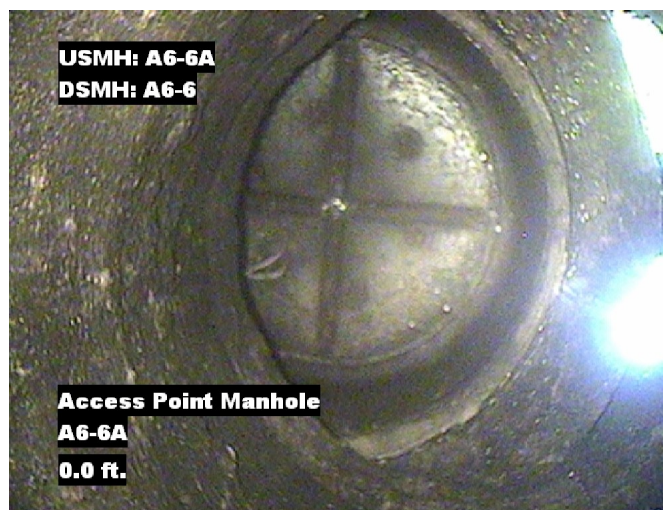
Distance: 0.0 ft. Grade: 0
Condition: Access Point Manhole
Remarks: A6-6A

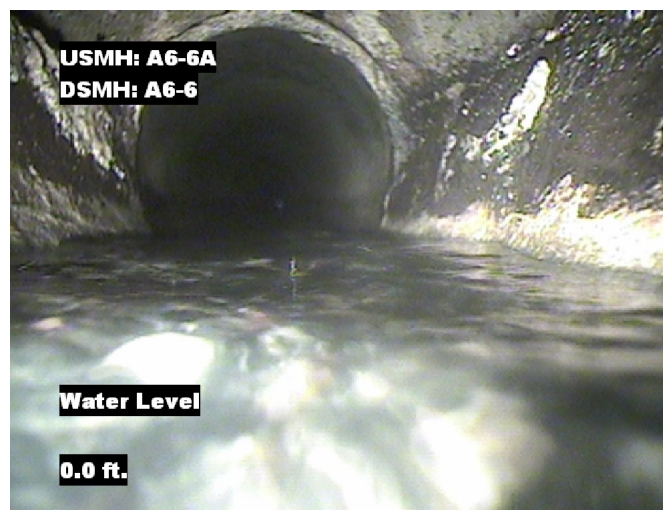
Distance: 0.0 ft. Grade: 0
Condition: Water Level
Remarks: N/A

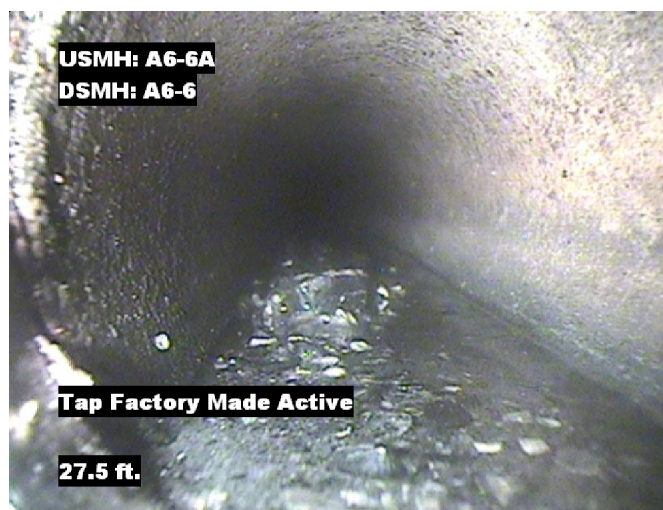
Distance: 27.5 ft. Grade: 0
Condition: Tap Factory Made Active
Remarks: N/A

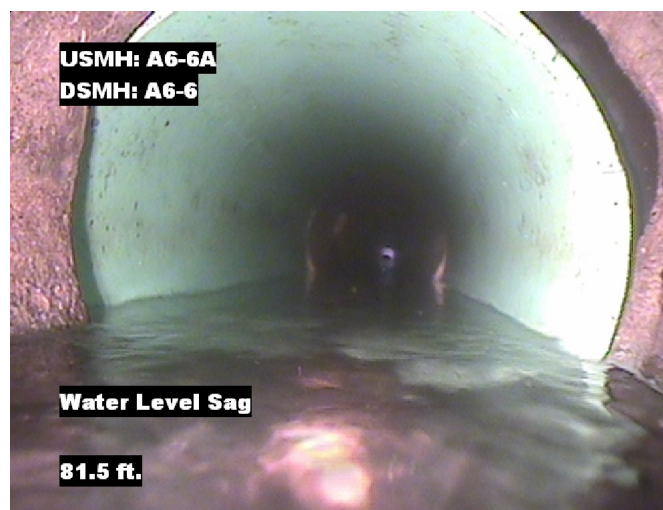
Distance: 81.5 ft. Grade: 2
Condition: Water Level Sag
Remarks: N/A

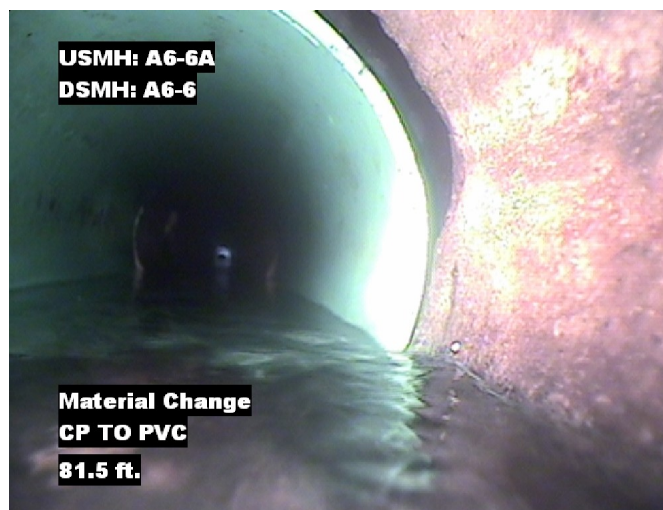
Distance: 81.5 ft. Grade: 0
Condition: Material Change
Remarks: CP TO PVC

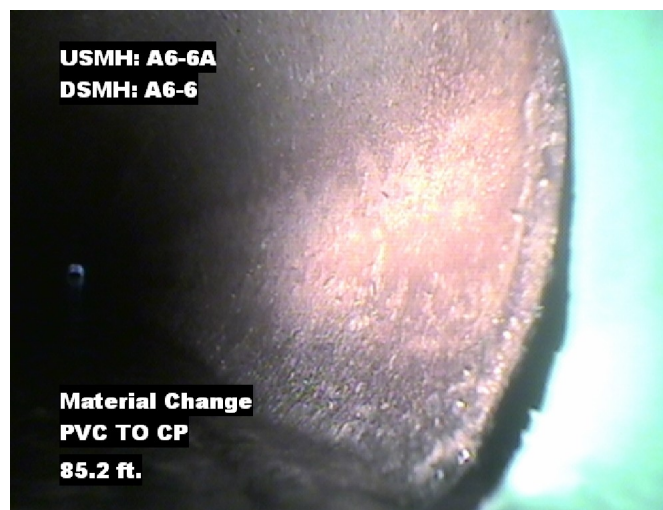
Distance: 85.2 ft. Grade: 0
Condition: Material Change
Remarks: PVC TO CP

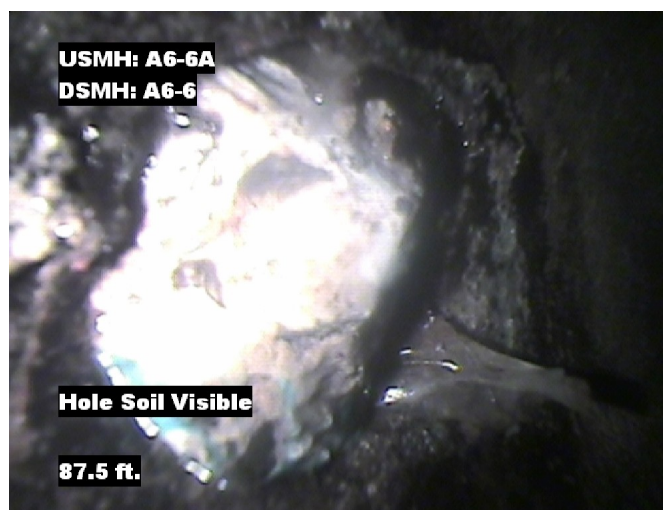
Distance: 87.5 ft. Grade: 5
Condition: Hole Soil Visible
Remarks: N/A

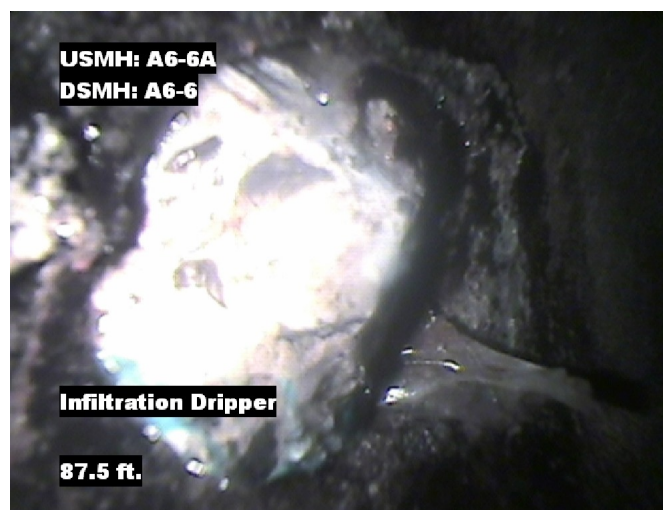
Distance: 87.5 ft. Grade: 3
Condition: Infiltration Dripper
Remarks: N/A

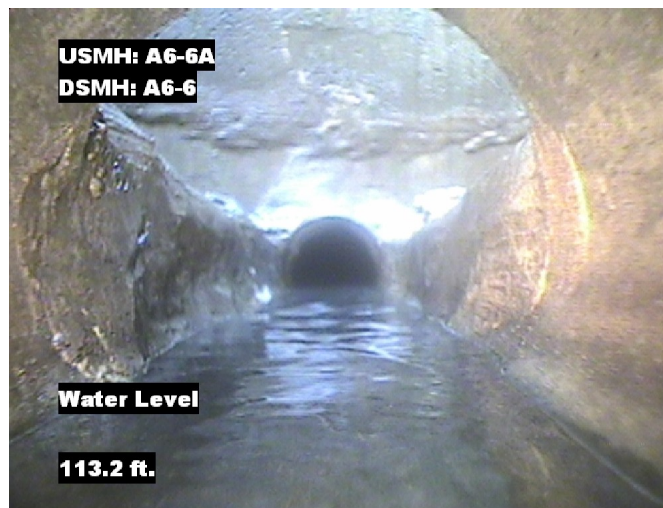
Distance: 113.0 ft. Grade: 0
Condition: Water Level
Remarks: N/A

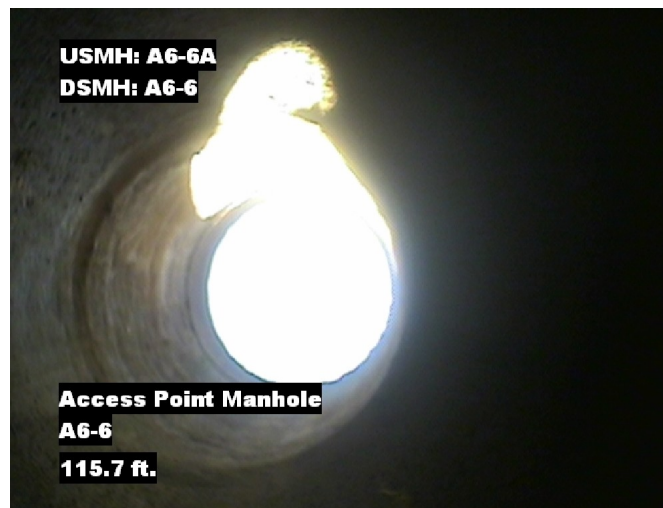
Distance: 115.7 ft. Grade: 0
Condition: Access Point Manhole
Remarks: A6-6
