## Defect Listing

Pipe Segment Refere... <b>A6-6B_A6-6A</b>	City <b>Oliver Springs</b>	Street <b>highway 61</b>	Material <b>Concrete Pipe (non-...</b>	Location C... <b>Yard</b>	Sewer Use <b>Sanitary</b>
Upstream MH <b>A6-6B</b>	Total Length <b>2</b>	Year Laid	Shape <b>Circular</b>	Location Details	
DS Manhole <b>A6-6A</b>	Length surveyed <b>2</b>	Year Renewed	Height <b>6</b>	Width <b>6</b>	Pipe Joint... <b>4</b>

## Image Report 4/Page

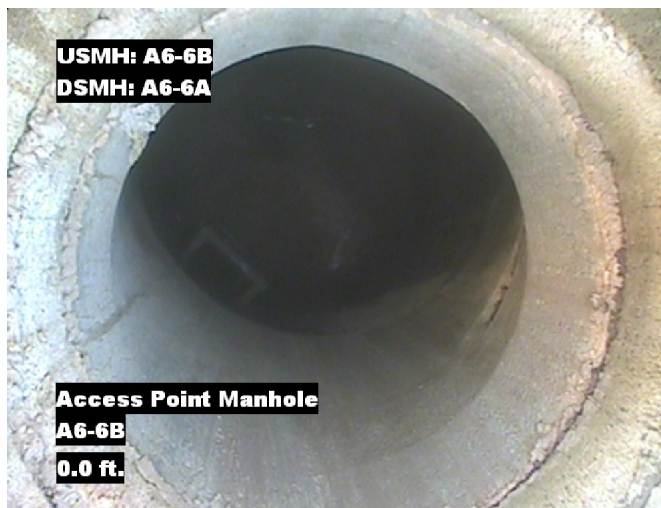
Distance: 0.0 ft. Grade: 0  
Condition: Access Point Manhole  
Remarks: A6-6B

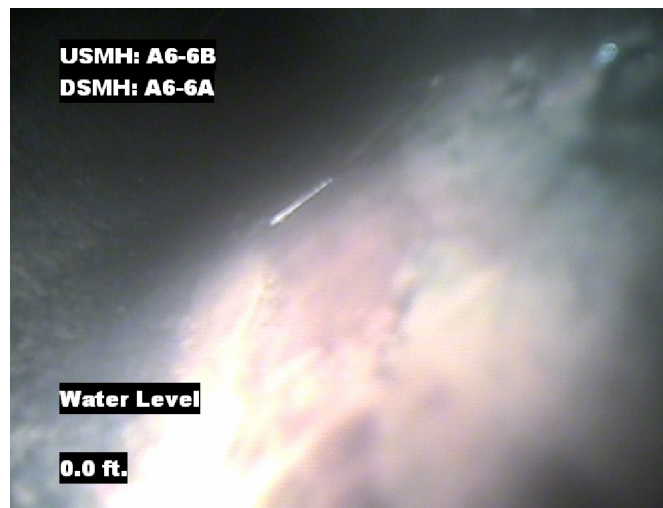
Distance: 0.0 ft. Grade: 0  
Condition: Water Level  
Remarks: N/A

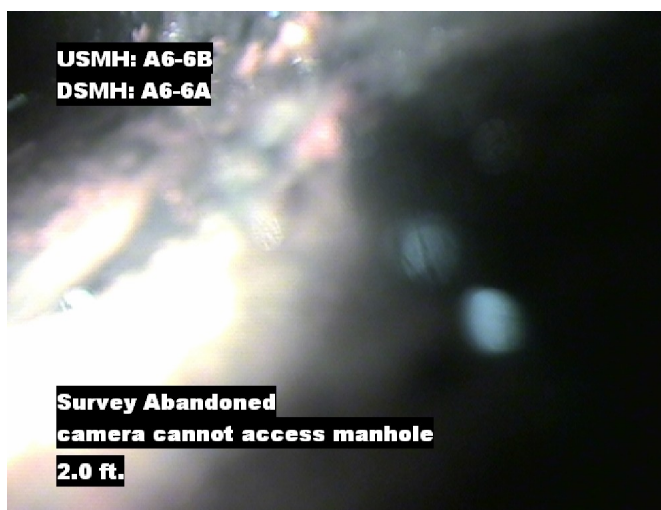
Distance: 2.0 ft. Grade: 0  
Condition: Survey Abandoned  
Remarks: camera cannot access manhole
