## **Defect Listing**

## **Image Report 4/Page**

Pipe Segment Refere	City	Street	Material		Location C	Sewer Use
A6-7_A6-6A	Oliver Springs	Tri-county boulevar	Fibreglass Reinforc		Easement/R	Sanitary
Upstream MH	Total Length	Year Laid	Shape		Location	Details
A6-7	249.1		Circ	ular		
DS Manhole	Length surveyed	Year Renewed	Height	Width	Pipe Joint	
A6-6A	249.1		8	8	N/A

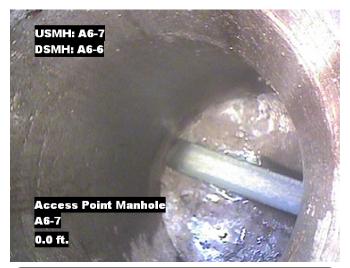
Distance: 0.0 ft. Grade: 0

Condition: Access Point Manhole

Remarks: A6-7

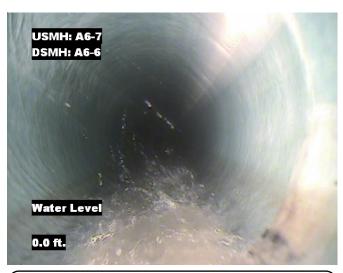
Distance: 0.0 ft. Grade: 0

Condition: Water Level

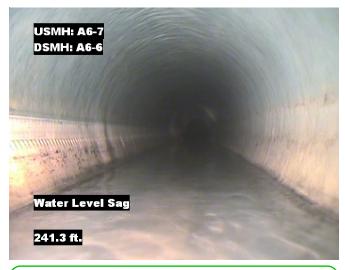
Distance: 241.3 ft. Grade: 2

Condition: Water Level Sag

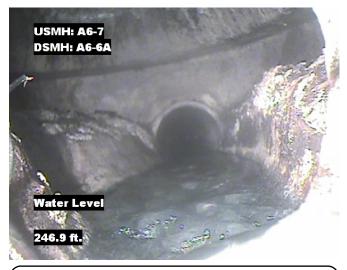
Distance: 246.9 ft. Grade: 0

Condition: Water Level

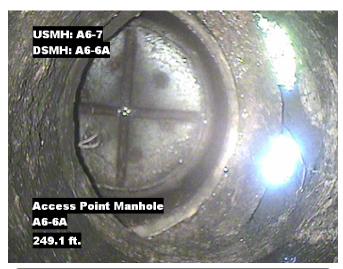
Distance: 249.1 ft. Grade: (

Condition: Access Point Manhole

Remarks: A6-6A
