Defect Listing

Pipe Segment Refere... A6-8_A6-7	City Oliver Springs	Street Tri- county bouleva...	Material Fibreglass Reinf...	Location C... Easement/R...	Sewer Use Sanitary
Upstream MH A6-8	Total Length 179.1	Year Laid	Shape Circular	Location Details	
DS Manhole A6-7	Length surveyed 179.1	Year Renewed	Height 8	Width 8	Pipe Joint... N/A

SPR 3	MPR N/A	PO Number 4397-03		Customer GRW	
SPRI 3	MPRI N/A	Work Order 4397-02		Purpose Pre-Rehabilitation Survey	
QSR 3100	QMR N/A				
OPR 3	Surveyed By Charlie Gordon	Direction Downstream	Date 20150826	Media label	
OPRI 3	Certificate Number U-615-07000491	Pre-Cleaning Jetting	Time 09:41	Weather Damp	
Date Cleaned 20150826			End Time 09:51	Additional Info

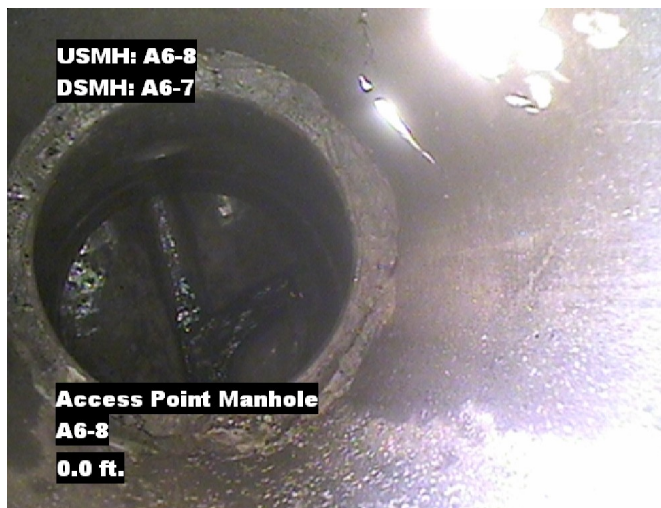
Distance: 0.0 ft. Grade: 0
Condition: Access Point Manhole
Remarks: A6-8

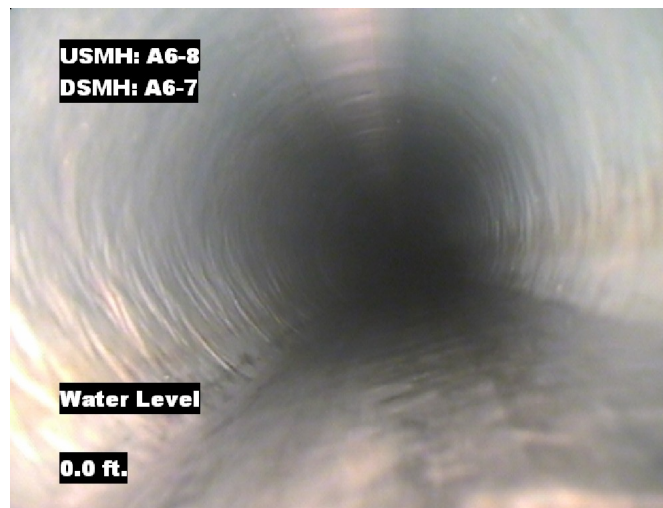
Distance: 0.0 ft. Grade: 0
Condition: Water Level
Remarks: N/A

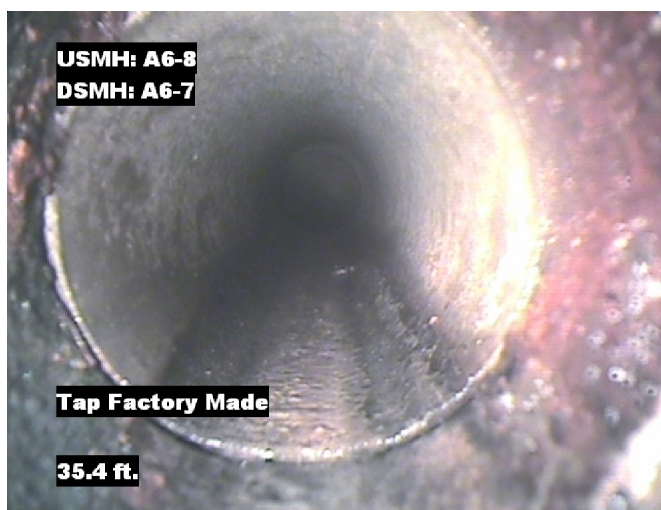
Distance: 35.4 ft. Grade: 0
Condition: Tap Factory Made
Remarks: N/A

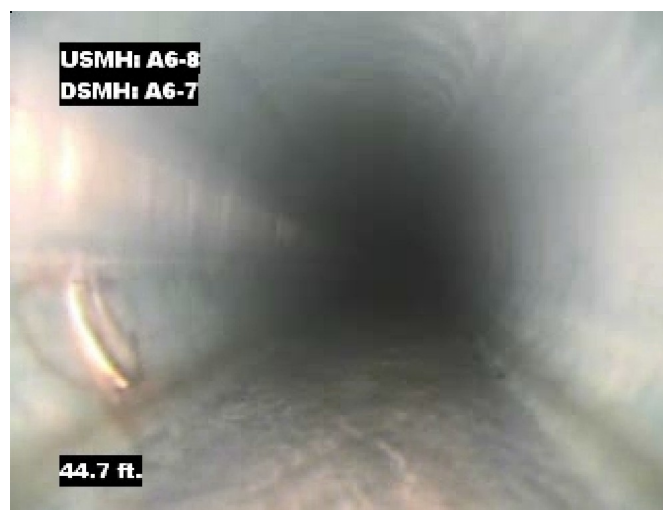
Distance: 44.8 ft. Grade: 3
Condition: Lining Failure Wrinkled
Remarks: N/A

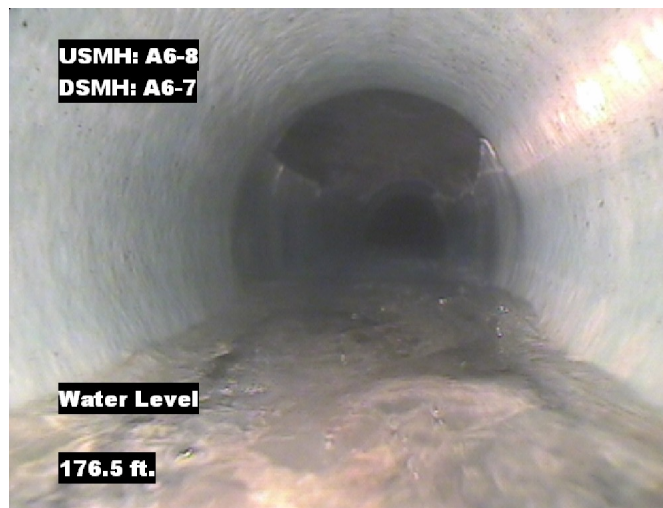
Distance: 176.5 ft. Grade: 0
Condition: Water Level
Remarks: N/A

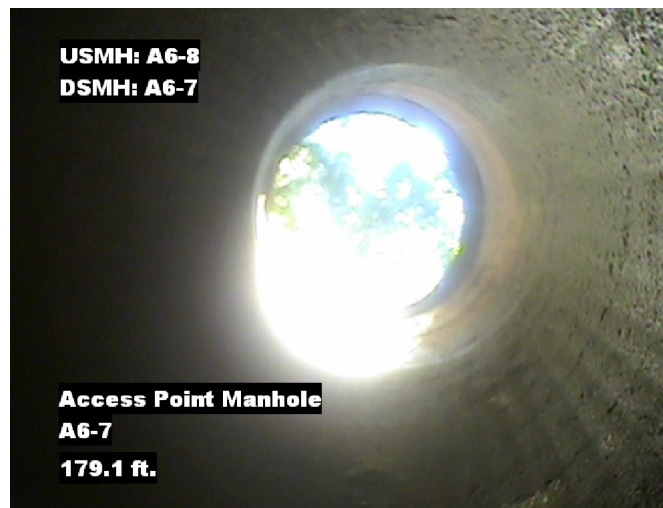
Distance: 179.1 ft. Grade: 0
Condition: Access Point Manhole
Remarks: A6-7
