## Defect Listing

Pipe Segment Refere... <b>A6-9_A6-8</b>	City <b>Oliver Springs</b>	Street <b>Tri- county bouleva...</b>	Material <b>Fibreglass Reinf...</b>	Location C... <b>Light High...</b>	Sewer Use <b>Sanitary</b>
Upstream MH <b>A6-9</b>	Total Length <b>62.8</b>	Year Laid	Shape <b>Circular</b>	Location Details	
DS Manhole <b>A6-8</b>	Length surveyed <b>62.8</b>	Year Renewed	Height <b>8</b>	Width <b>8</b>	Pipe Joint... <b>N/A</b>

SPR <b>N/A</b>	MPR <b>5</b>	PO Number <b>4397-03</b>	Customer <b>GRW</b>
SPRI <b>N/A</b>	MPRI <b>2.5</b>	Work Order <b>4397-02</b>	Purpose <b>Pre-Rehabilitation Survey</b>
QSR <b>N/A</b>	QMR <b>3121</b>		
OPR <b>5</b>	Surveyed By <b>Charlie Gordon</b>	Direction <b>Downstream</b>	Date <b>20150826</b>
OPRI <b>2.5</b>	Certificate Number <b>U-615-07000491</b>	Pre-Cleaning <b>Jetting</b>	Time <b>09:08</b>
	Date Cleaned <b>20150826</b>	End Time <b>09:14</b>	Weather <b>Damp</b>
			Media label
			Additional Info

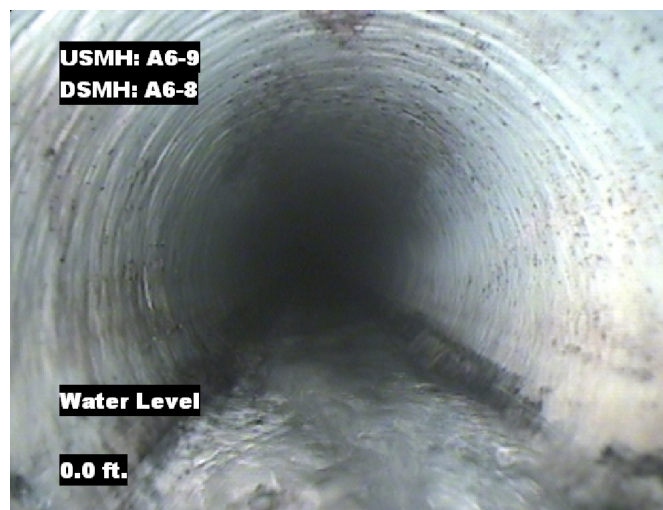
Distance: 0.0 ft. Grade: 0  
Condition: Water Level  
Remarks: N/A

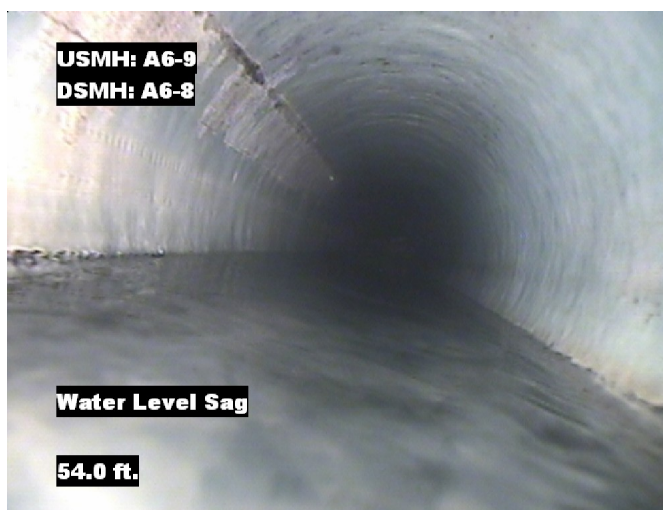
Distance: 53.9 ft. Grade: 2  
Condition: Water Level Sag  
Remarks: N/A

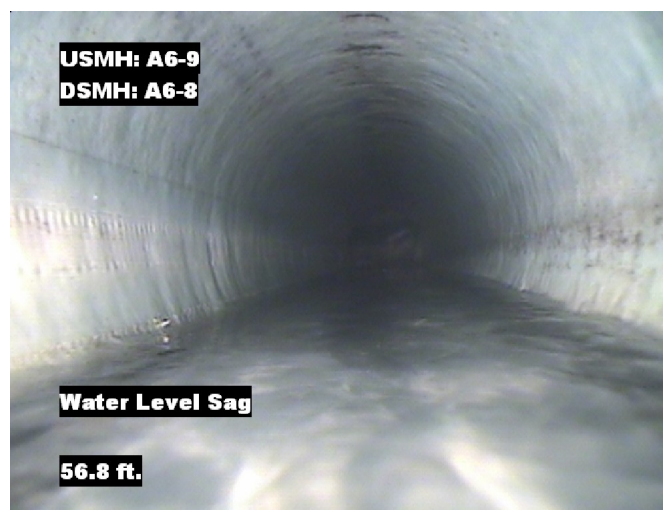
Distance: 56.8 ft. Grade: 3  
Condition: Water Level Sag  
Remarks: N/A

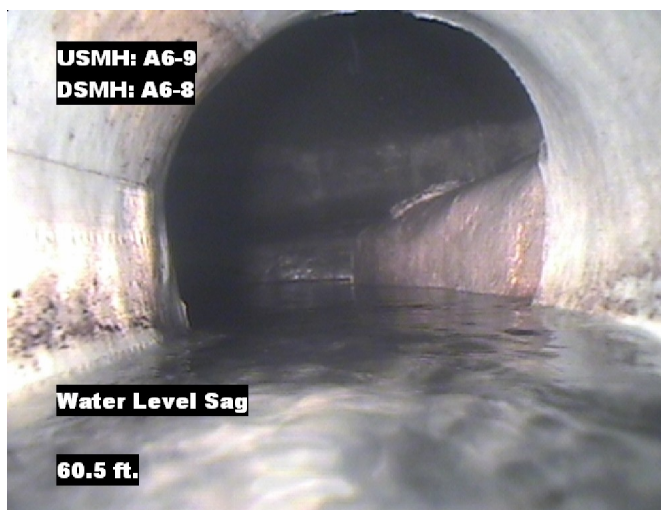
Distance: 60.5 ft. Grade: 3  
Condition: Water Level Sag  
Remarks: N/A

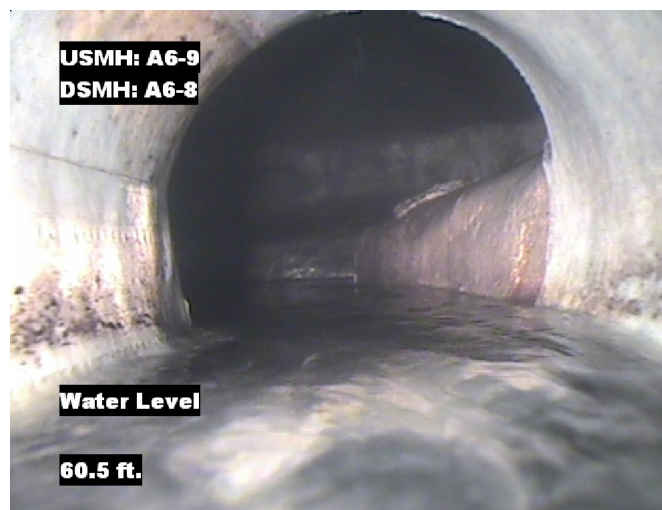
Distance: 60.5 ft. Grade: 0  
Condition: Water Level  
Remarks: N/A
