Defect Listing

Pipe Segment Refere... A7-2_A7-1	City Oliver Springs	Street highway 62	Material PolyVinyl Chloride	Location C... Easement/R...	Sewer Use Sanitary
Upstream MH A7-2	Total Length 301.2	Year Laid	Shape Circular	Location Details	
DS Manhole A7-1	Length surveyed 301.2	Year Renewed	Height 8	Width 8	Pipe Joint... 13

SPR 5	MPR 22	PO Number 4397-03		Customer GRW	
SPRI 5	MPRI 2	Work Order 4397-02		Purpose Pre-Rehabilitation Survey	
QSR 5100	QMR 2A00				
OPR 27	Surveyed By Charlie Gordon	Direction Downstream	Date 20150831	Media label	
OPRI 2.3	Certificate Number U-615-07000491	Pre-Cleaning Jetting	Time 09:53	Weather Dry	
Date Cleaned 20150831			End Time 10:10	Additional Info

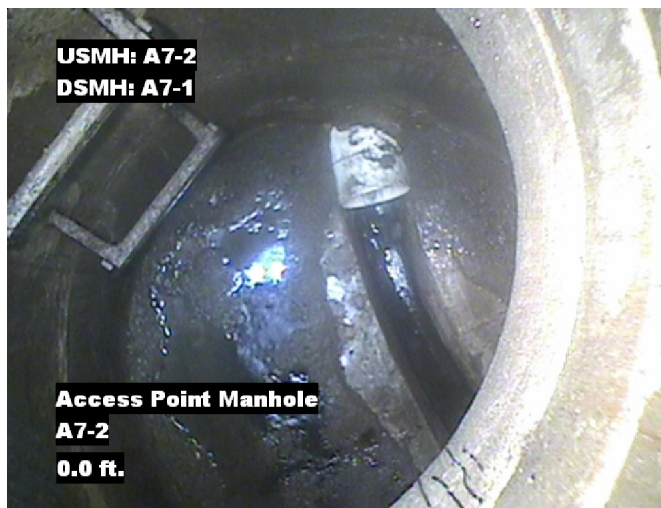
Distance: 0.0 ft. Grade: 0
Condition: Access Point Manhole
Remarks: A7-2

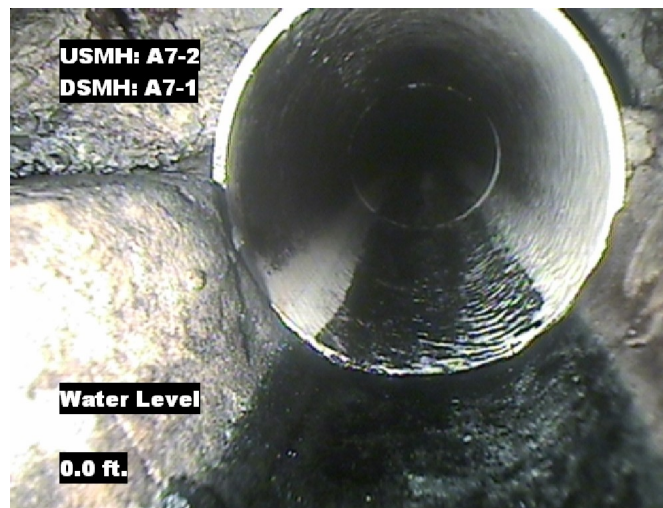
Distance: 0.0 ft. Grade: 0
Condition: Water Level
Remarks: N/A

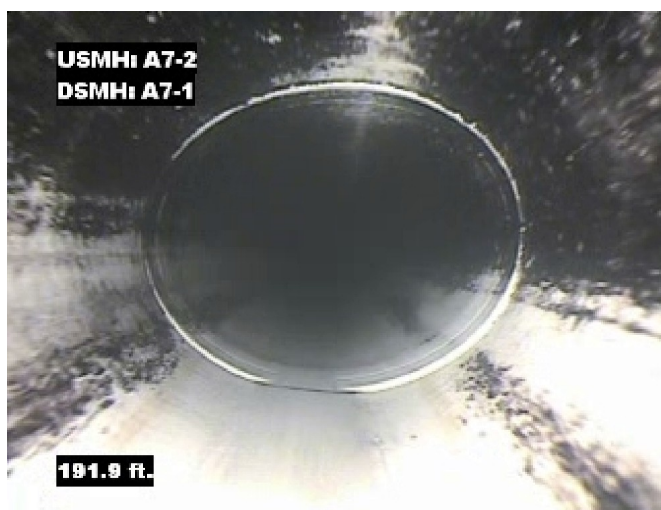
Distance: 191.9 ft. Grade: 5
Condition: Deformed Vertically
Remarks: N/A

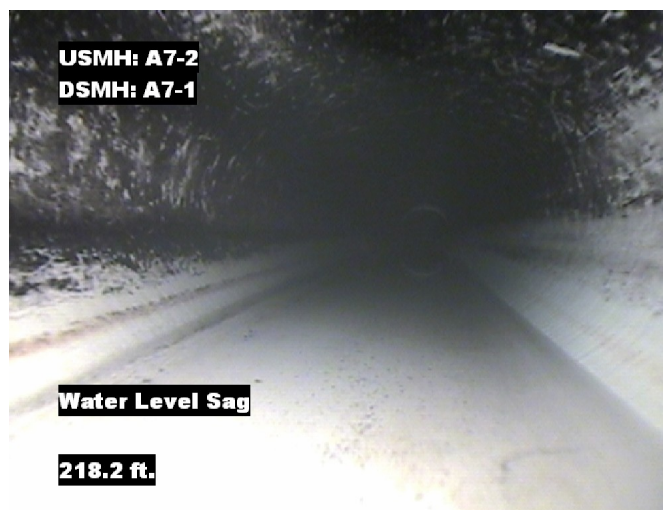
Distance: 218.2 ft. Grade: 2
Condition: Water Level Sag
Remarks: N/A

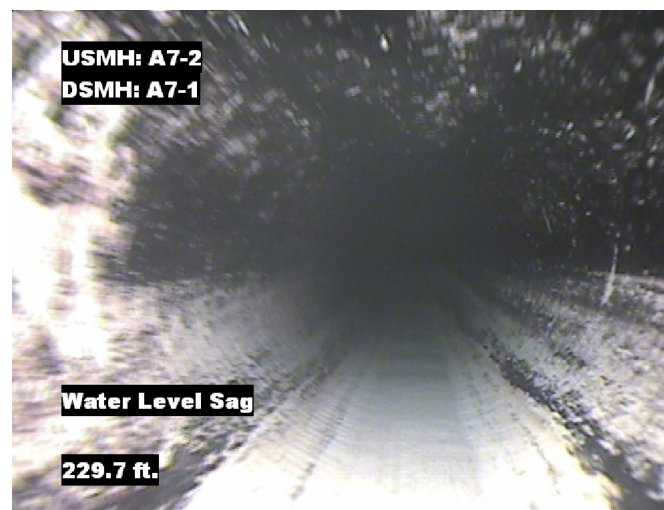
Distance: 229.7 ft. Grade: 2
Condition: Water Level Sag
Remarks: N/A

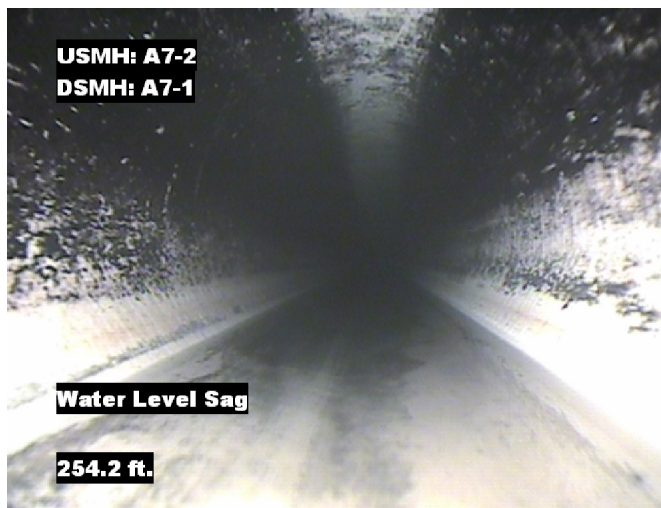
Distance: 254.2 ft. Grade: 2
Condition: Water Level Sag
Remarks: N/A

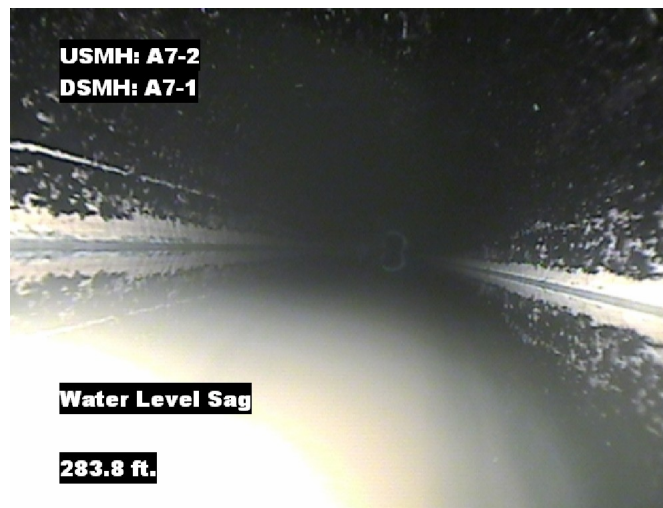
Distance: 283.8 ft. Grade: 2
Condition: Water Level Sag
Remarks: N/A

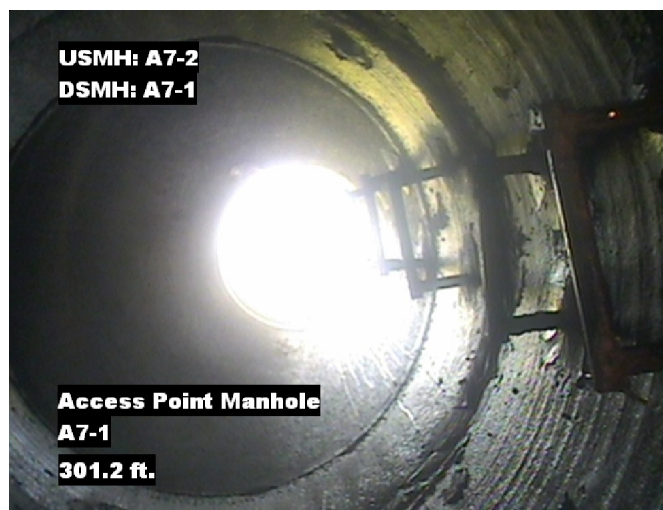
Distance: 301.2 ft. Grade: 0
Condition: Access Point Manhole
Remarks: A7-1
