Defect Listing

Pipe Segment Refere... A7-4_A7-3	City Oliver Springs	Street highway 62	Material Vitrified Clay Pipe	Location C... Easement/R...	Sewer Use Sanitary
Upstream MH A7-4	Total Length	Year Laid	Shape Circular	Location Details	
DS Manhole A7-3	Length surveyed 100.2	Year Renewed	Height 8	Width 8	Pipe Joint... 13

SPR N/A	MPR 12	PO Number 4397-03	Customer GRW
SPRI N/A	MPRI 2	Work Order	Purpose
QSR N/A	QMR 2600	4397-02	Pre-Rehabilitation Survey
OPR 12	Surveyed By Charlie Gordon	Direction Upstream	Date 20150831
OPRI 2	Certificate Number U-615-07000491	Pre-Cleaning Jetting	Time 08:13
Date Cleaned 20150831		End Time 08:32	Weather Dry
Additional Info UPSTREAM MANHOLE A7...

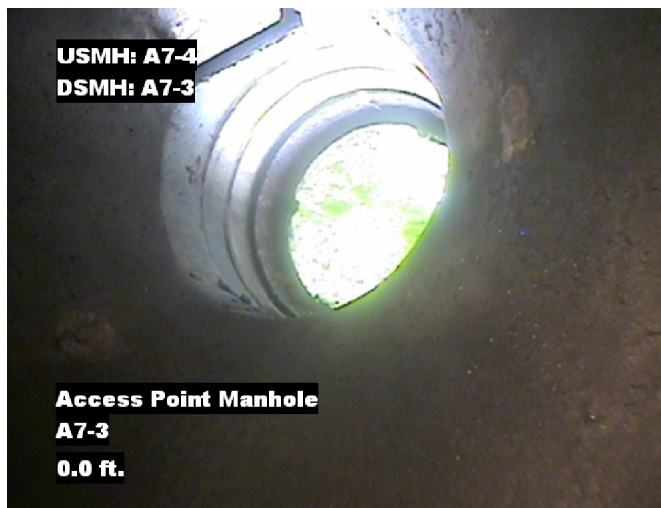
Distance: 0.0 ft. Grade: 0
Condition: Access Point Manhole
Remarks: A7-3

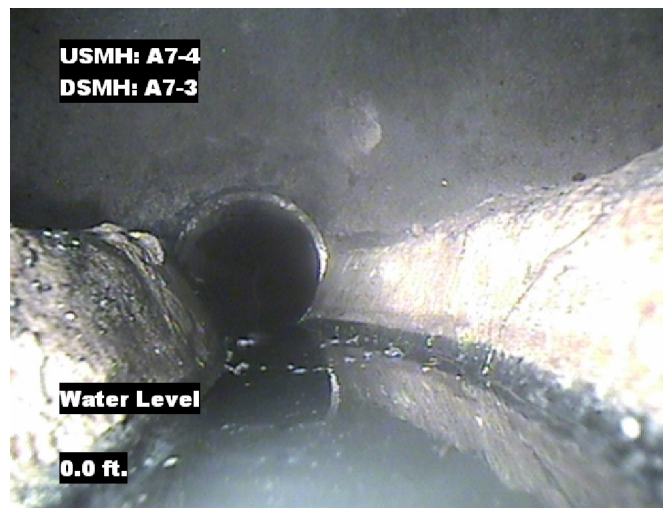
Distance: 0.0 ft. Grade: 0
Condition: Water Level
Remarks: N/A

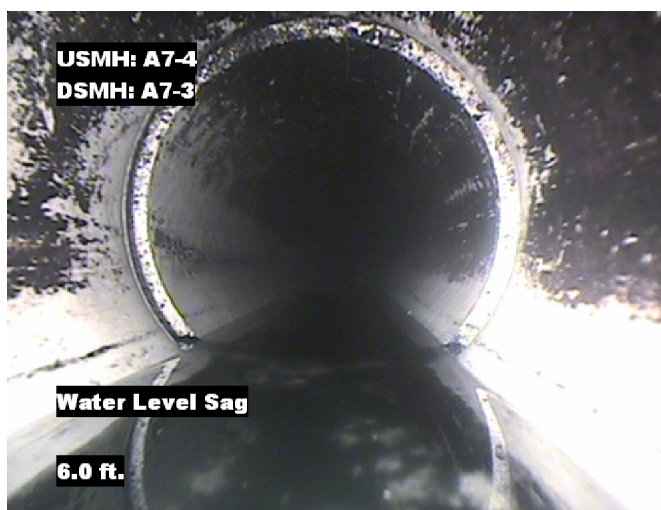
Distance: 6.0 ft. Grade: 2
Condition: Water Level Sag
Remarks: N/A

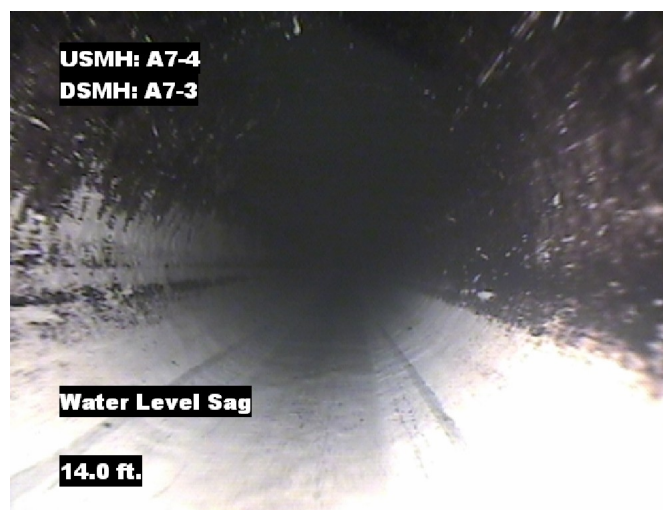
Distance: 14.0 ft. Grade: 2
Condition: Water Level Sag
Remarks: N/A

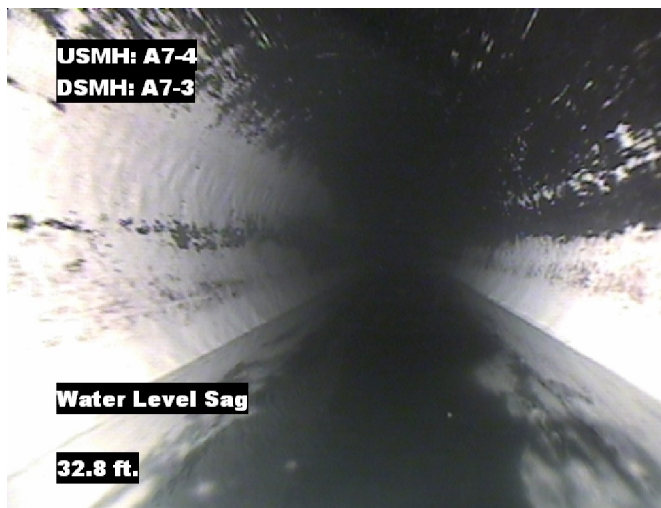
Distance: 32.5 ft. Grade: 2
Condition: Water Level Sag
Remarks: N/A

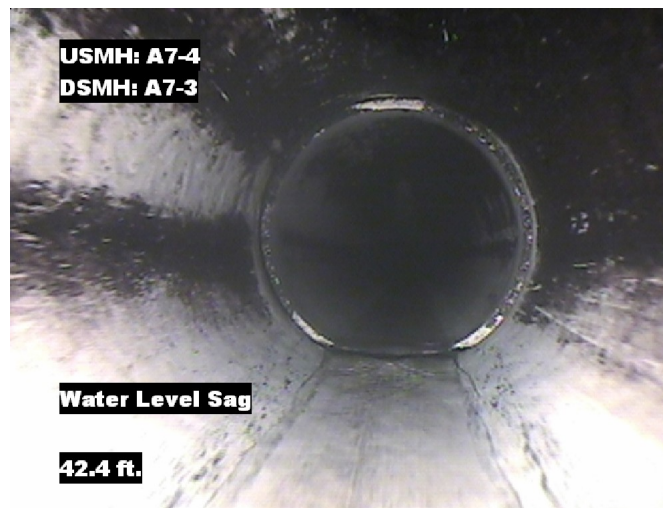
Distance: 41.9 ft. Grade: 2
Condition: Water Level Sag
Remarks: N/A

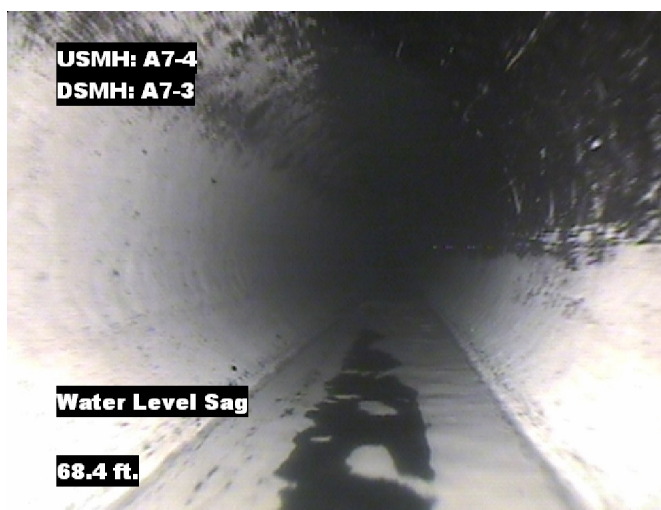
Distance: 68.3 ft. Grade: 2
Condition: Water Level Sag
Remarks: N/A

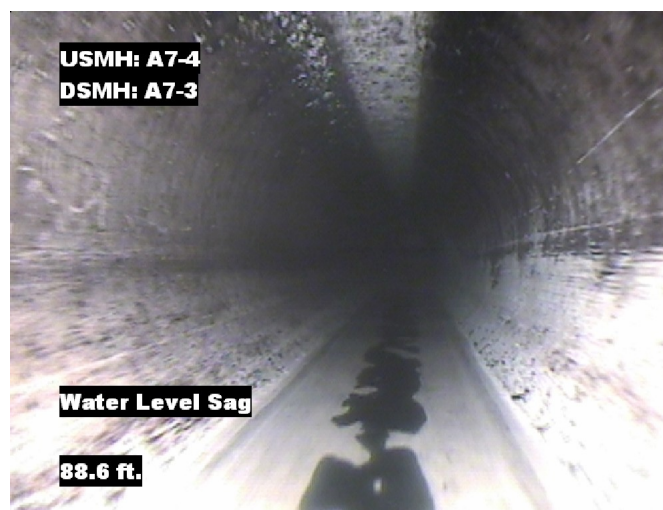
Distance: 88.6 ft. Grade: 2
Condition: Water Level Sag
Remarks: N/A

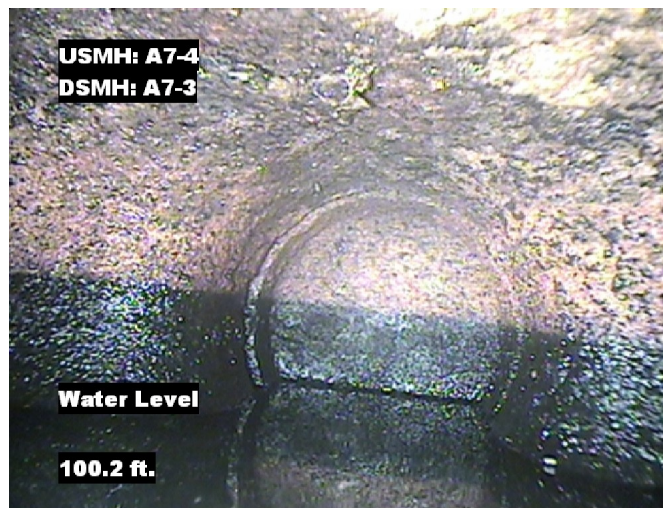
Distance: 100.2 ft. Grade: 0
Condition: Water Level
Remarks: N/A

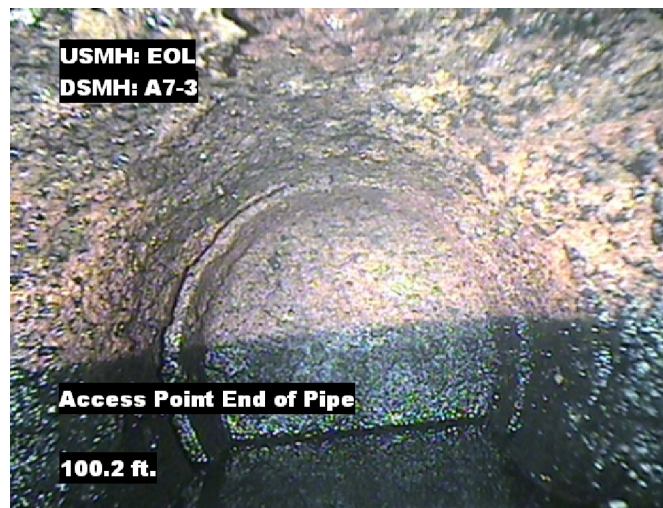
Distance: 100.2 ft. Grade: 0
Condition: Access Point End of Pipe
Remarks: N/A

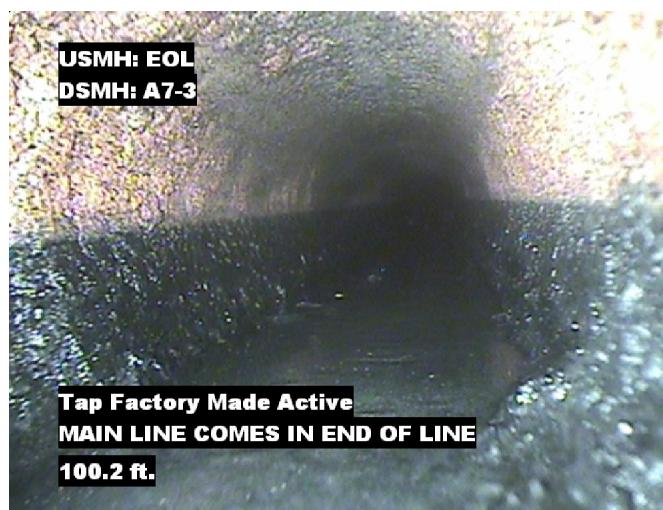
Distance: 100.2 ft. Grade: 0
Condition: Tap Factory Made Active
Remarks: MAIN LINE COMES IN END OF LINE
