Defect Listing

Pipe Segment Refere... A7-5_A7-4	City Oliver Springs	Street Lookout Ave	Material Ductile Iron Pipe	Location C... Easement/R...	Sewer Use Sanitary
Upstream MH A7-5	Total Length 11.3	Year Laid	Shape Circular	Location Details	
DS Manhole A7-4	Length surveyed 11.3	Year Renewed	Height 8	Width 8	Pipe Joint... 13

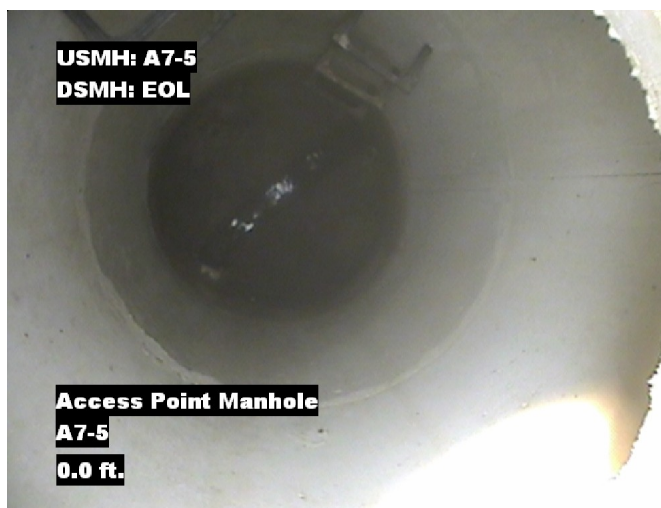
Distance: 0.0 ft. Grade: 0
Condition: Access Point Manhole
Remarks: A7-5

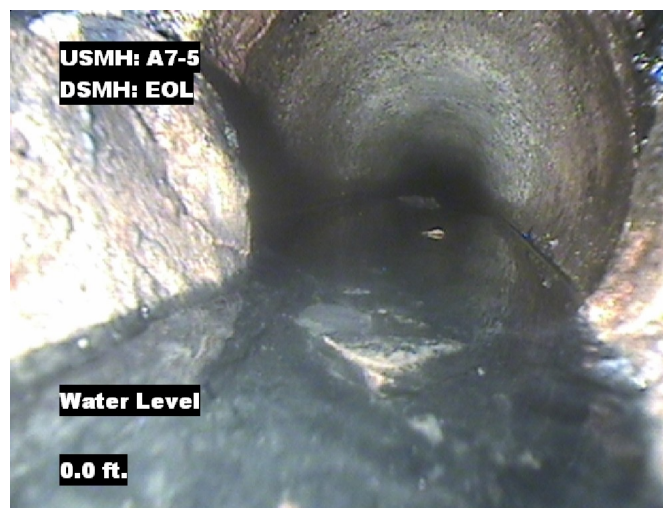
Distance: 0.0 ft. Grade: 0
Condition: Water Level
Remarks: N/A

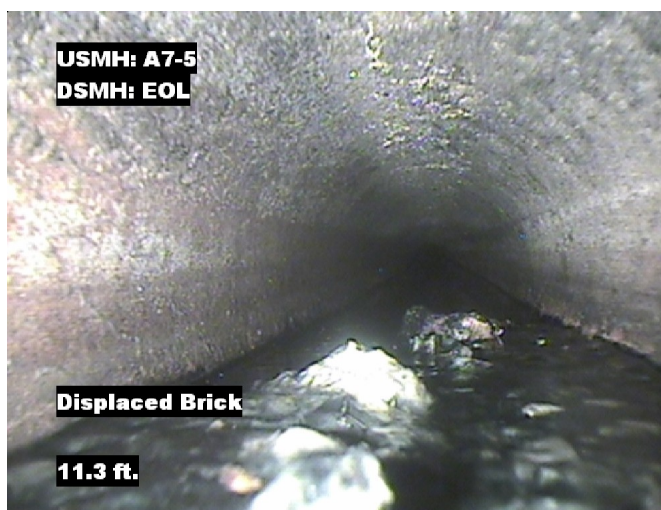
Distance: 11.3 ft. Grade: 3
Condition: Displaced Brick
Remarks: N/A

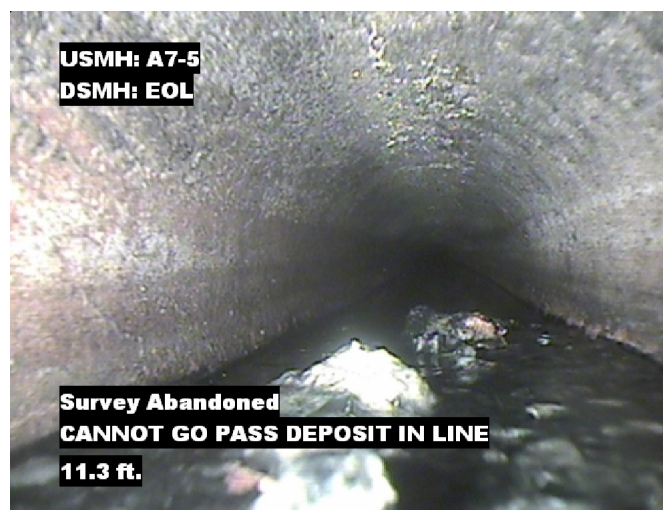
Distance: 11.3 ft. Grade: 0
Condition: Survey Abandoned
Remarks: CANNOT GO PASS DEPOSIT IN LINE
