Defect Listing

Pipe Segment Refere... A7-6_A7-5	City Oliver Springs	Street Lookout Ave	Material PolyVinyl Chloride		Location C... Easement/R...	Sewer Use Sanitary
Upstream MH A7-6	Total Length 187	Year Laid	Shape Circular		Location Details	
DS Manhole A7-5	Length surveyed 187	Year Renewed	Height 8	Width 8	Pipe Joint... 13

Image Report 4/Page

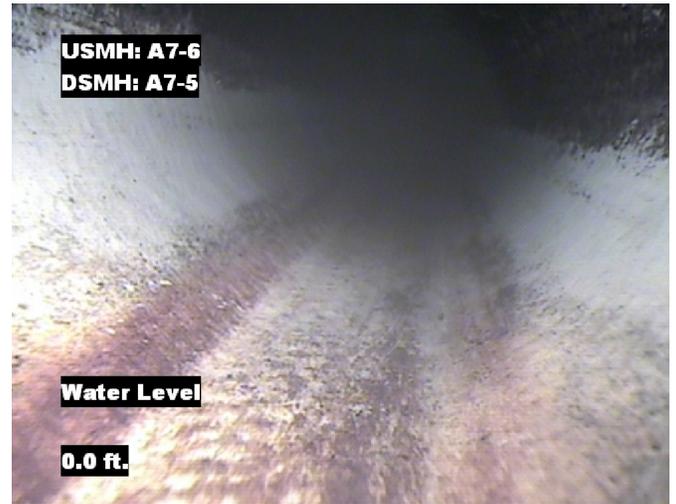
Distance: 0.0 ft. Grade: 0
 Condition: Water Level
 Remarks: N/A

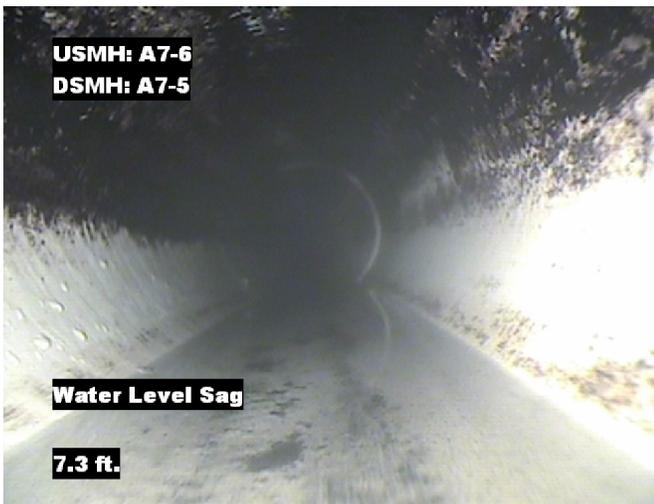
Distance: 7.3 ft. Grade: 2
 Condition: Water Level Sag
 Remarks: N/A

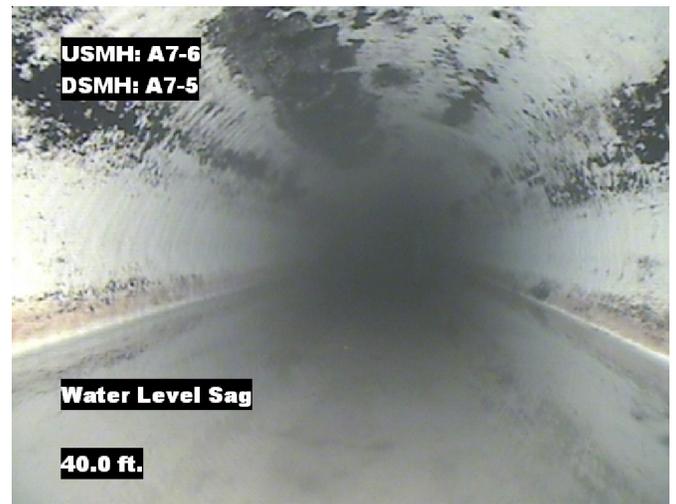
Distance: 40.0 ft. Grade: 2
 Condition: Water Level Sag
 Remarks: N/A

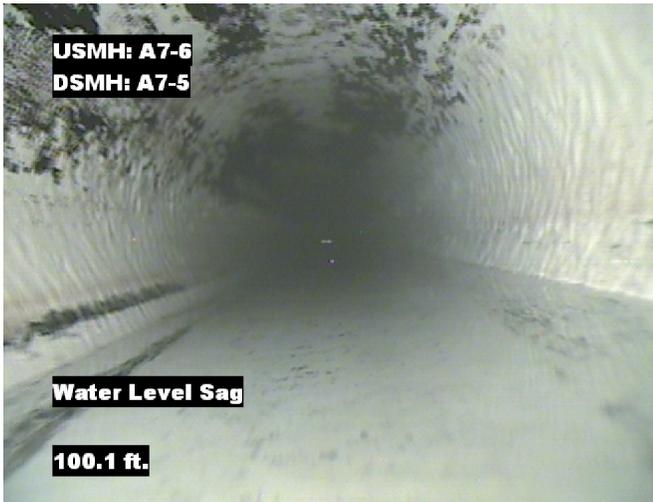
Distance: 100.1 ft. Grade: 2
 Condition: Water Level Sag
 Remarks: N/A

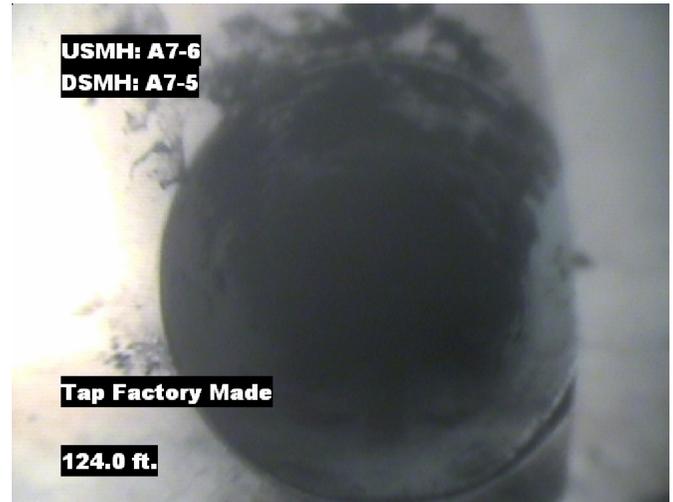
Distance: 124.0 ft. Grade: 0
 Condition: Tap Factory Made
 Remarks: N/A

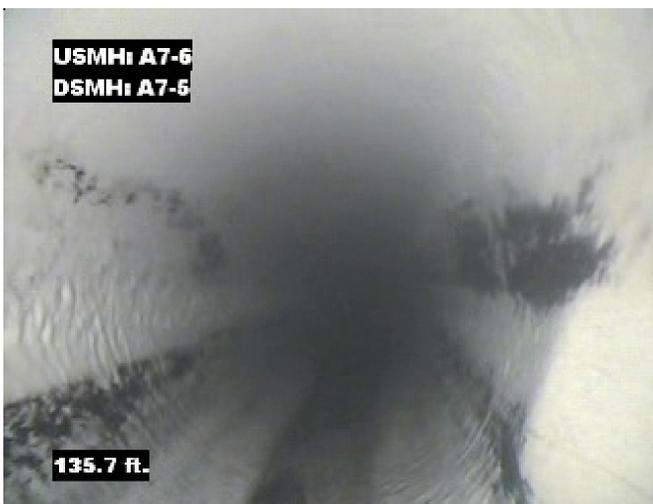
Distance: 135.7 ft. Grade: 3
 Condition: Lining Failure Buckled
 Remarks: N/A

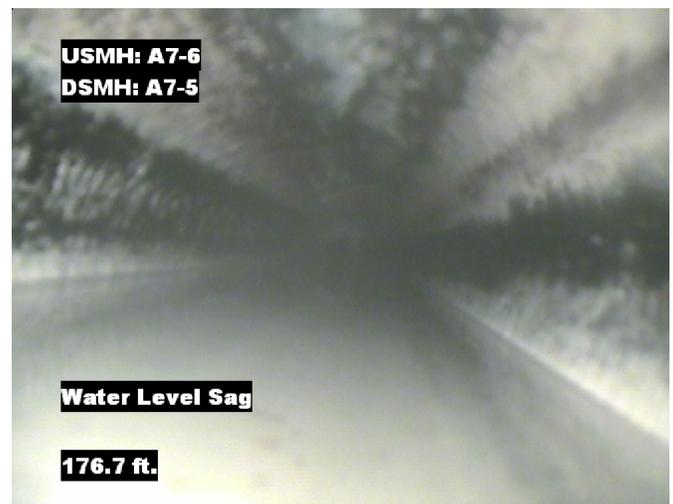
Distance: 176.7 ft. Grade: 2
 Condition: Water Level Sag
 Remarks: N/A

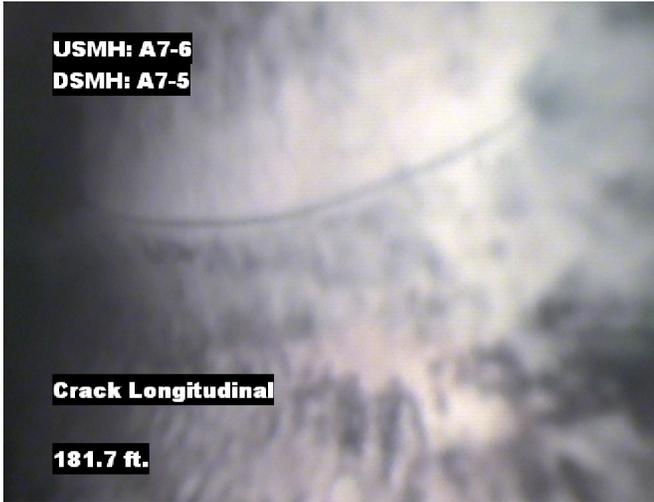
Distance: 181.7 ft. Grade: 2
 Condition: Crack Longitudinal
 Remarks: N/A

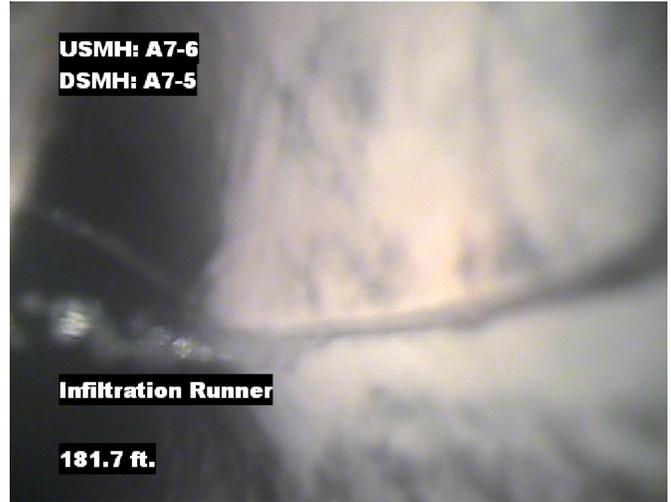
Distance: 181.7 ft. Grade: 4
 Condition: Infiltration Runner
 Remarks: N/A

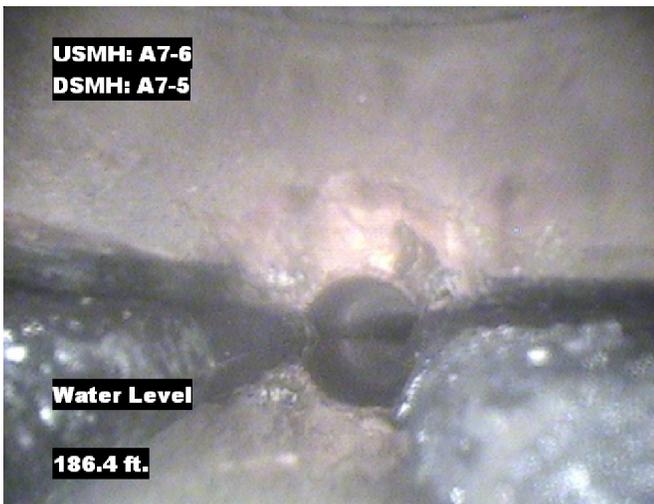
Distance: 186.4 ft. Grade: 0
 Condition: Water Level
 Remarks: N/A
