Defect Listing

Pipe Segment Refere... A7-7_A7-6	City Oliver Springs	Street Lookout Ave	Material PolyVinyl Chloride	Location C... Easement/R...	Sewer Use Sanitary
Upstream MH A7-7	Total Length 199.9	Year Laid	Shape Circular	Location Details	
DS Manhole A7-6	Length surveyed 199.9	Year Renewed	Height 8	Width 8	Pipe Joint... 13

SPR 3	MPR 9	PO Number 4397-03	Customer GRW
SPRI 3	MPRI 3	Work Order 4397-02	Purpose Pre-Rehabilitation Survey
QSR 3100	QMR 4131		
OPR 12	Surveyed By Barry Rogers	Direction Downstream	Date 20150806
OPRI 3	Certificate Number U-1012-16405	Pre-Cleaning Jetting	Time 08:14
	Date Cleaned 20150806	End Time 08:30	Weather Damp
			Media label
			Additional Info

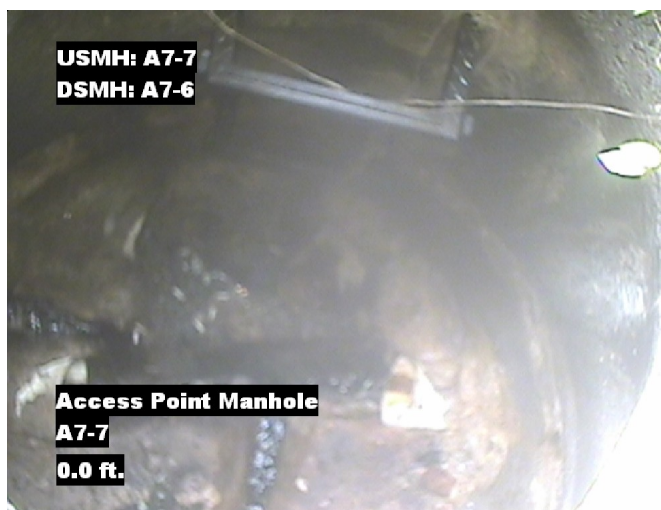
Distance: 0.0 ft. Grade: 0
Condition: Access Point Manhole
Remarks: A7-7

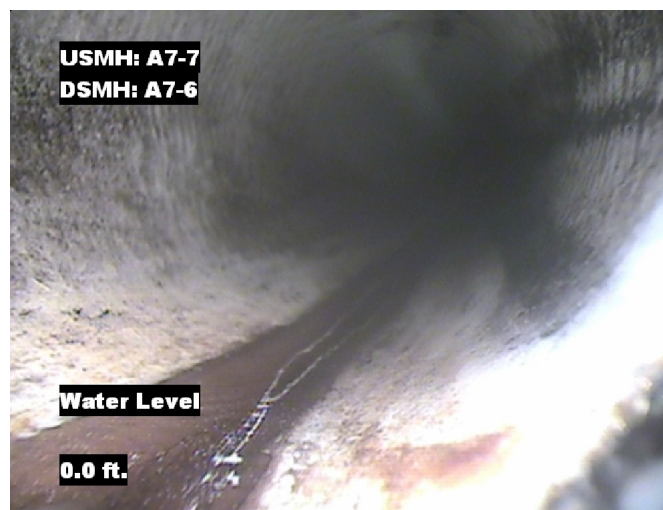
Distance: 0.0 ft. Grade: 0
Condition: Water Level
Remarks: N/A

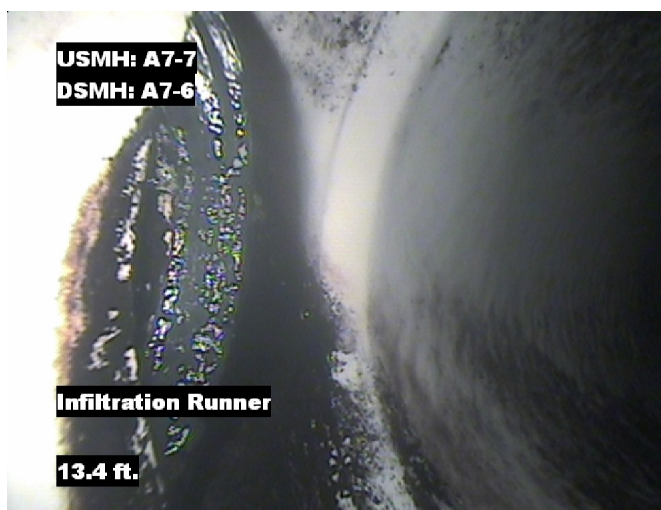
Distance: 13.4 ft. Grade: 4
Condition: Infiltration Runner
Remarks: N/A

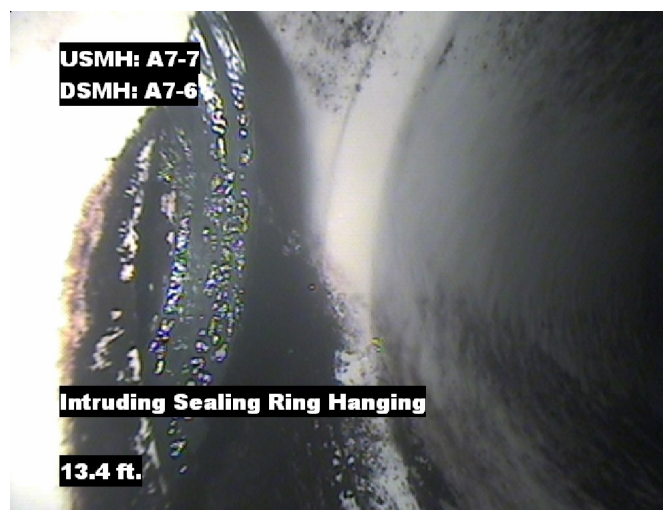
Distance: 13.4 ft. Grade: 2
Condition: Intruding Sealing Ring Hanging
Remarks: N/A

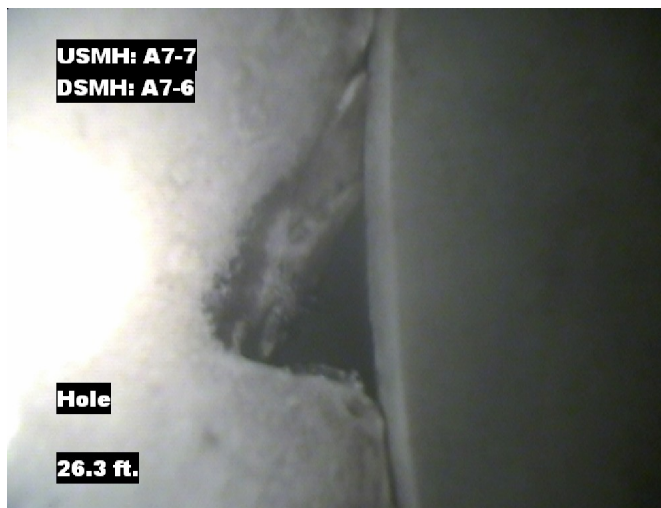
Distance: 26.3 ft. Grade: 3
Condition: Hole
Remarks: N/A

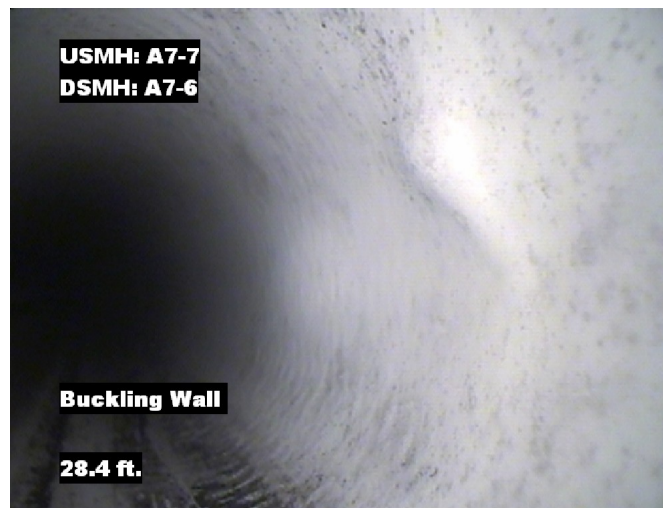
Distance: 28.4 ft. Grade: 0
Condition: Buckling Wall
Remarks: N/A

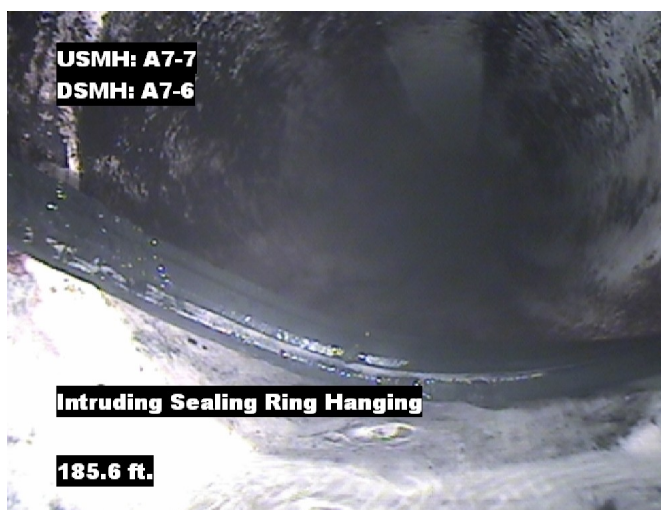
Distance: 185.6 ft. Grade: 3
Condition: Intruding Sealing Ring Hanging
Remarks: N/A

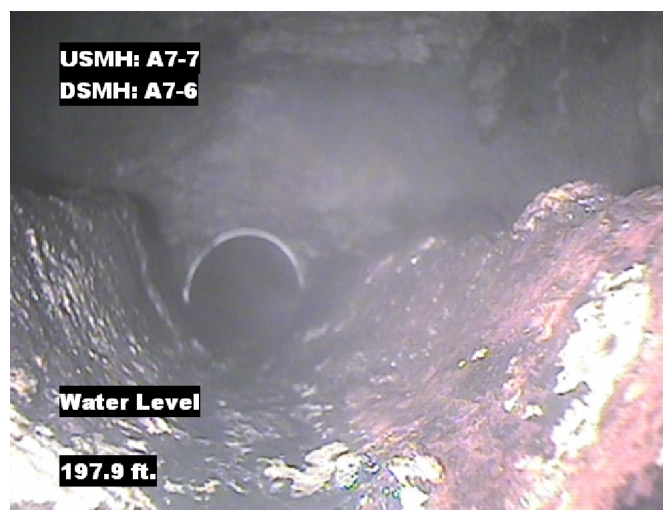
Distance: 197.9 ft. Grade: 0
Condition: Water Level
Remarks: N/A

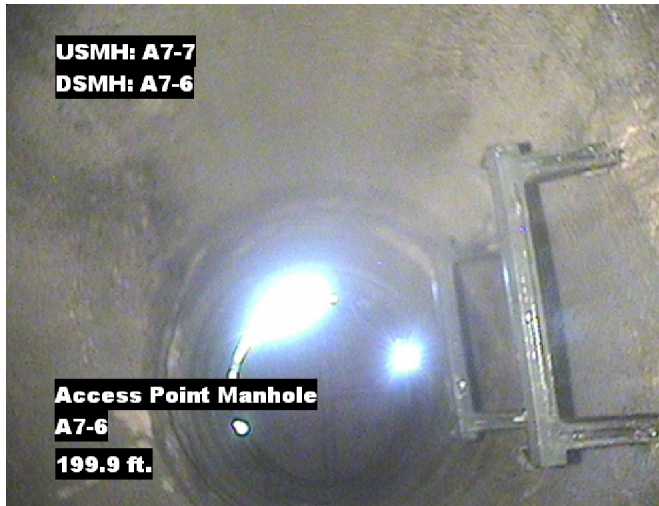
Distance: 199.9 ft. Grade: 0
Condition: Access Point Manhole
Remarks: A7-6
