Defect Listing

Pipe Segment Refere... A7-8_A7-7	City Oliver Springs	Street Lookout Ave	Material PolyVinyl Chloride	Location C... Easement/R...	Sewer Use Sanitary
Upstream MH A7-8	Total Length 198	Year Laid	Shape Circular	Location Details	
DS Manhole A7-7	Length surveyed 13.8	Year Renewed	Height 6	Width 6	Pipe Joint... 13

SPR 2	MPR N/A	PO Number 4397-03	Customer GRW
SPRI 2	MPRI N/A	Work Order 4397-02	Purpose Pre-Rehabilitation Survey
QSR 2100	QMR N/A		
OPR 2	Surveyed By Barry Rogers	Direction Upstream	Date 20150806
OPRI 2	Certificate Number U-1012-16405	Pre-Cleaning Jetting	Time 10:31
	Date Cleaned 20150806	End Time 10:40	Weather Damp
			Media label
			Additional Info

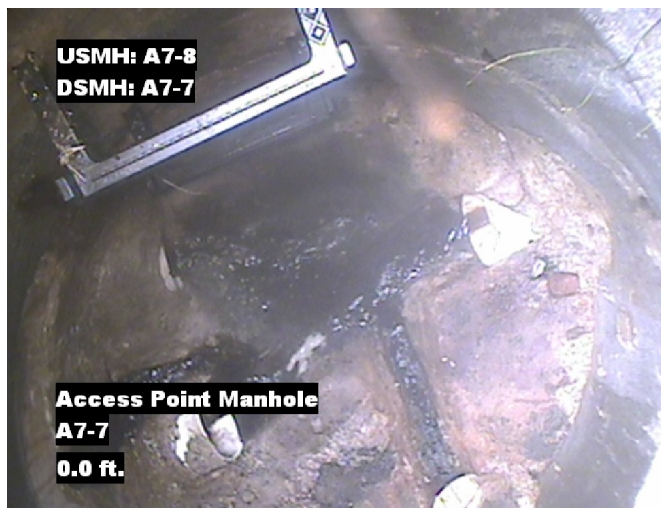
Distance: 0.0 ft. Grade: 0
Condition: Access Point Manhole
Remarks: A7-7

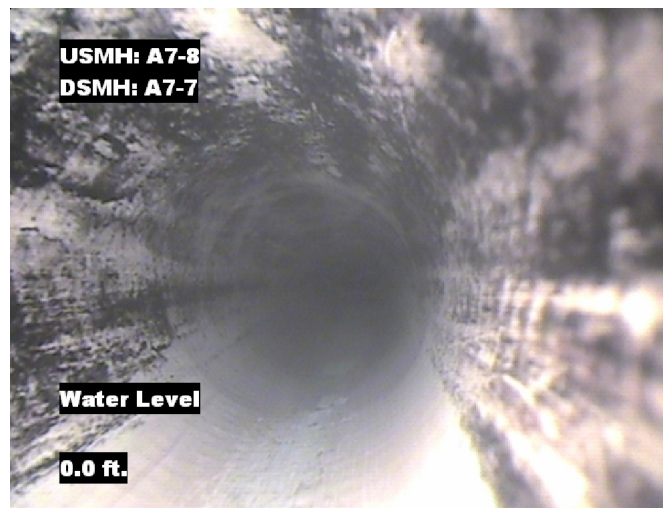
Distance: 0.0 ft. Grade: 0
Condition: Water Level
Remarks: N/A

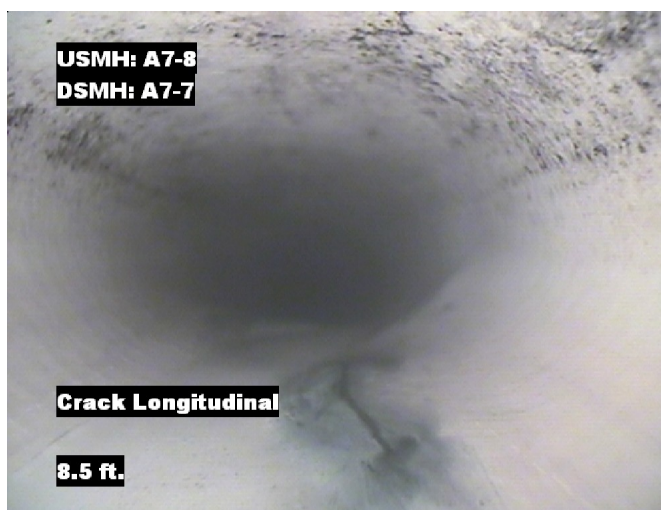
Distance: 8.5 ft. Grade: 2
Condition: Crack Longitudinal
Remarks: N/A

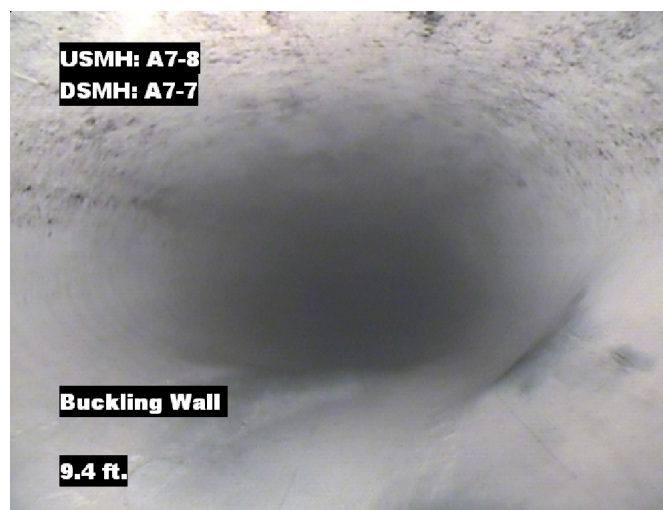
Distance: 9.4 ft. Grade: 0
Condition: Buckling Wall
Remarks: N/A

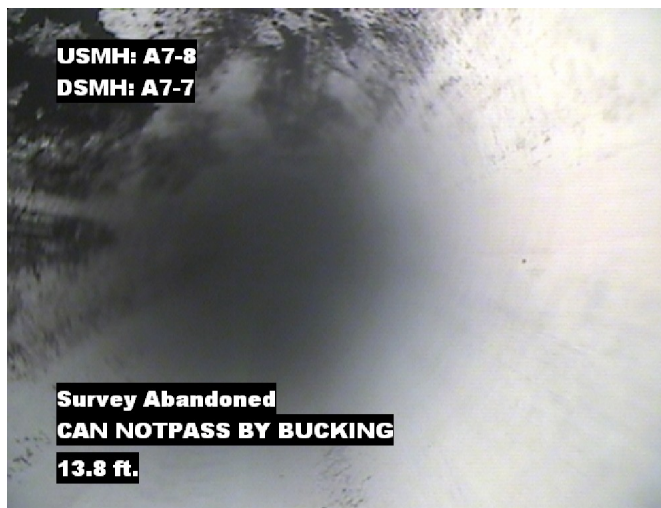
Distance: 13.8 ft. Grade: 0
Condition: Survey Abandoned
Remarks: CAN NOTPASS BY BUCKING
