Defect Listing

Pipe Segment Refere... A8-1_A-46	City Oliver Springs	Street Central	Material Fibreglass Reinforc...	Location C... Creek	Sewer Use Sanitary
Upstream MH A8-1	Total Length 81.3	Year Laid	Shape Circular	Location Details	
DS Manhole A-46	Length surveyed 81.3	Year Renewed	Height 8	Width 8	Pipe Joint... N/A

Image Report 4/Page

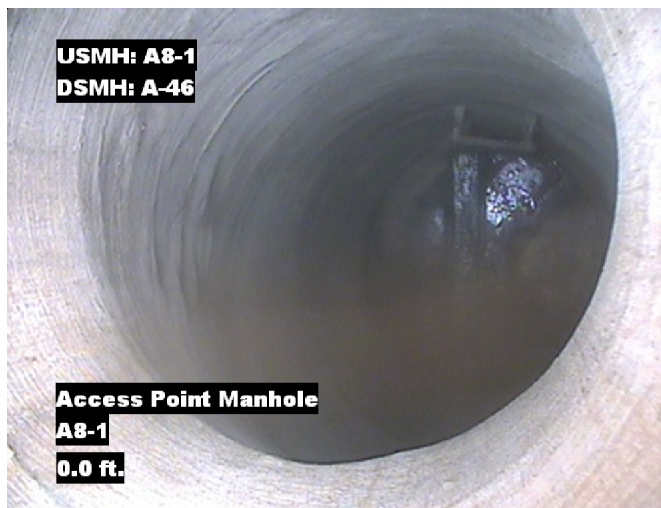
Distance: 0.0 ft. Grade: 0
Condition: Access Point Manhole
Remarks: A8-1

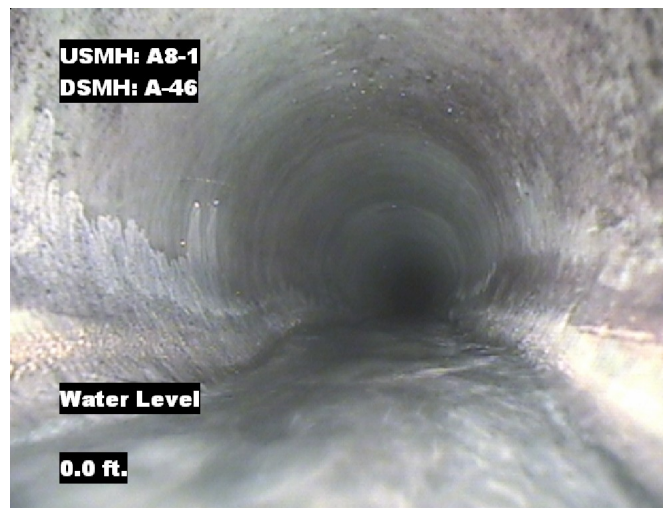
Distance: 0.0 ft. Grade: 0
Condition: Water Level
Remarks: N/A

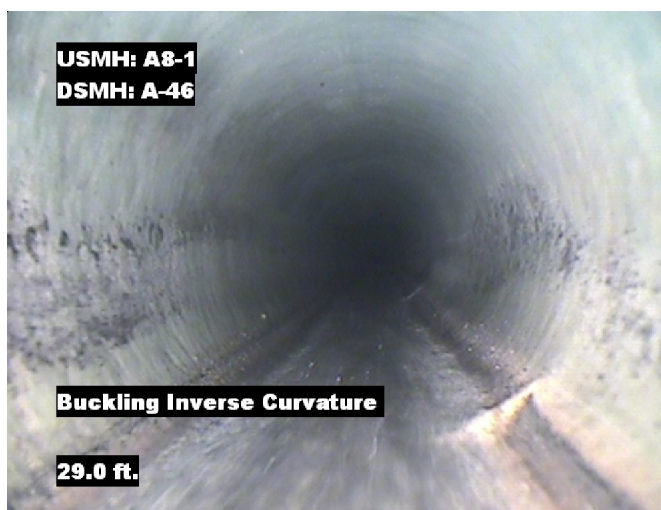
Distance: 29.0 ft. Grade: 0
Condition: Buckling Inverse Curvature
Remarks: N/A

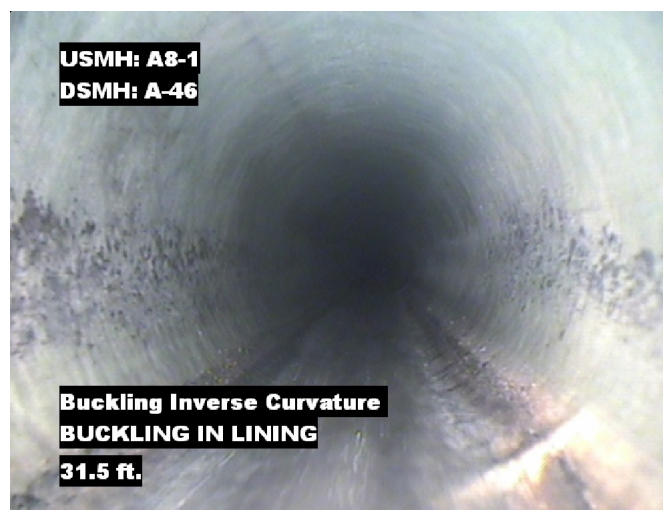
Distance: 31.5 ft. Grade: 0
Condition: Buckling Inverse Curvature
Remarks: BUCKLING IN LINING

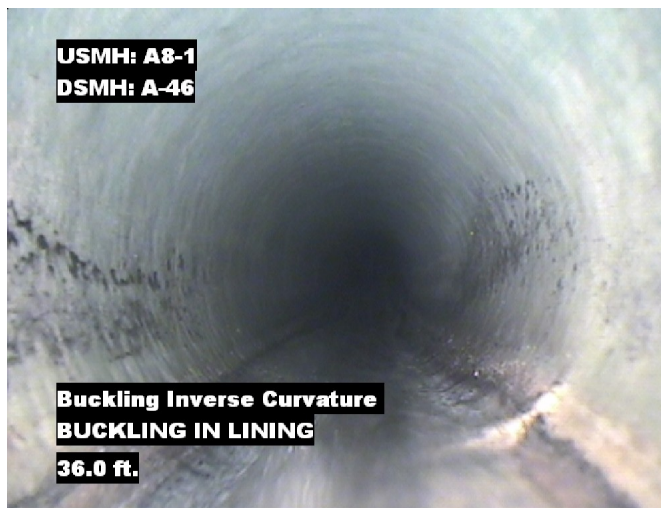
Distance: 36.0 ft. Grade: 0
Condition: Buckling Inverse Curvature
Remarks: BUCKLING IN LINING

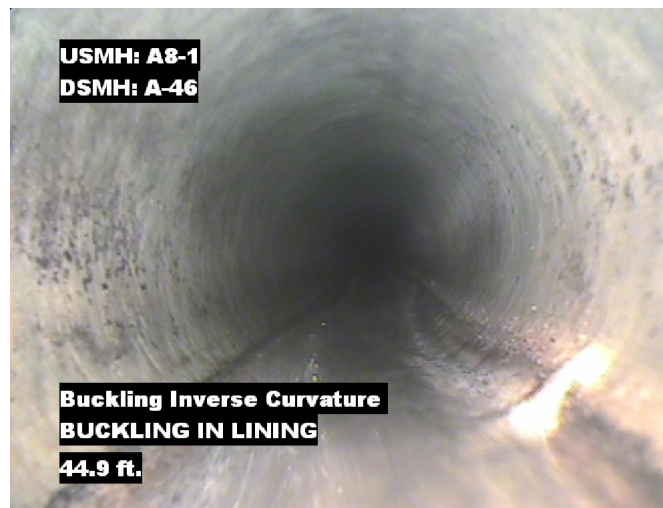
Distance: 44.9 ft. Grade: 0
Condition: Buckling Inverse Curvature
Remarks: BUCKLING IN LINING

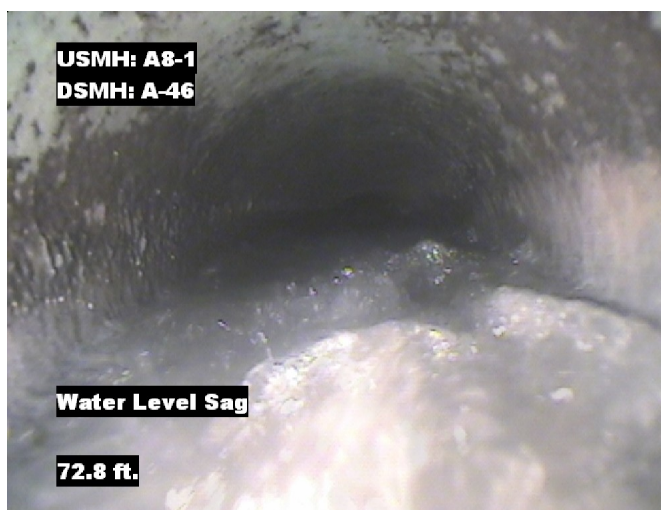
Distance: 72.8 ft. Grade: 3
Condition: Water Level Sag
Remarks: N/A

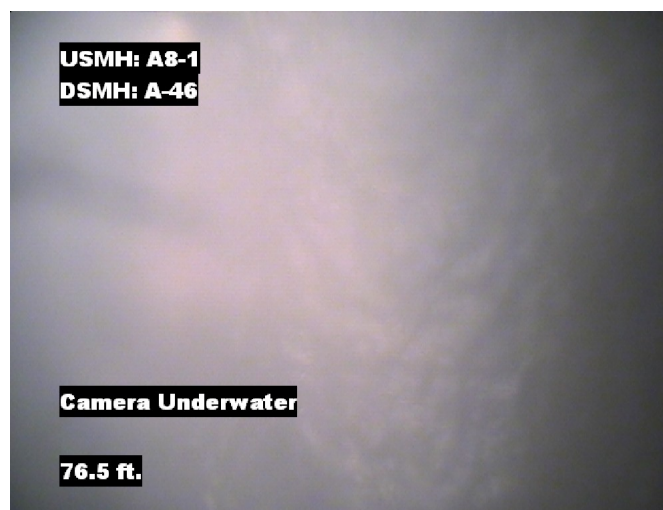
Distance: 76.5 ft. Grade: 4
Condition: Camera Underwater
Remarks: N/A

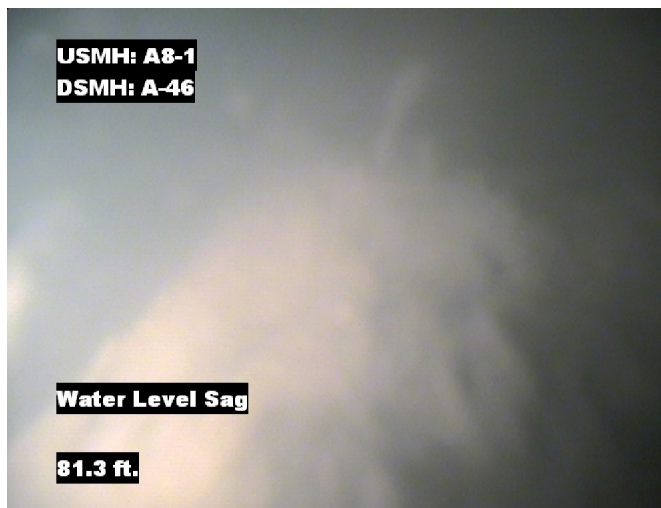
Distance: 81.3 ft. Grade: 3
Condition: Water Level Sag
Remarks: N/A

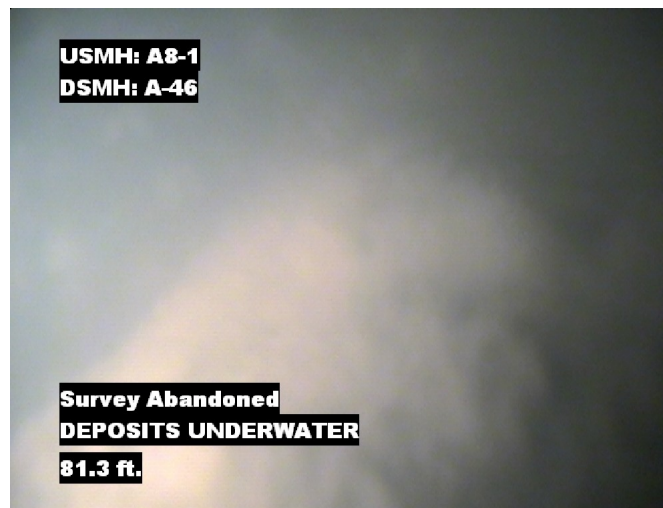
Distance: 81.3 ft. Grade: 0
Condition: Survey Abandoned
Remarks: DEPOSITS UNDERWATER
