Defect Listing

Pipe Segment Refere... A8-10_A8-9	City Oliver Springs	Street Railroad Rd	Material Fibreglass Reinforc...	Location C... Light High...	Sewer Use Sanitary
Upstream MH A8-10	Total Length 324.5	Year Laid	Shape Circular	Location Details	
DS Manhole A8-9	Length surveyed 324.5	Year Renewed	Height 8	Width 8	Pipe Joint... N/A

SPR 18	MPR 14	PO Number 4397-03	Customer GRW
SPRI 3	MPRI 2.3	Work Order 4397-02	Purpose Pre-Rehabilitation Survey
QSR 3600	QMR 3224		
OPR 32	Surveyed By Barry Rogers	Direction Downstream	Date 20150731
OPRI 2.7	Certificate Number U-1012-16405	Pre-Cleaning Jetting	Time 09:35
	Date Cleaned 20150731	End Time 09:56	Weather Dry
		Additional Info

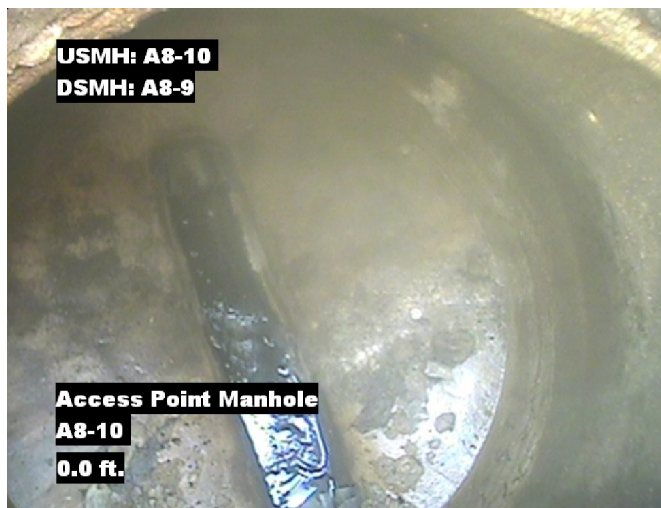
Distance: 0.0 ft. Grade: 0
Condition: Access Point Manhole
Remarks: A8-10

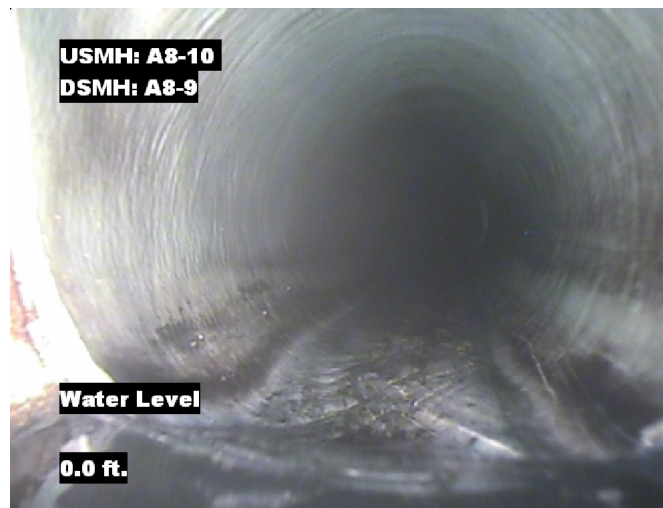
Distance: 0.0 ft. Grade: 0
Condition: Water Level
Remarks: N/A

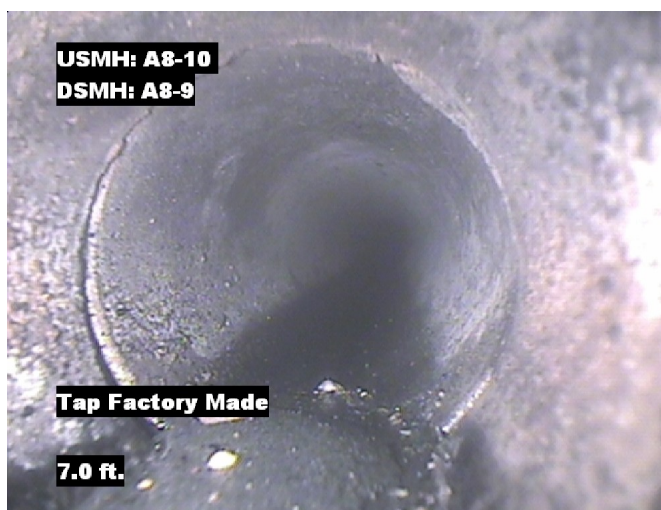
Distance: 7.0 ft. Grade: 0
Condition: Tap Factory Made
Remarks: N/A

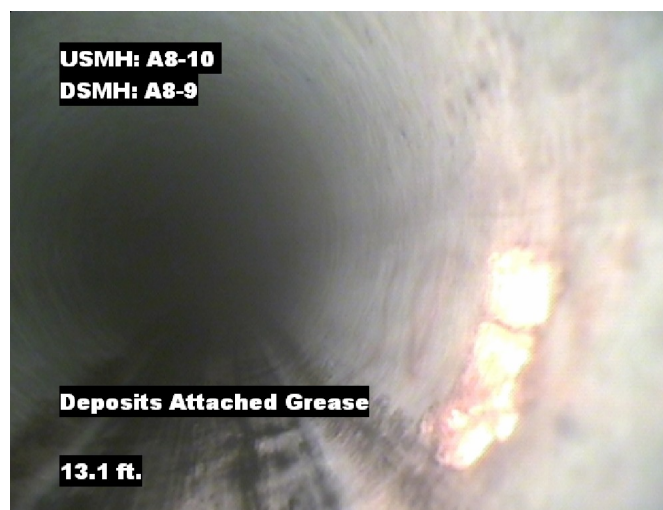
Distance: 13.1 ft. Grade: 2
Condition: Deposits Attached Grease
Remarks: N/A

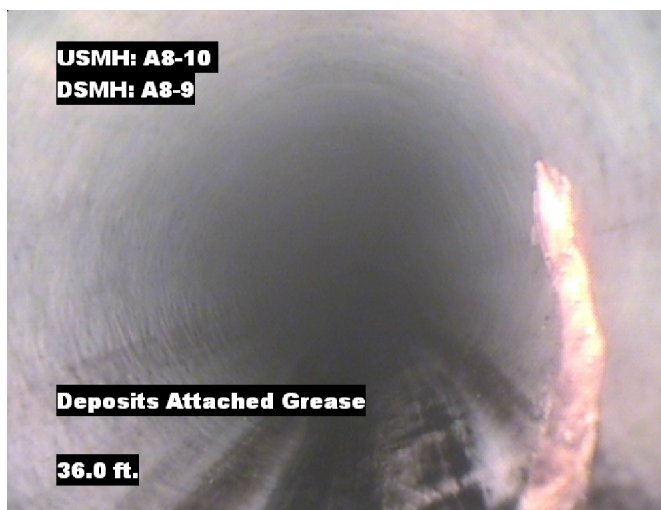
Distance: 36.0 ft. Grade: 2
Condition: Deposits Attached Grease
Remarks: N/A

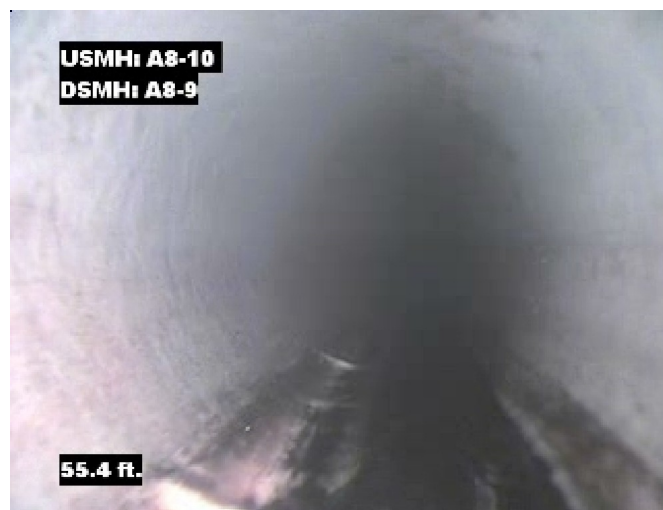
Distance: 55.4 ft. Grade: 3
Condition: Lining Failure Wrinkled
Remarks: This defect is present through out the pipe

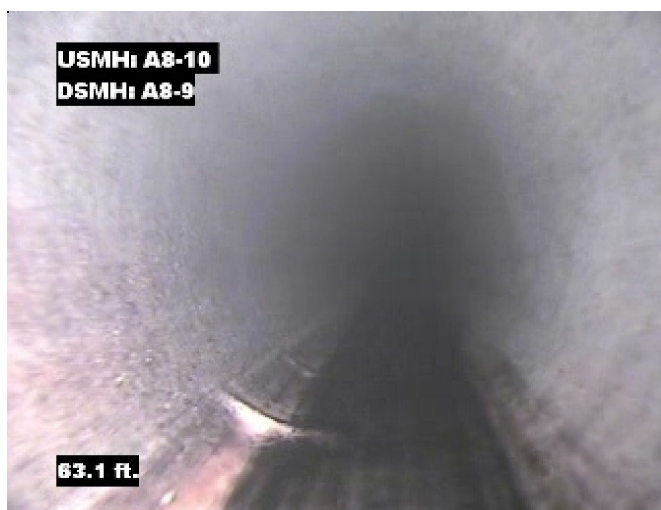
Distance: 63.2 ft. Grade: 3
Condition: Lining Failure Wrinkled
Remarks: N/A

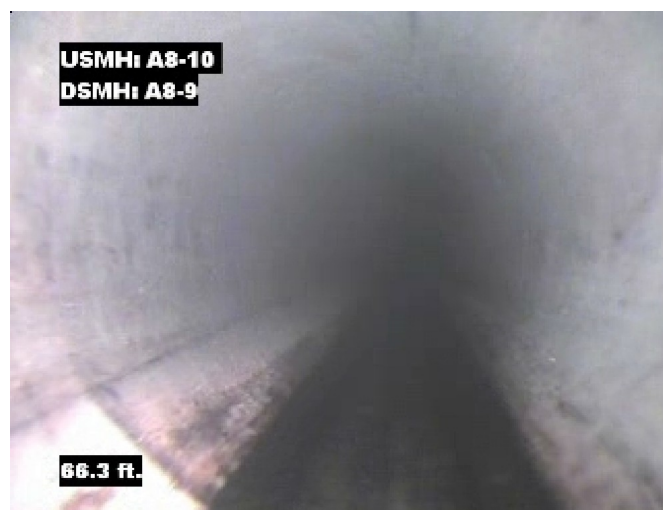
Distance: 66.3 ft. Grade: 3
Condition: Lining Failure Wrinkled
Remarks: N/A

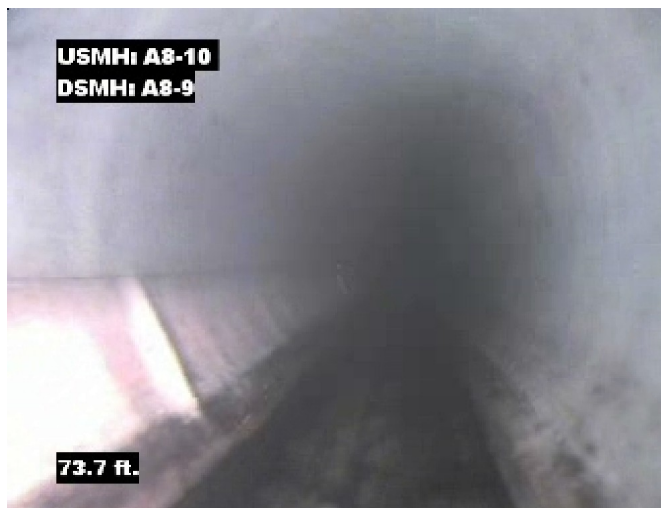
Distance: 73.7 ft. Grade: 3
Condition: Lining Failure Wrinkled
Remarks: N/A

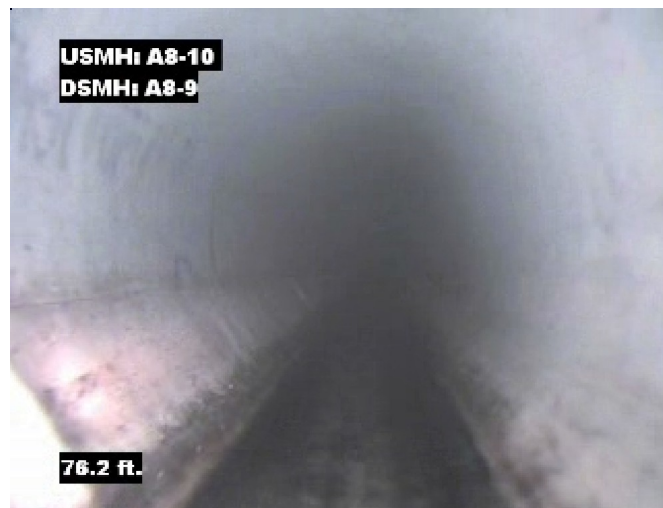
Distance: 76.2 ft. Grade: 3
Condition: Lining Failure Wrinkled
Remarks: N/A

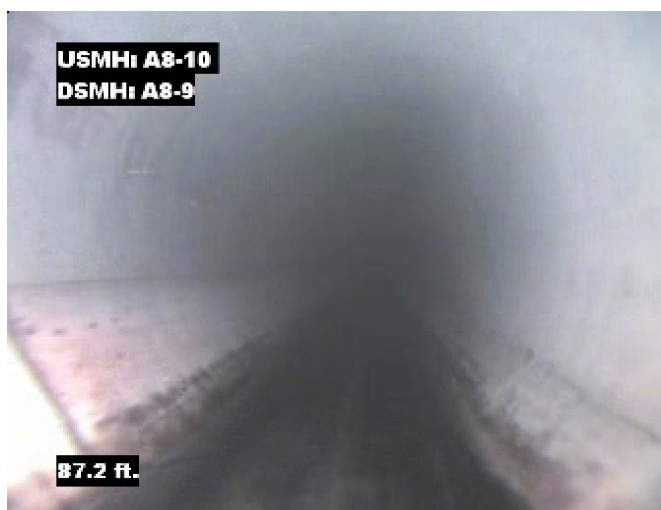
Distance: 87.2 ft. Grade: 3
Condition: Lining Failure Wrinkled
Remarks: N/A

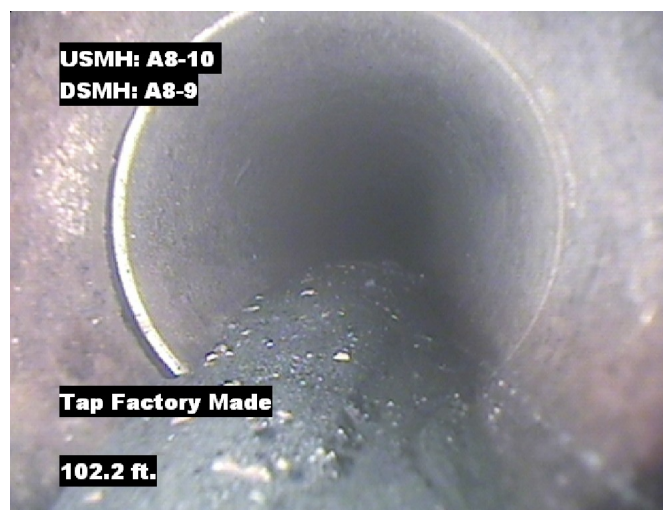
Distance: 102.2 ft. Grade: 0
Condition: Tap Factory Made
Remarks: N/A

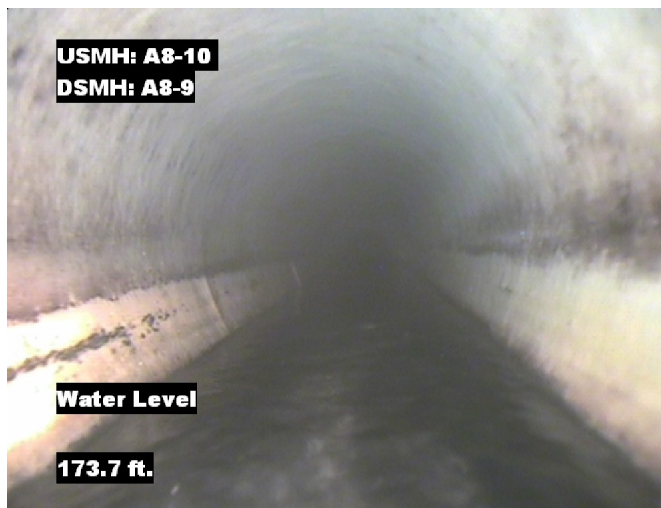
Distance: 173.7 ft. Grade: 0
Condition: Water Level
Remarks: N/A

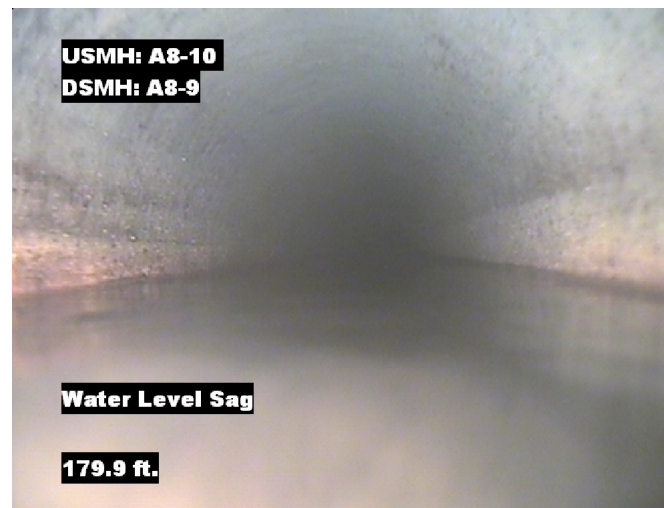
Distance: 179.9 ft. Grade: 2
Condition: Water Level Sag
Remarks: N/A

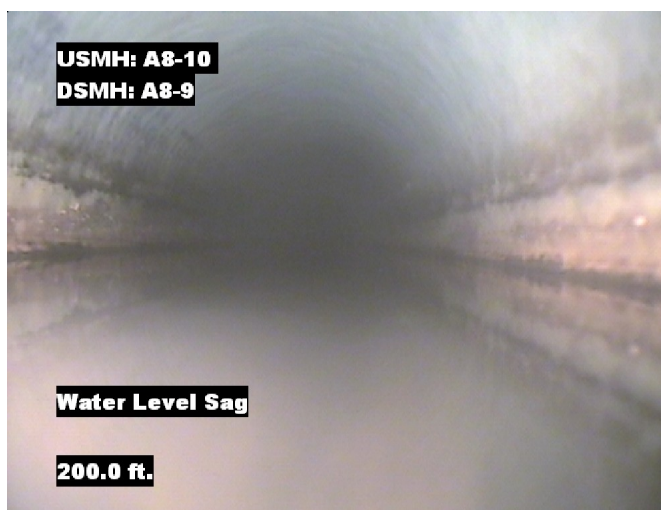
Distance: 200.0 ft. Grade: 3
Condition: Water Level Sag
Remarks: N/A

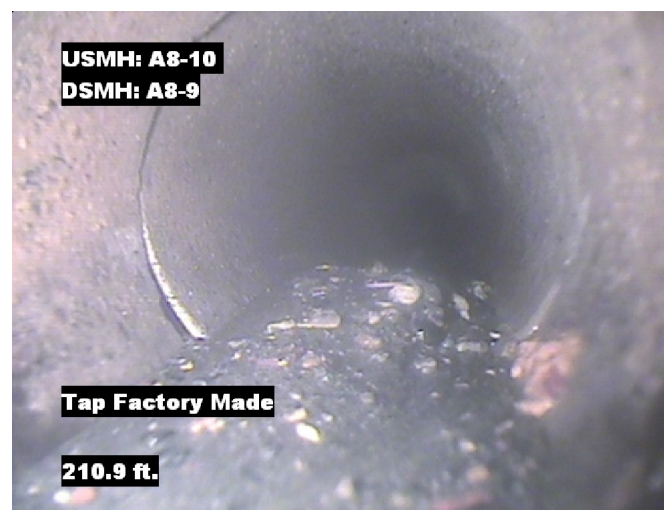
Distance: 210.9 ft. Grade: 0
Condition: Tap Factory Made
Remarks: N/A

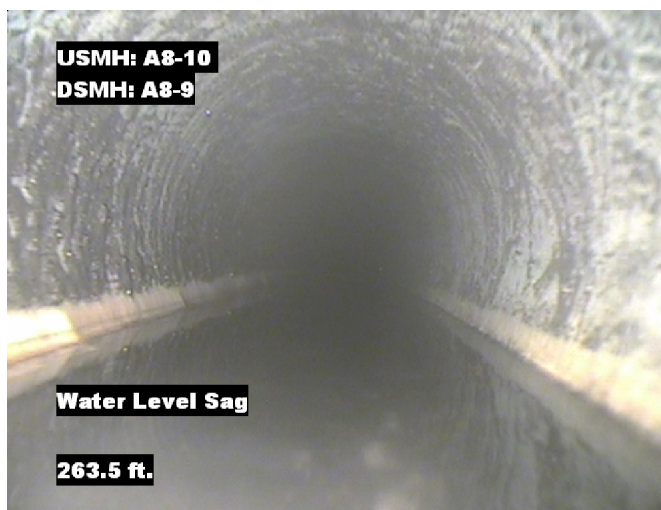
Distance: 263.5 ft. Grade: 2
Condition: Water Level Sag
Remarks: N/A

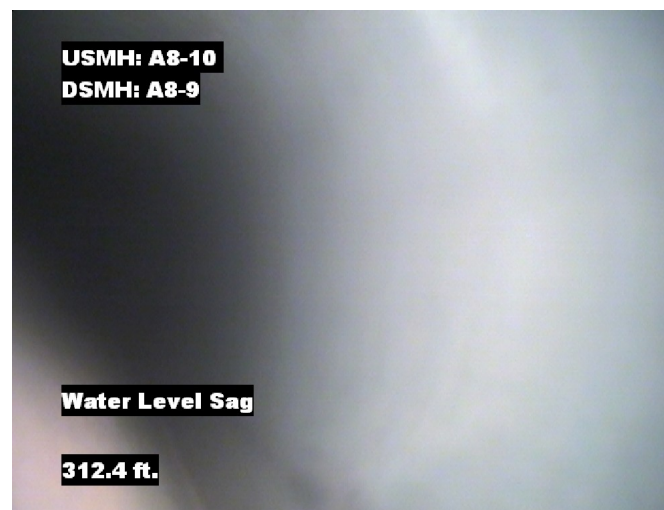
Distance: 312.3 ft. Grade: 3
Condition: Water Level Sag
Remarks: N/A

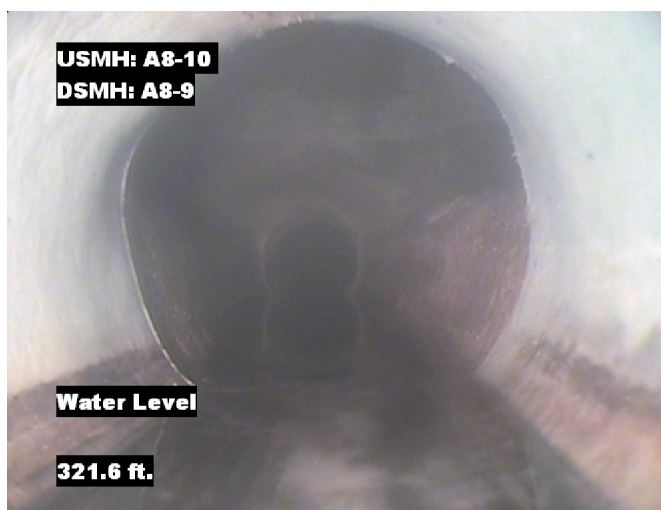
Distance: 321.6 ft. Grade: 0
Condition: Water Level
Remarks: N/A

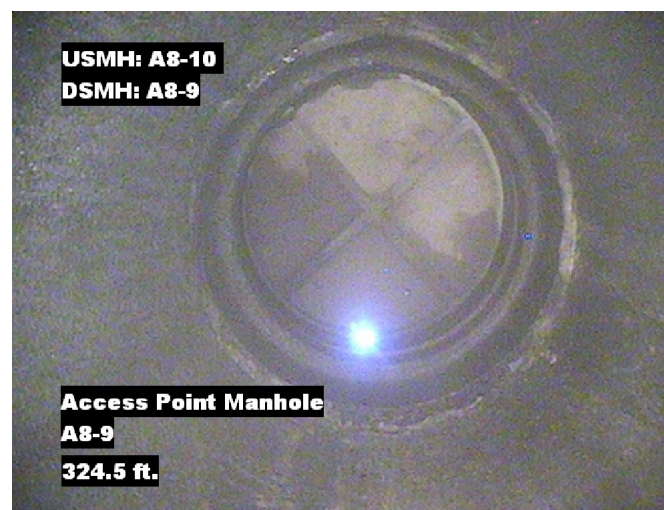
Distance: 324.5 ft. Grade: 0
Condition: Access Point Manhole
Remarks: A8-9
