Defect Listing

Pipe Segment Refere... A8-11_A8-10	City Oliver Springs	Street Railroad Ave	Material Fibreglass Reinforc...	Location C... Light High...	Sewer Use Sanitary
Upstream MH A8-11	Total Length 325.4	Year Laid	Shape Circular	Location Details	
DS Manhole A8-10	Length surveyed 325.4	Year Renewed	Height 8	Width 8	Pipe Joint... N/A

SPR N/A	MPR 5	PO Number 4397-03	Customer GRW
SPRI N/A	MPRI 2.5	Work Order 4397-02	Purpose Pre-Rehabilitation Survey
QSR N/A	QMR 3121		
OPR 5	Surveyed By Barry Rogers	Direction Downstream	Date 20150731
OPRI 2.5	Certificate Number U-1012-16405	Pre-Cleaning Jetting	Time 09:06
	Date Cleaned 20150731	End Time 09:24	Weather Dry
			Media label
			Additional Info

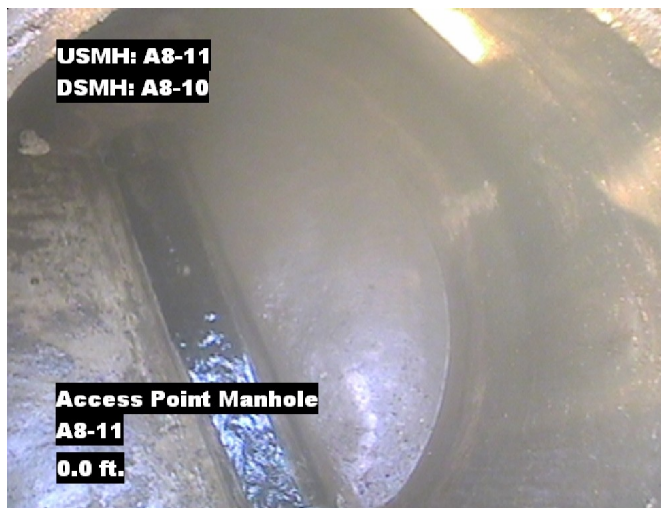
Distance: 0.0 ft. Grade: 0
Condition: Access Point Manhole
Remarks: A8-11

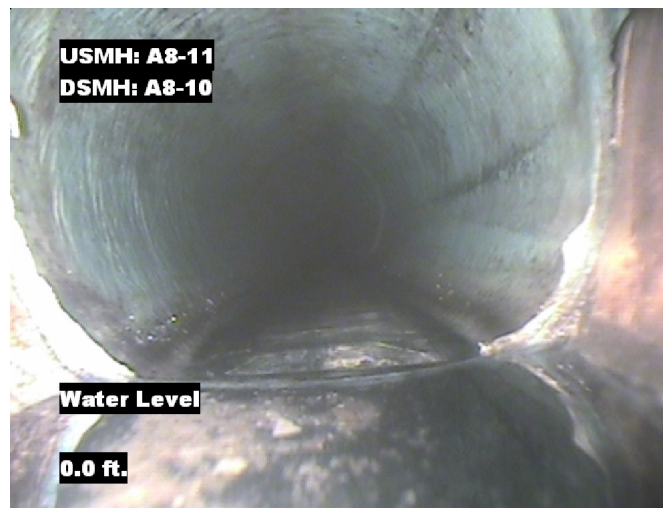
Distance: 0.0 ft. Grade: 0
Condition: Water Level
Remarks: N/A

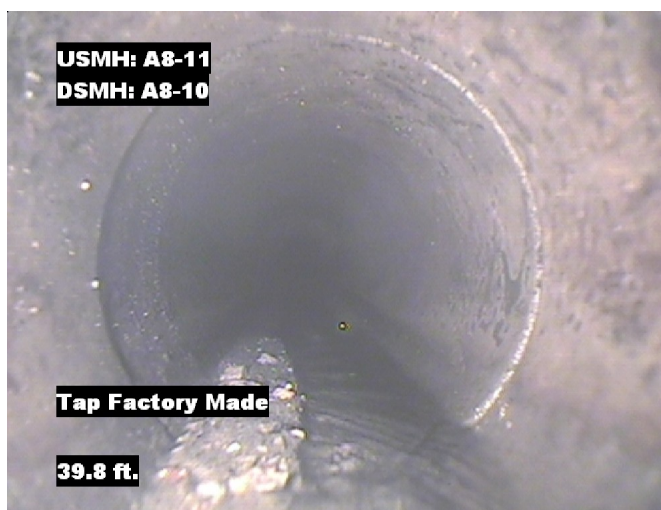
Distance: 39.8 ft. Grade: 0
Condition: Tap Factory Made
Remarks: N/A

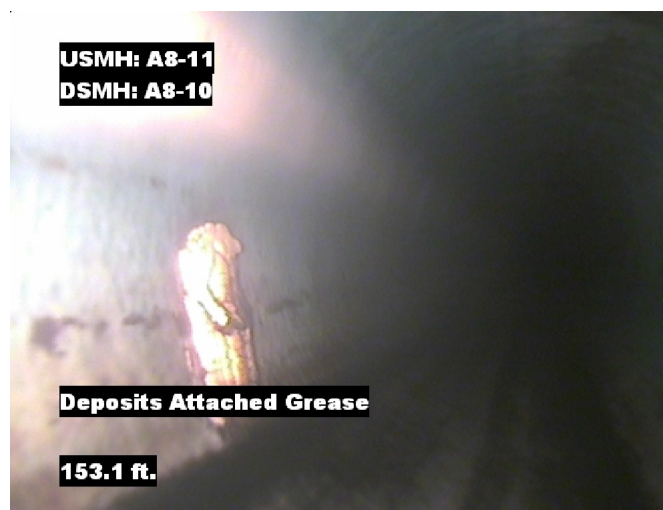
Distance: 153.1 ft. Grade: 2
Condition: Deposits Attached Grease
Remarks: N/A

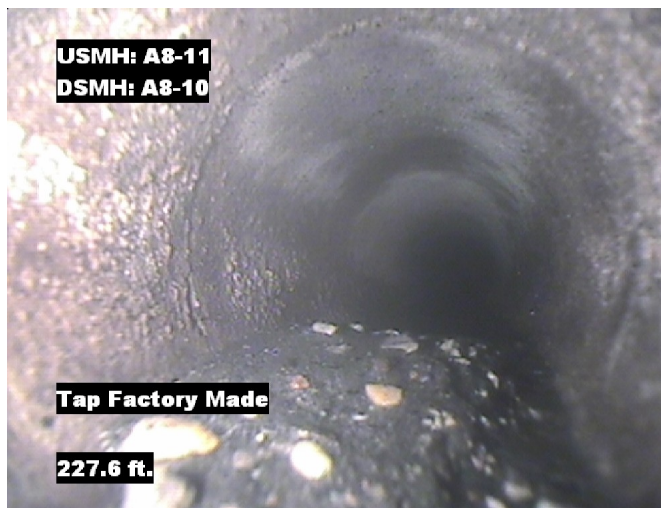
Distance: 227.6 ft. Grade: 0
Condition: Tap Factory Made
Remarks: N/A

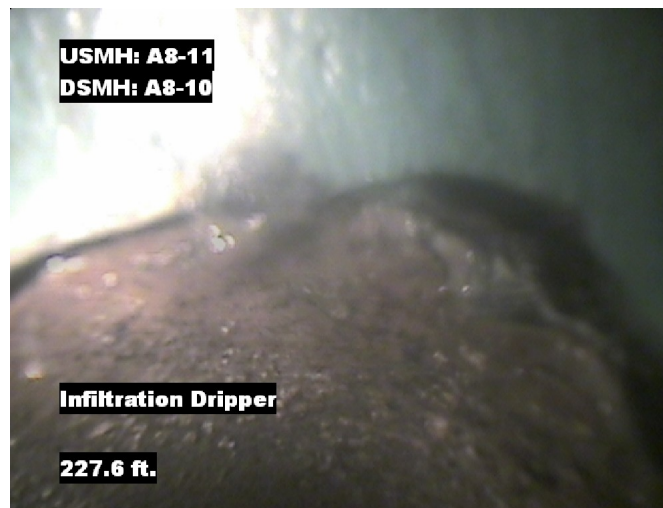
Distance: 227.6 ft. Grade: 3
Condition: Infiltration Dripper
Remarks: N/A

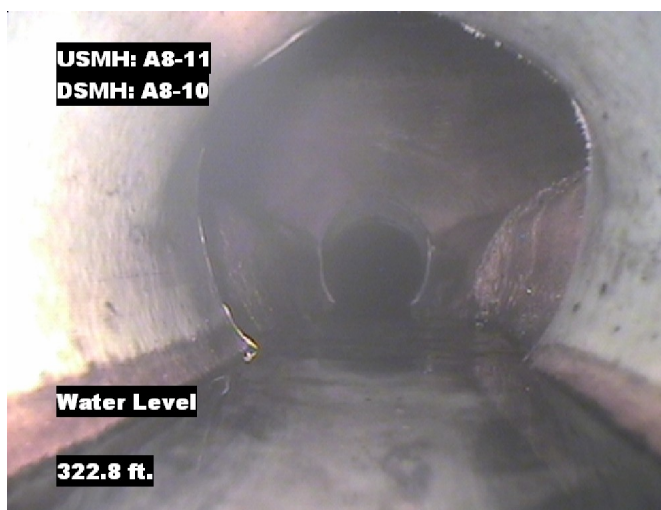
Distance: 322.8 ft. Grade: 0
Condition: Water Level
Remarks: N/A

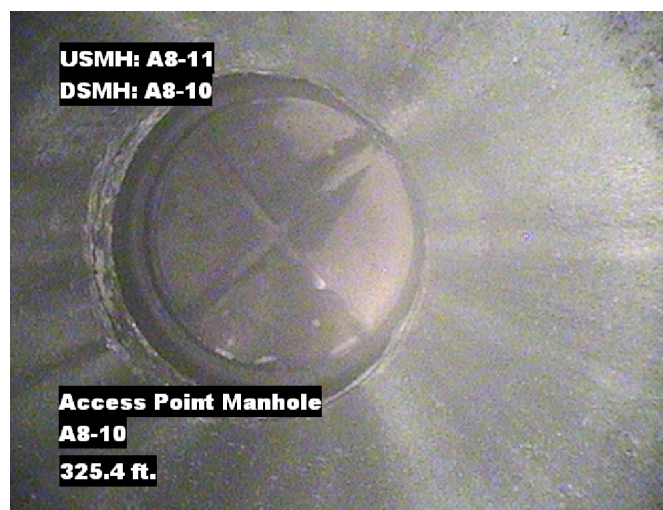
Distance: 325.4 ft. Grade: 0
Condition: Access Point Manhole
Remarks: A8-10
