## Defect Listing

Pipe Segment Refere... <b>A8-12_A8-11</b>	City <b>Oliver Springs</b>	Street <b>Walden Rd</b>	Material <b>Fibreglass Reinforc...</b>	Location C... <b>Easement/R...</b>	Sewer Use <b>Sanitary</b>
Upstream MH <b>A8-12</b>	Total Length <b>330.4</b>	Year Laid	Shape <b>Circular</b>	Location Details	
DS Manhole <b>A8-11</b>	Length surveyed <b>330.4</b>	Year Renewed	Height <b>8</b>	Width <b>8</b>	Pipe Joint... <b>N/A</b>

SPR <b>N/A</b>	MPR <b>4</b>	PO Number <b>4397-03</b>	Customer <b>GRW</b>
SPRI <b>N/A</b>	MPRI <b>2</b>	Work Order <b>4397-02</b>	Purpose <b>Pre-Rehabilitation Survey</b>
QSR <b>N/A</b>	QMR <b>2200</b>		
OPR <b>4</b>	Surveyed By <b>Barry Rogers</b>	Direction <b>Downstream</b>	Date <b>20150731</b>
OPRI <b>2</b>	Certificate Number <b>U-1012-16405</b>	Pre-Cleaning <b>Jetting</b>	Time <b>08:30</b>
	Date Cleaned <b>20150731</b>	End Time <b>08:44</b>	Weather <b>Dry</b>
			Media label
			Additional Info

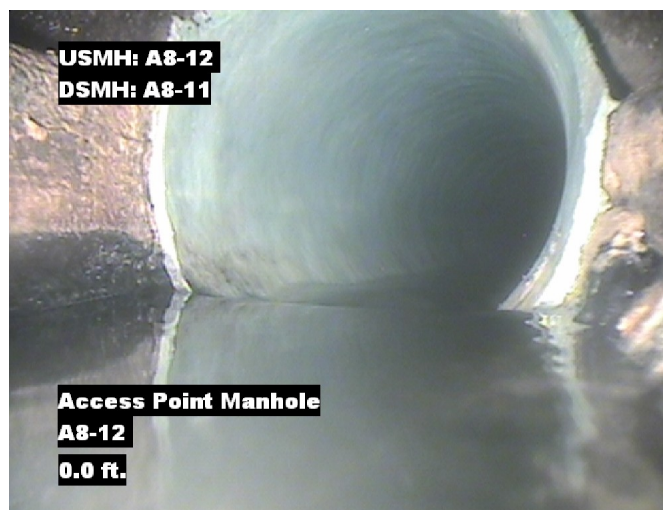
Distance: 0.0 ft. Grade: 0  
Condition: Access Point Manhole  
Remarks: A8-12

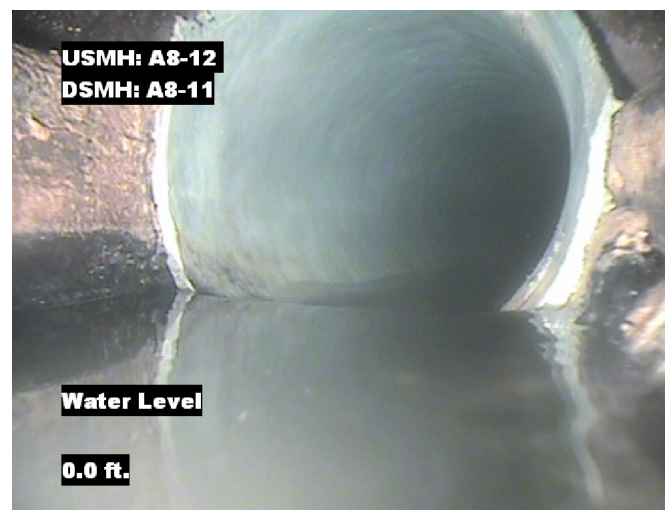
Distance: 0.0 ft. Grade: 0  
Condition: Water Level  
Remarks: N/A

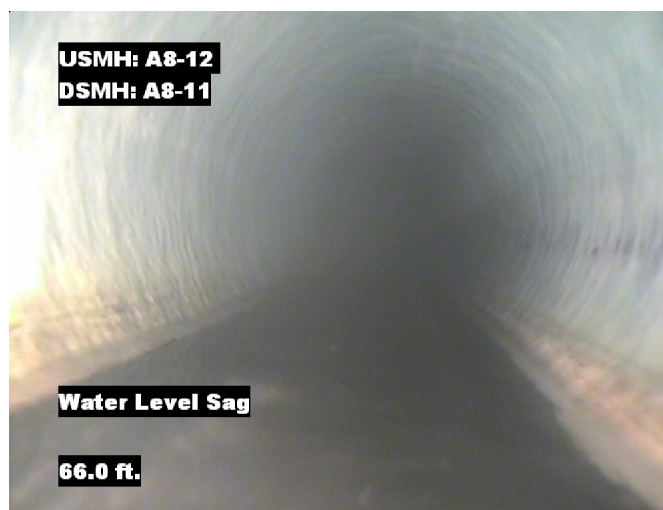
Distance: 66.0 ft. Grade: 2  
Condition: Water Level Sag  
Remarks: N/A

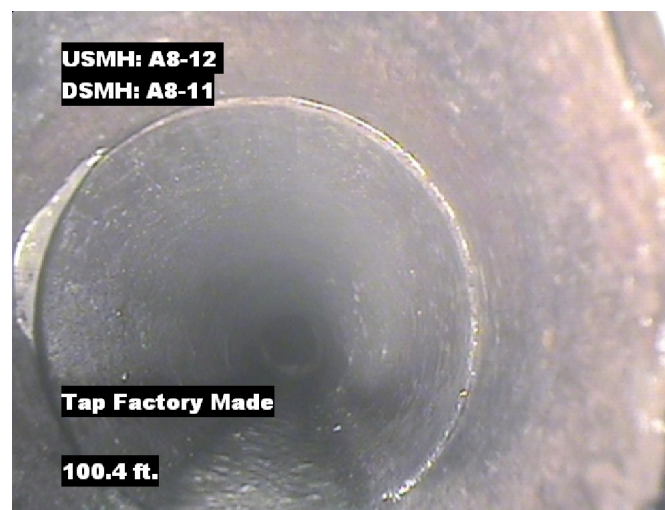
Distance: 100.4 ft. Grade: 0  
Condition: Tap Factory Made  
Remarks: N/A

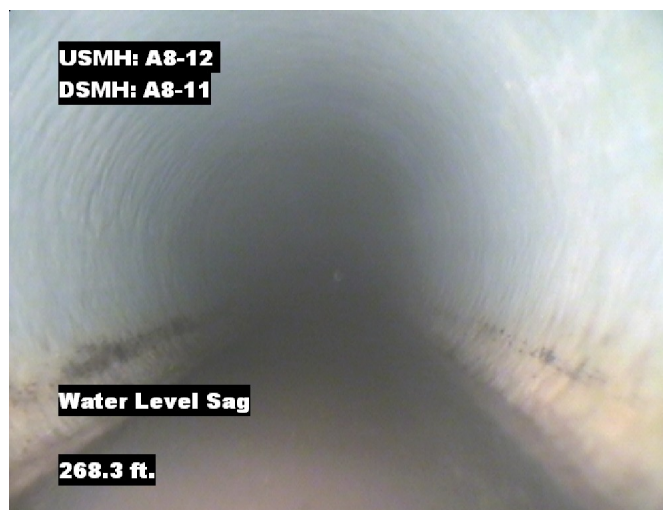
Distance: 268.3 ft. Grade: 2  
Condition: Water Level Sag  
Remarks: N/A

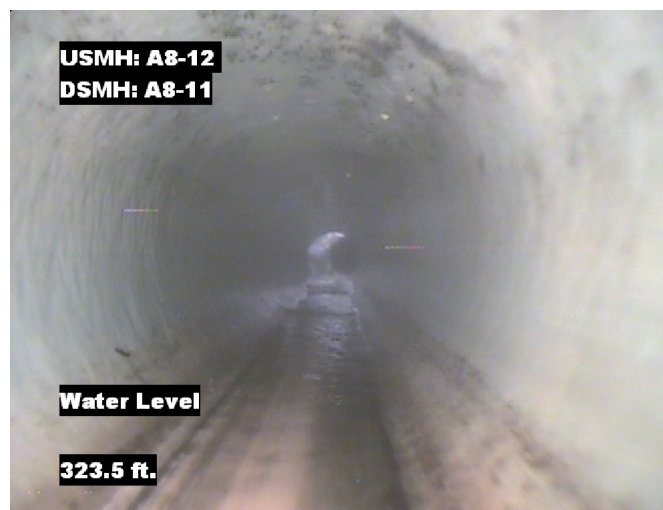
Distance: 323.2 ft. Grade: 0  
Condition: Water Level  
Remarks: N/A

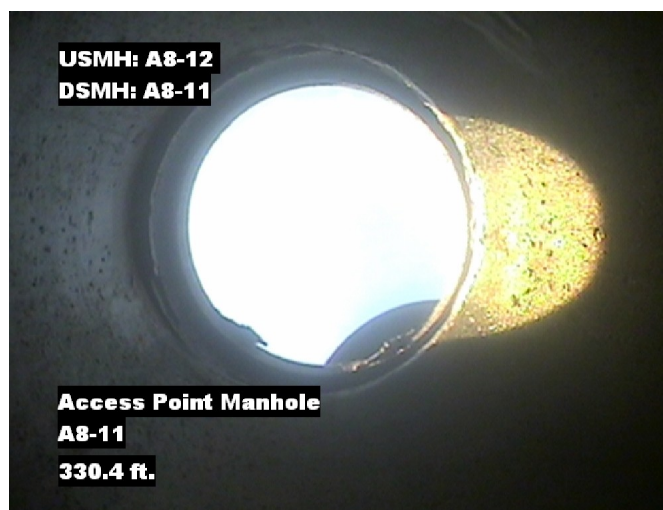
Distance: 330.4 ft. Grade: 0  
Condition: Access Point Manhole  
Remarks: A8-11
