Defect Listing

Pipe Segment Refere... A8-13_A8-12	City Oliver Springs	Street Walden rd	Material Concrete Pipe (non-...	Location C... Yard	Sewer Use Sanitary
Upstream MH A8-13	Total Length 188.2	Year Laid	Shape Circular	Location Details	
DS Manhole A8-12	Length surveyed 188.2	Year Renewed	Height 8	Width 8	Pipe Joint... 4

Image Report 4/Page

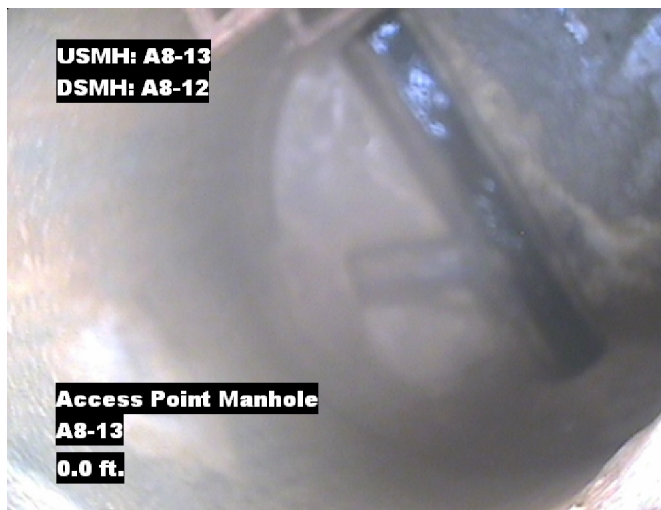
Distance: 0.0 ft. Grade: 0
Condition: Access Point Manhole
Remarks: A8-13

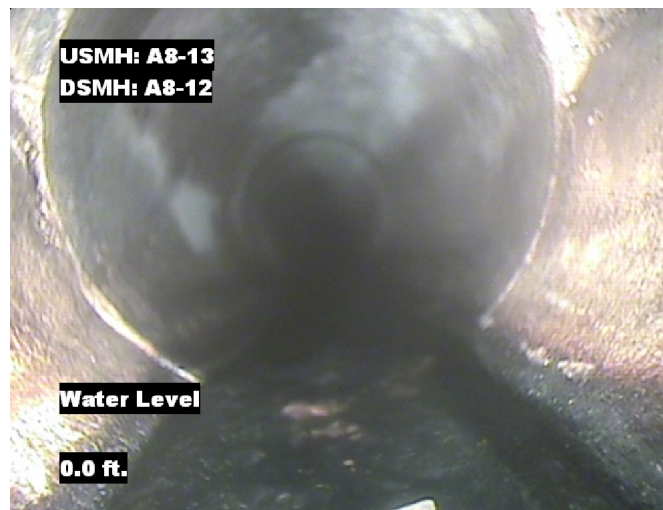
Distance: 0.0 ft. Grade: 0
Condition: Water Level
Remarks: N/A

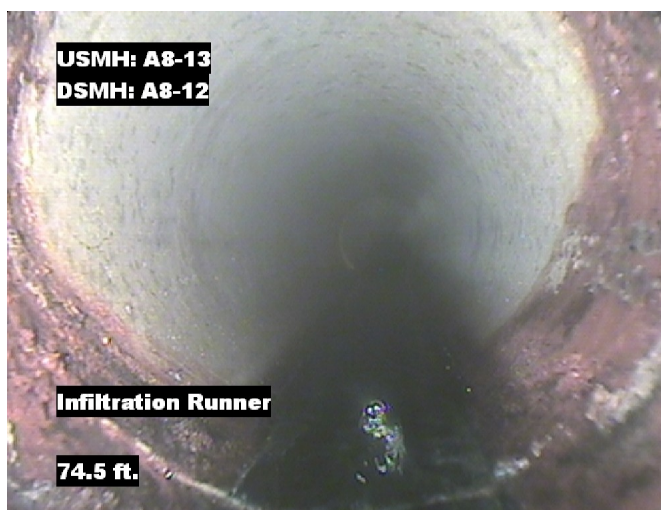
Distance: 74.5 ft. Grade: 4
Condition: Infiltration Runner
Remarks: N/A

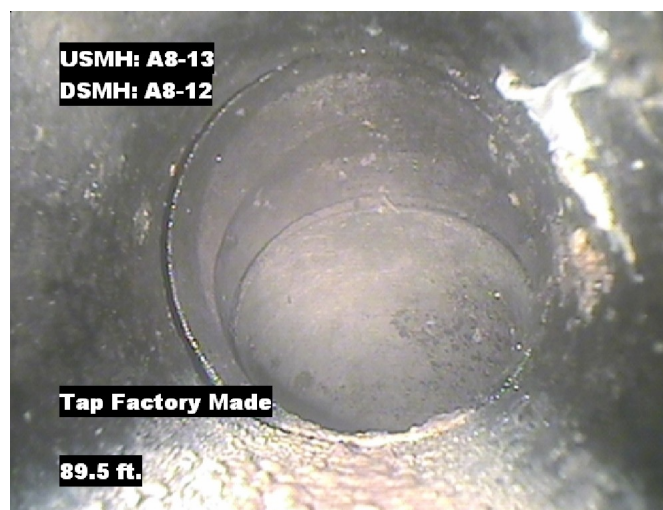
Distance: 89.5 ft. Grade: 0
Condition: Tap Factory Made
Remarks: N/A

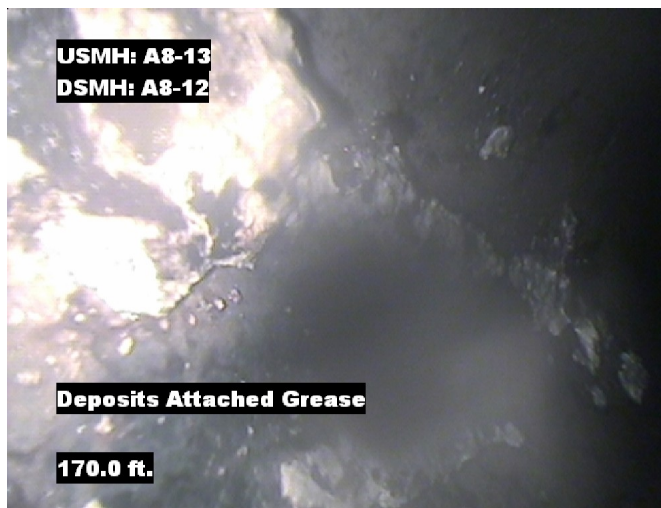
Distance: 170.0 ft. Grade: 2
Condition: Deposits Attached Grease
Remarks: N/A

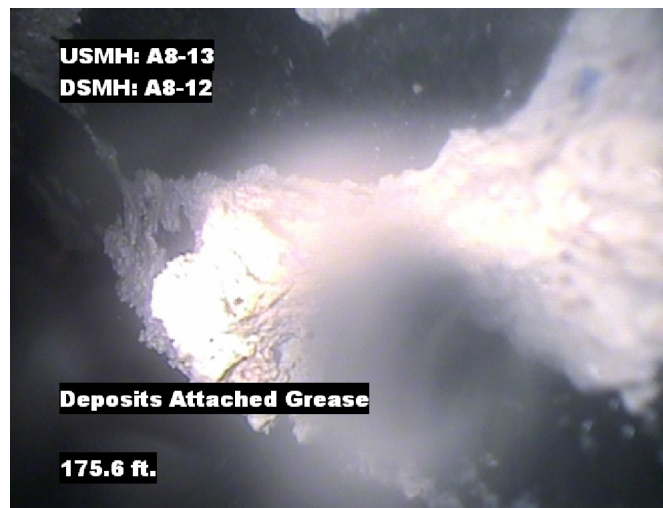
Distance: 175.6 ft. Grade: 2
Condition: Deposits Attached Grease
Remarks: N/A

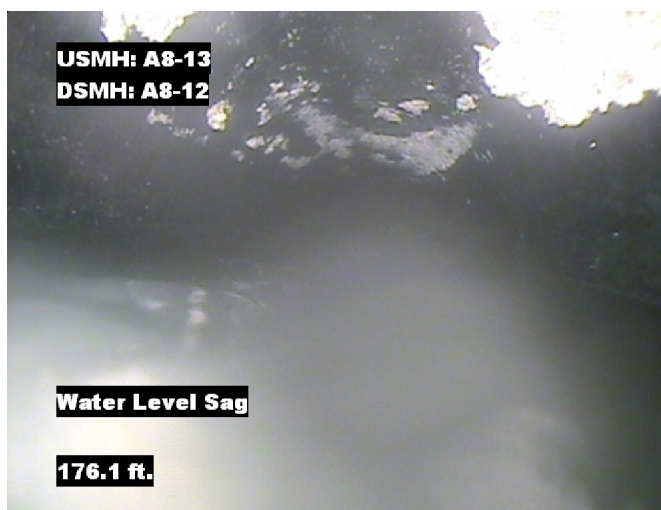
Distance: 176.1 ft. Grade: 2
Condition: Water Level Sag
Remarks: N/A

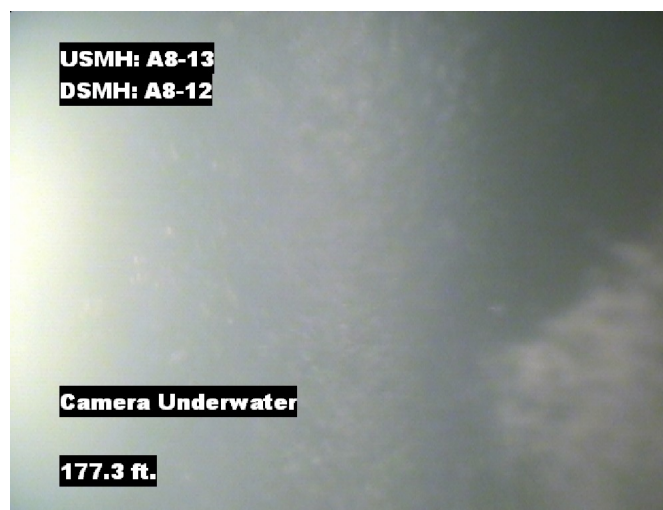
Distance: 177.1 ft. Grade: 4
Condition: Camera Underwater
Remarks: N/A

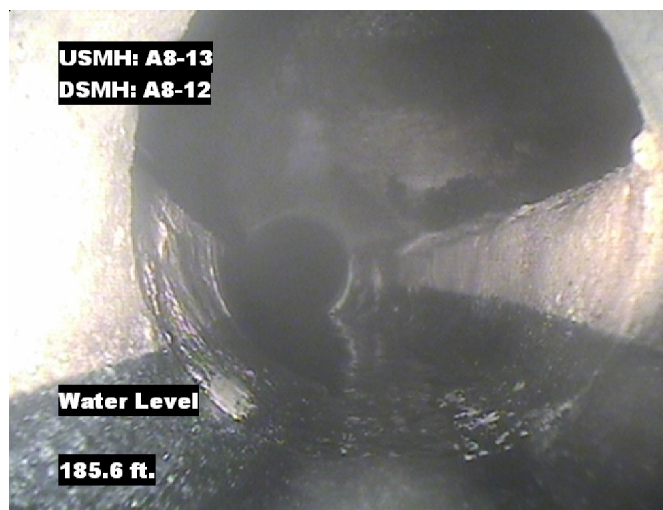
Distance: 185.6 ft. Grade: 0
Condition: Water Level
Remarks: N/A

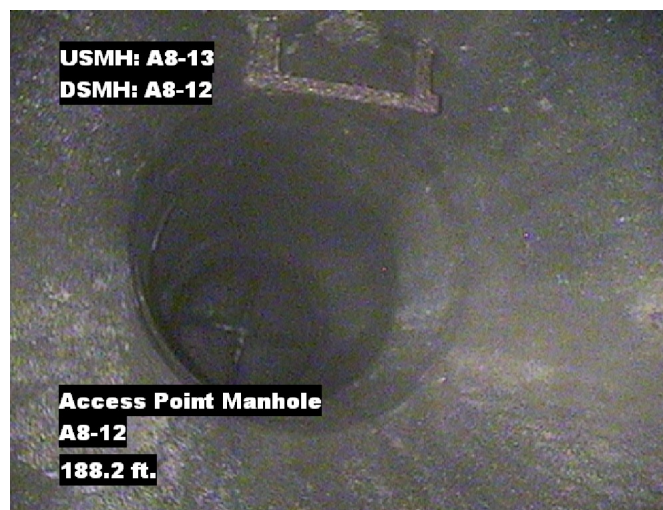
Distance: 188.2 ft. Grade: 0
Condition: Access Point Manhole
Remarks: A8-12
