Defect Listing

Pipe Segment Refere... A8-14_A8-13	City Oliver Springs	Street walden rd	Material Concrete Pipe (non-...	Location C... Light High...	Sewer Use Sanitary
Upstream MH A8-14	Total Length 165.6	Year Laid	Shape Circular	Location Details	
DS Manhole A8-13	Length surveyed 165.6	Year Renewed	Height 8	Width 8	Pipe Joint... 4

SPR 3	MPR 13	PO Number 4397-03		Customer GRW	
SPRI 1.5	MPRI 2.6	Work Order 4397-02		Purpose Pre-Rehabilitation Survey	
QSR 2111	QMR 4222				
OPR 16	Surveyed By Barry Rogers	Direction Downstream	Date 20150731	Media label	
OPRI 2.3	Certificate Number U-1012-16405	Pre-Cleaning Heavy Cleaning	Time 06:37	Weather Dry	
Date Cleaned 20150731			End Time 07:01	Additional Info Used root saw

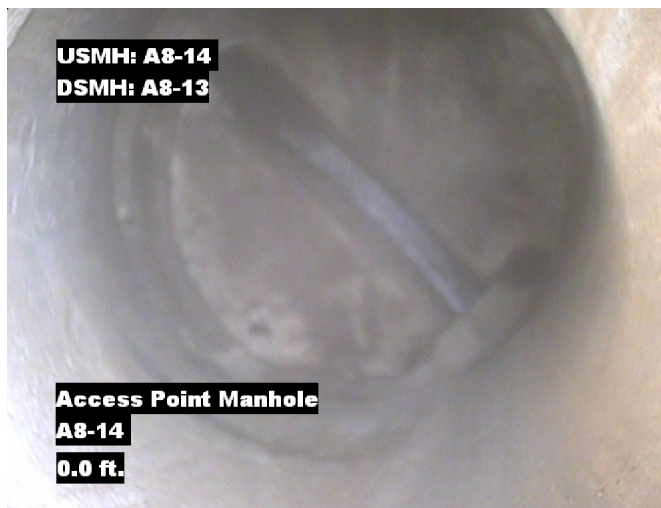
Distance: 0.0 ft. Grade: 0
Condition: Access Point Manhole
Remarks: A8-14

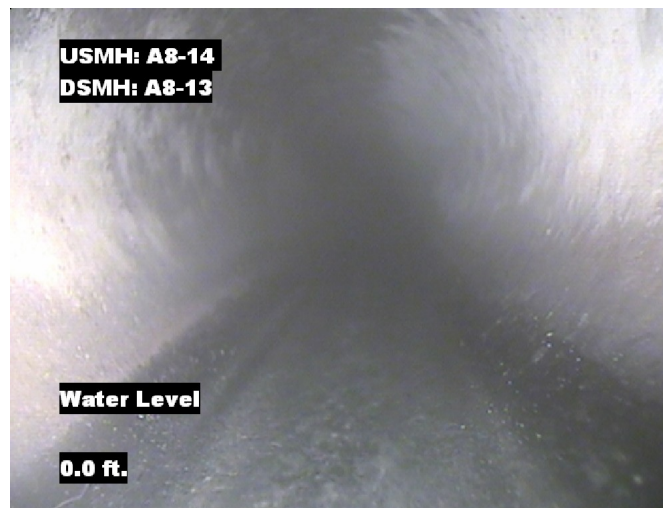
Distance: 0.0 ft. Grade: 0
Condition: Water Level
Remarks: N/A

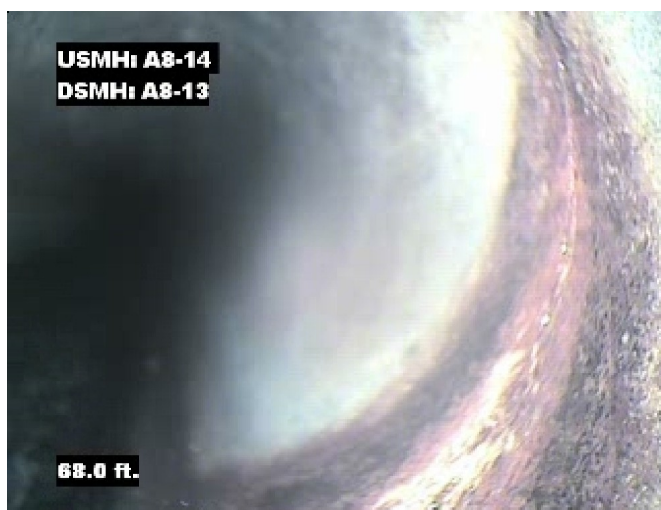
Distance: 68.0 ft. Grade: 4
Condition: Infiltration Runner
Remarks: N/A

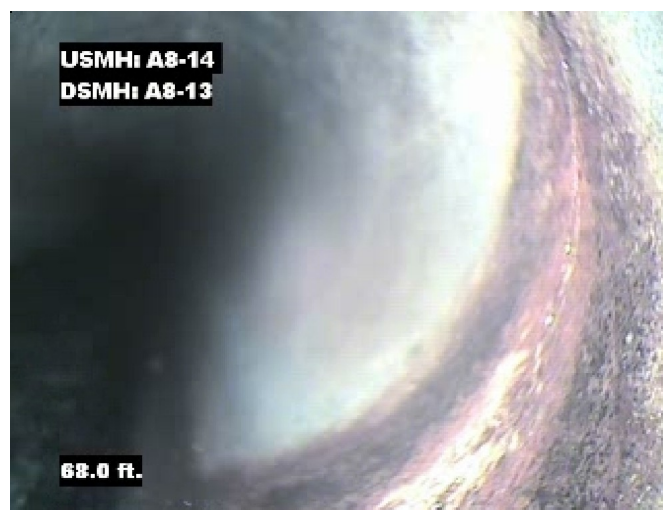
Distance: 68.0 ft. Grade: 0
Condition: Infiltration Stain
Remarks: N/A

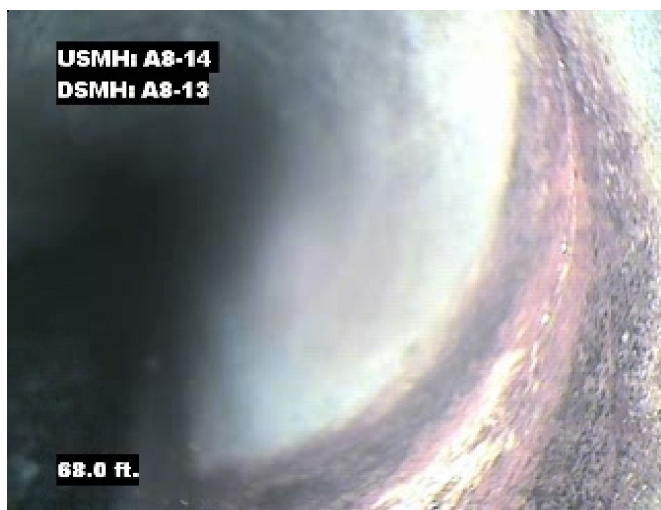
Distance: 68.0 ft. Grade: 4
Condition: Infiltration Runner
Remarks: N/A

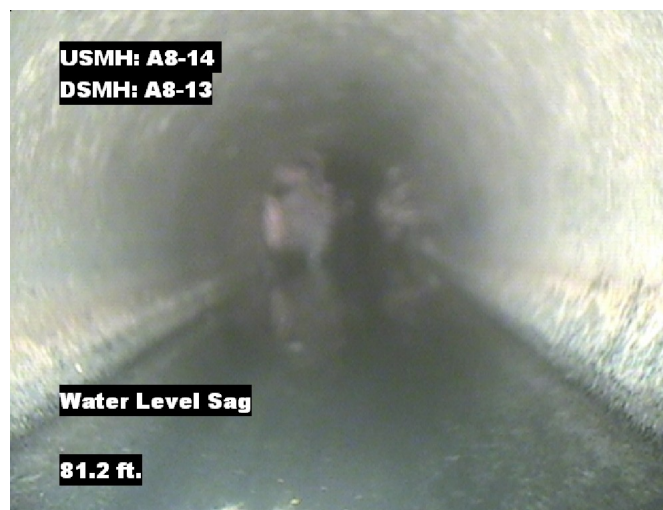
Distance: 81.2 ft. Grade: 2
Condition: Water Level Sag
Remarks: N/A

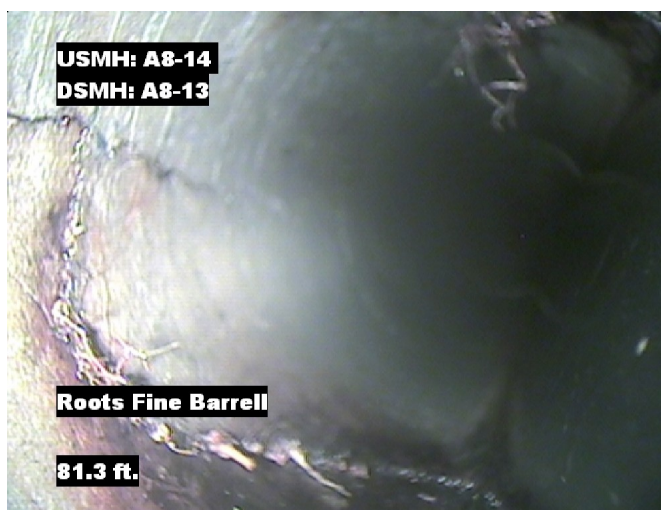
Distance: 81.3 ft. Grade: 2
Condition: Roots Fine Barrell
Remarks: N/A

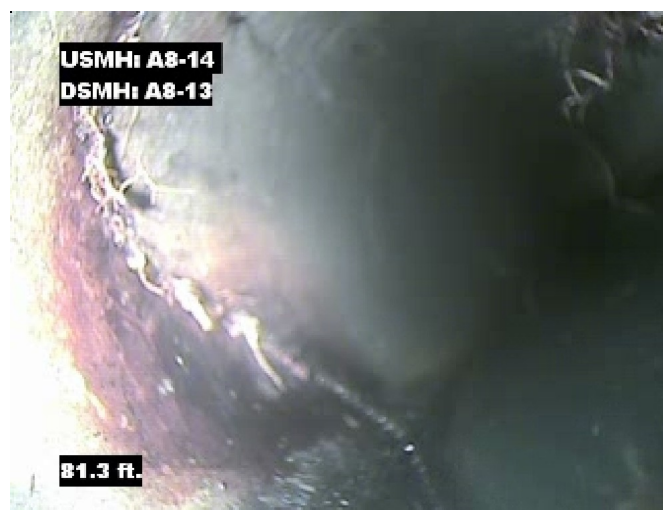
Distance: 81.3 ft. Grade: 0
Condition: Infiltration Stain
Remarks: N/A

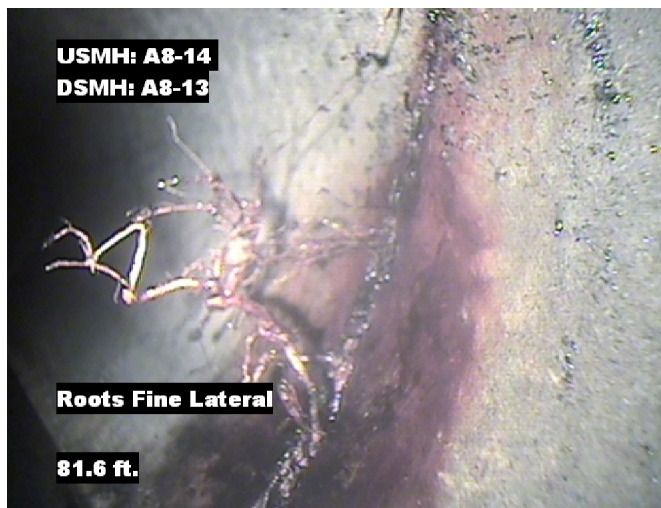
Distance: 81.6 ft. Grade: 1
Condition: Roots Fine Lateral
Remarks: N/A

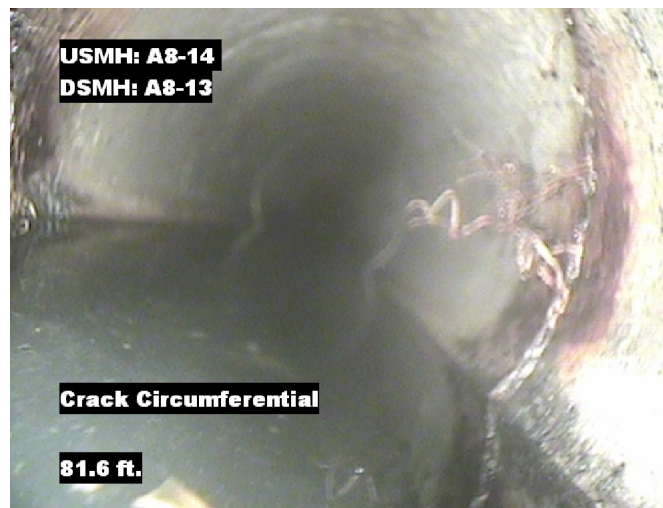
Distance: 81.6 ft. Grade: 1
Condition: Crack Circumferential
Remarks: N/A

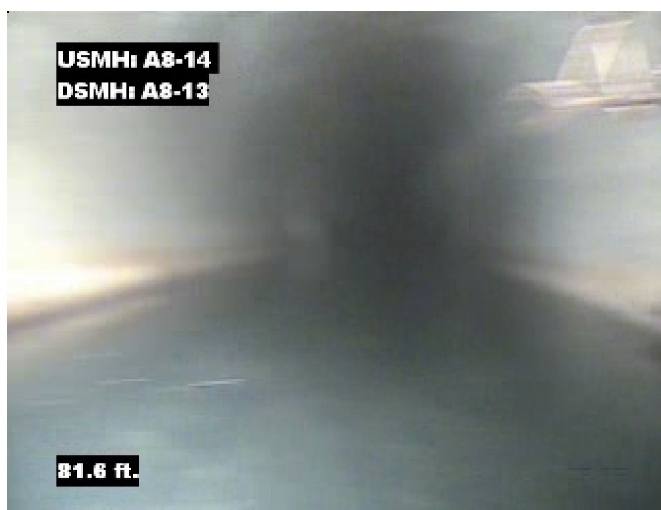
Distance: 81.6 ft. Grade: 0
Condition: Infiltration Stain
Remarks: N/A

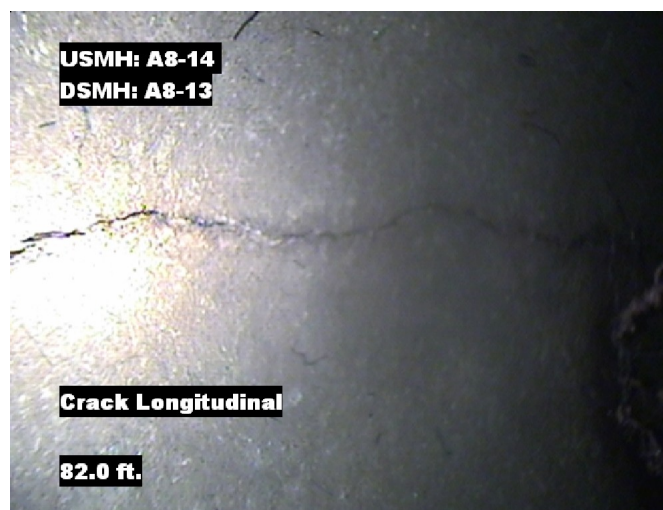
Distance: 82.0 ft. Grade: 2
Condition: Crack Longitudinal
Remarks: N/A

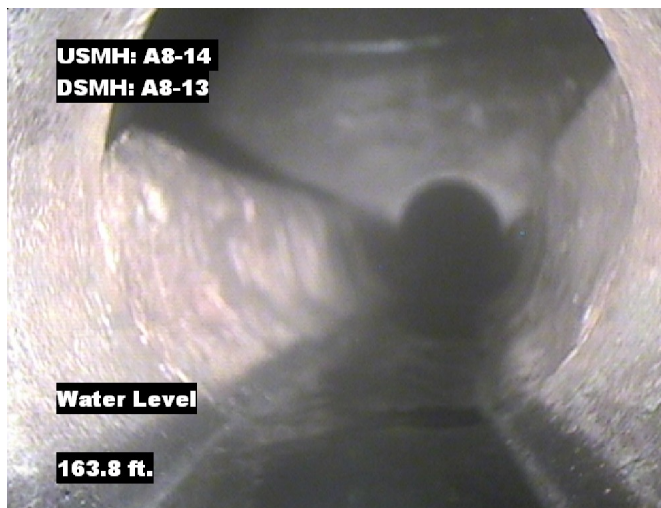
Distance: 163.8 ft. Grade: 0
Condition: Water Level
Remarks: N/A

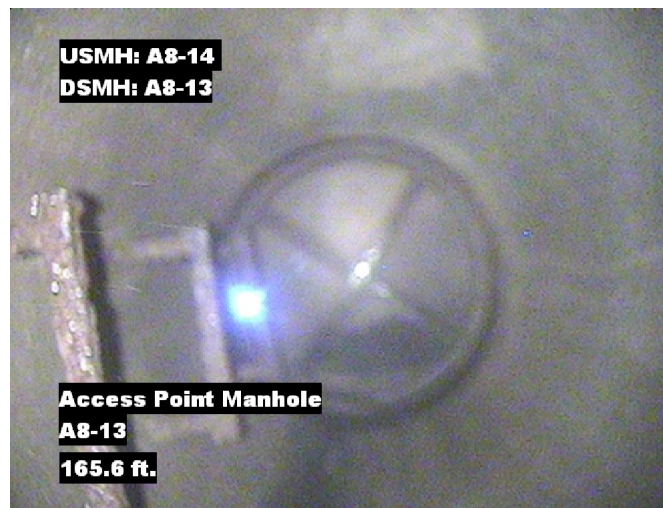
Distance: 165.6 ft. Grade: 0
Condition: Access Point Manhole
Remarks: A8-13
