Defect Listing

| Pipe Segment Refere... A8-15_A8-14 | City Oliver Springs | Street Walden Rd | Material Concrete Pipe (non-... | Location C... Light High... | Sewer Use Sanitary |

| SPRI 5 | MPRI 3 | Work Order 4397-02 | Purpose Pre-Rehabilitation Survey |

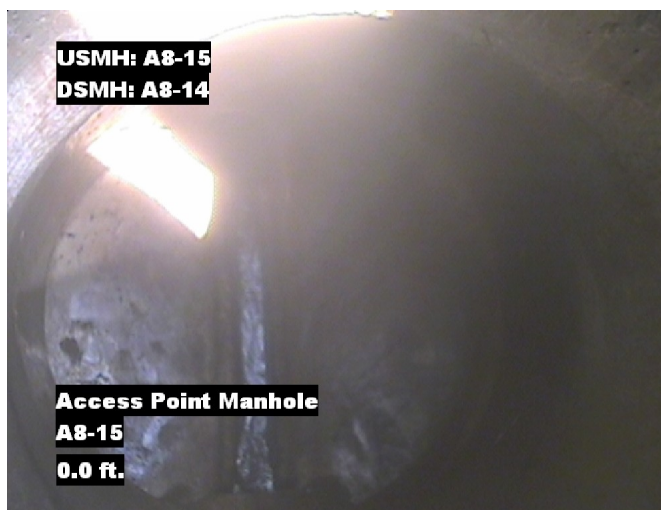
Distance: 0.0 ft. Grade: 0
Condition: Access Point Manhole
Remarks: A8-15

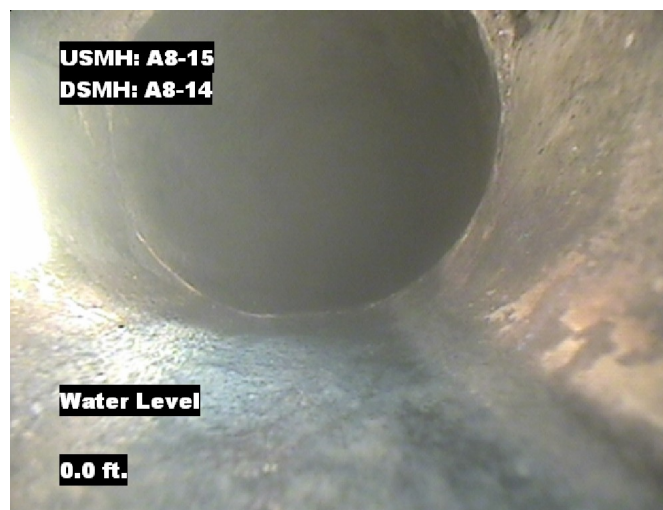
Distance: 0.0 ft. Grade: 0
Condition: Water Level
Remarks: N/A

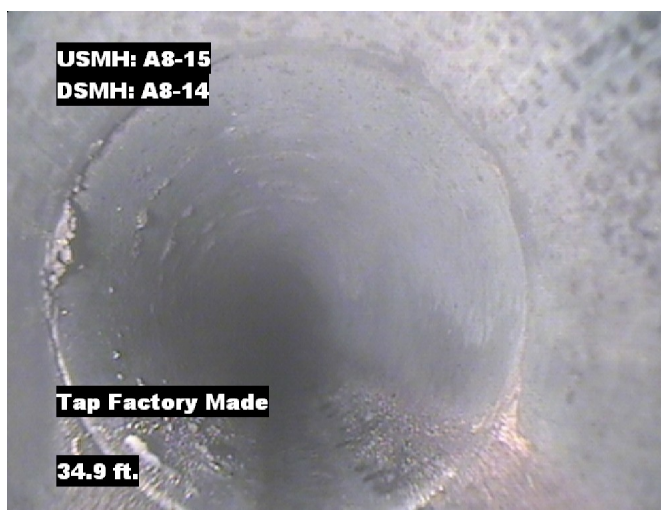
Distance: 34.9 ft. Grade: 0
Condition: Tap Factory Made
Remarks: N/A

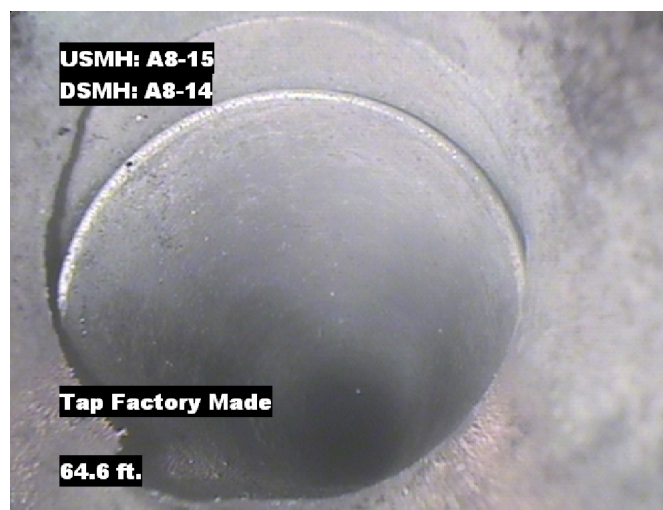
Distance: 64.6 ft. Grade: 0
Condition: Tap Factory Made
Remarks: N/A

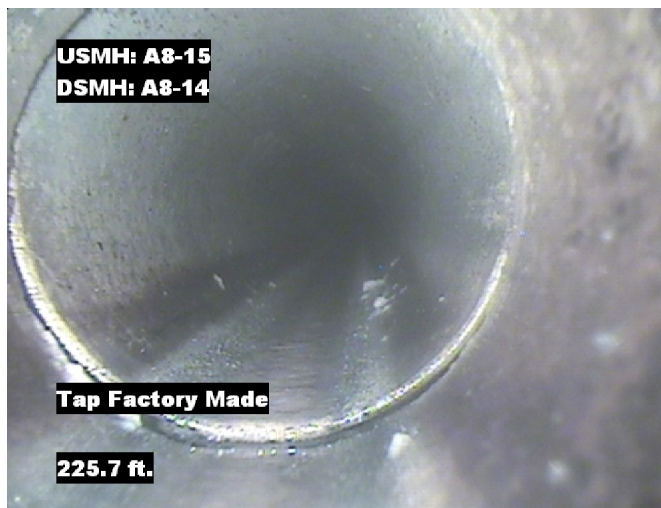
Distance: 225.7 ft. Grade: 0
Condition: Tap Factory Made
Remarks: N/A

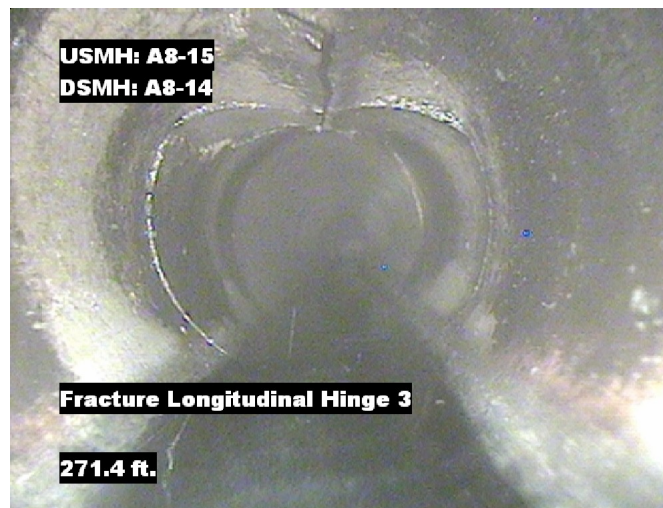
| Distance | Condition | Cont. Dfct. | Values | | | Joint | Clock Position | | Grade |
|---|---|---|---|---|---|---|---|---|---|
| 271.4 ft. | Fracture Longitudinal Hinge 3 | | | | 0 | <input type="checkbox"/> | 11 | 2 | 5 |

Distance: 271.4 ft. Grade: 5
Condition: Fracture Longitudinal Hinge 3
Remarks: N/A

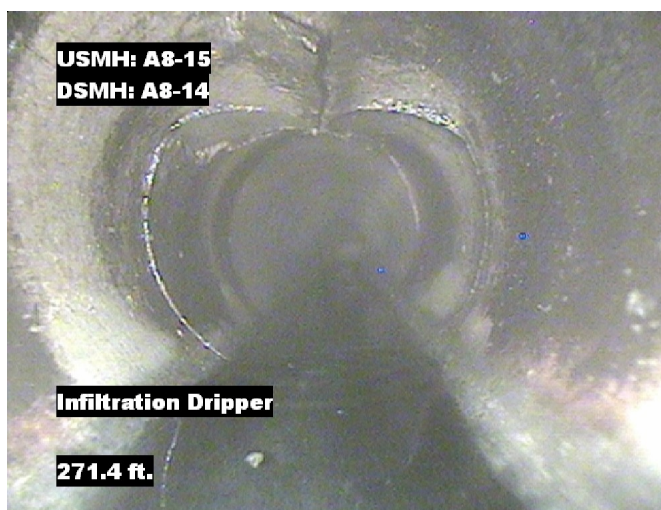
| Distance | Condition | Cont. Dfct. | Values | | | Joint | Clock Position | | Grade |
|---|---|---|---|---|---|---|---|---|---|
| 271.4 ft. | Infiltration Dripper | | | | 0 | <input type="checkbox"/> | 12 | | 3 |

Distance: 271.4 ft. Grade: 3
Condition: Infiltration Dripper
Remarks: N/A

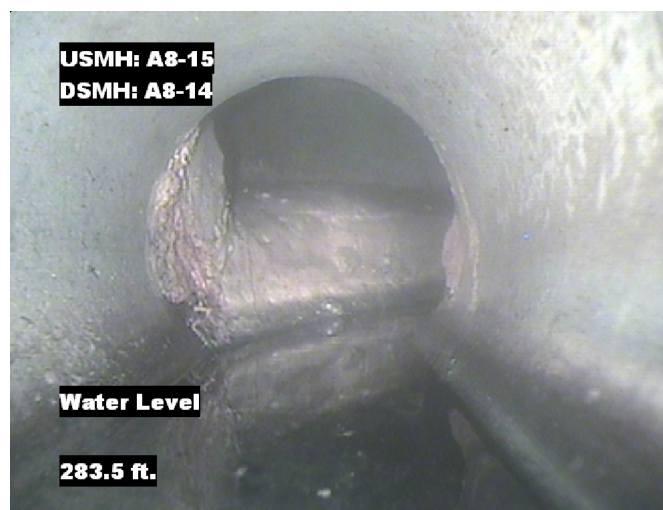
Distance: 283.5 ft. Grade: 0
Condition: Water Level
Remarks: N/A

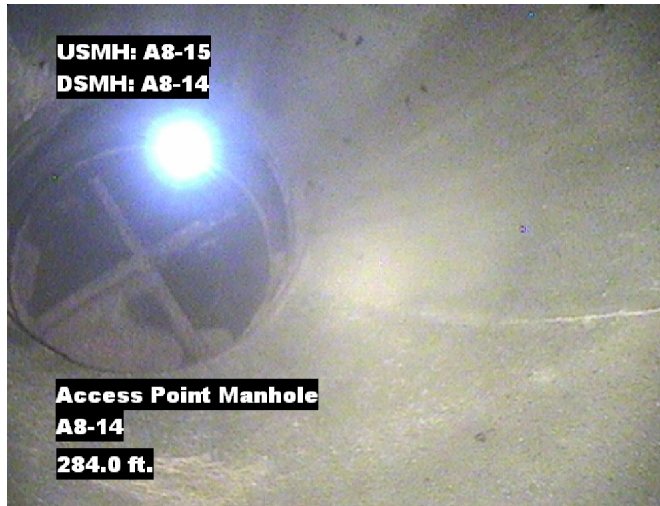
Distance: 284.0 ft. Grade: 0
Condition: Access Point Manhole
Remarks: A8-14
