Defect Listing

| Pipe Segment Refere... A8-16_A8-15 | City Oliver Springs | Street Walden rd | Material Concrete Pipe (non-... | Location C... Light High... | Sewer Use Sanitary |

| SPRI 3 | MPRI N/A | Work Order 4397-02 | Purpose Pre-Rehabilitation Survey |

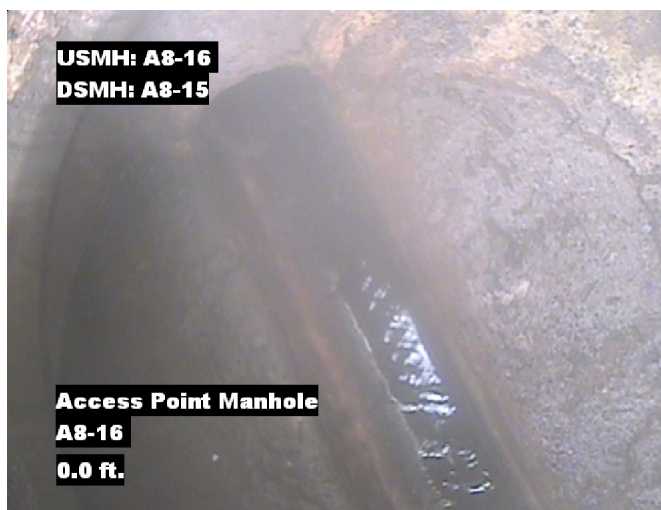
Distance: 0.0 ft. Grade: 0
Condition: Access Point Manhole
Remarks: A8-16

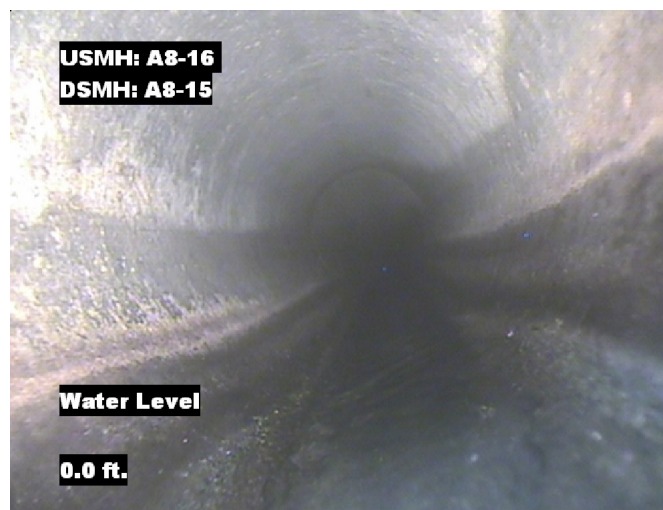
Distance: 0.0 ft. Grade: 0
Condition: Water Level
Remarks: N/A

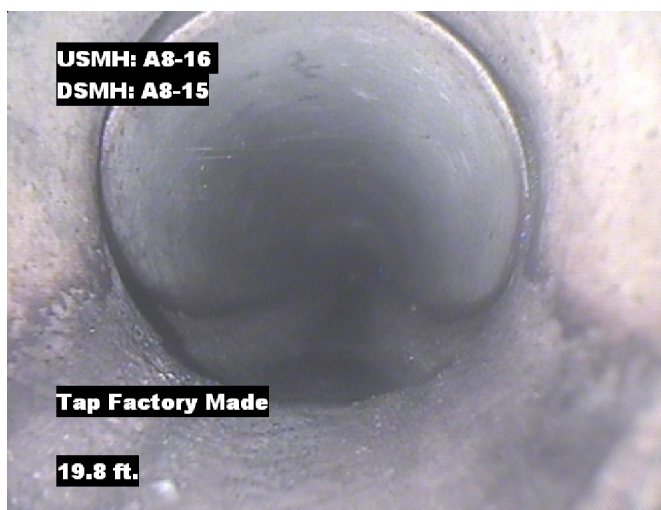
Distance: 19.8 ft. Grade: 0
Condition: Tap Factory Made
Remarks: N/A

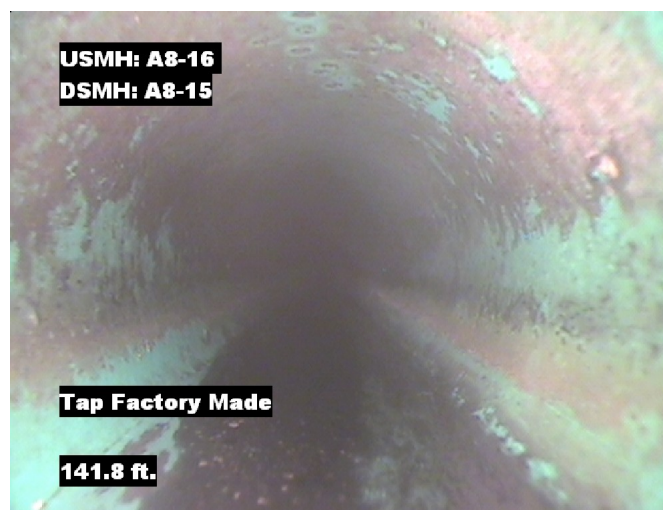
Distance: 141.8 ft. Grade: 0
Condition: Tap Factory Made
Remarks: N/A

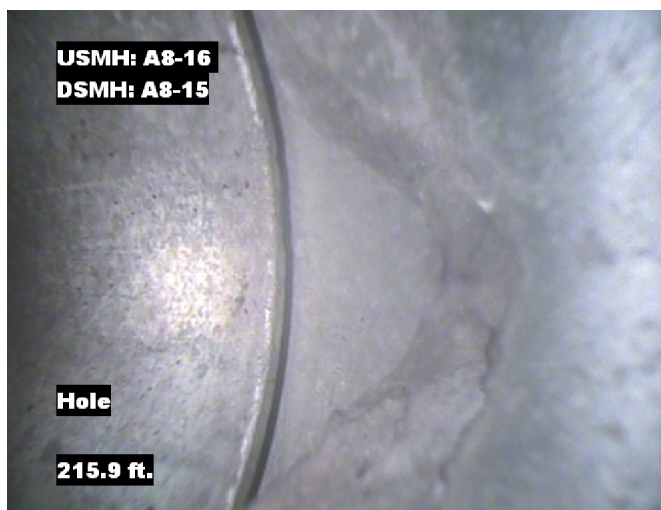
| Distance | Condition | Cont. Dfct. | Values | | | Joint | Clock Position | | Grade |
|---|---|---|---|---|---|---|---|---|---|
| 215.9 ft. | Hole | | | | 0 | <input type="checkbox"/> | 2 | | 3 |

Distance: 215.9 ft. Grade: 3
Condition: Hole
Remarks: N/A

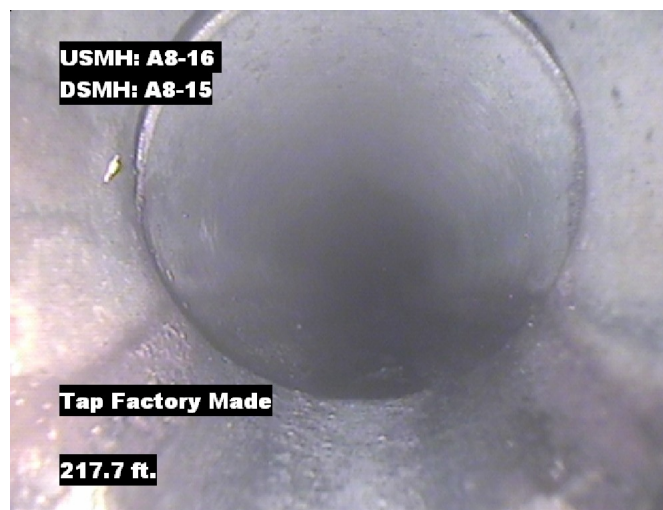
Distance: 217.7 ft. Grade: 0
Condition: Tap Factory Made
Remarks: N/A

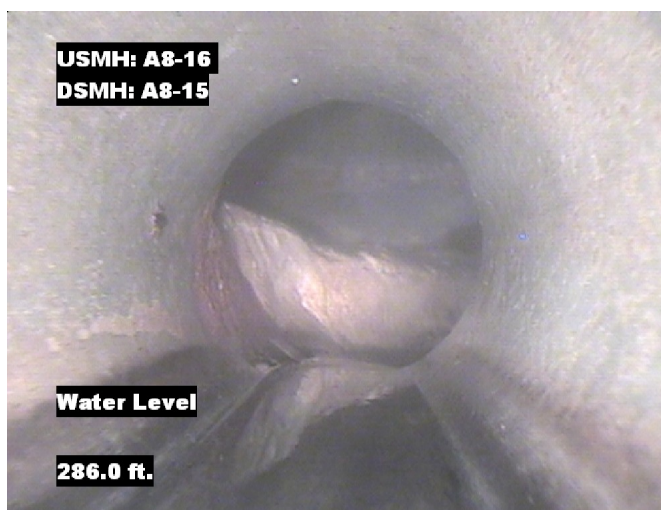
Distance: 285.9 ft. Grade: 0
Condition: Water Level
Remarks: N/A

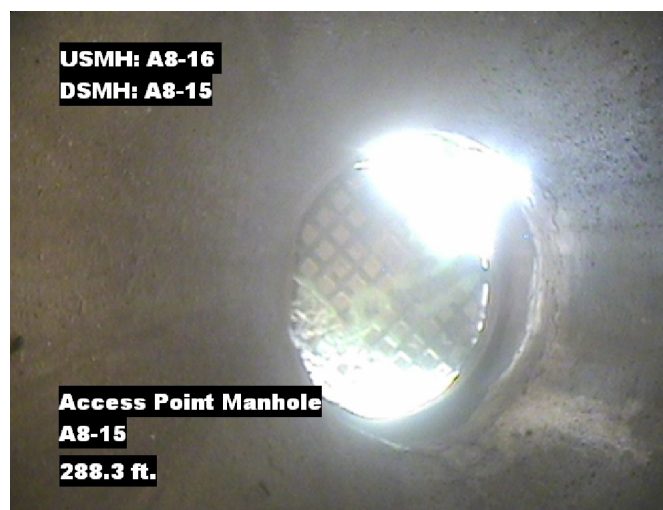
Distance: 288.3 ft. Grade: 0
Condition: Access Point Manhole
Remarks: A8-15
