Defect Listing

Pipe Segment Refere... A8-17_A8-16	City Oliver Springs	Street Walden Rd	Material Concrete Pipe (non-...	Location C... Light High...	Sewer Use Sanitary
Upstream MH A8-17	Total Length 332.9	Year Laid	Shape Circular	Location Details	
DS Manhole A8-16	Length surveyed 332.9	Year Renewed	Height 8	Width 8	Pipe Joint... 4

SPR N/A	MPR 4	PO Number 4397-03	Customer GRW
SPRI N/A	MPRI 2	Work Order 4397-02	Purpose Pre-Rehabilitation Survey
QSR N/A	QMR 2200		
OPR 4	Surveyed By Barry Rogers	Direction Upstream	Date 20150730
OPRI 2	Certificate Number U-1012-16405	Pre-Cleaning Jetting	Time 13:22
	Date Cleaned 20150730	End Time 13:41	Weather Dry
			Media label
			Additional Info

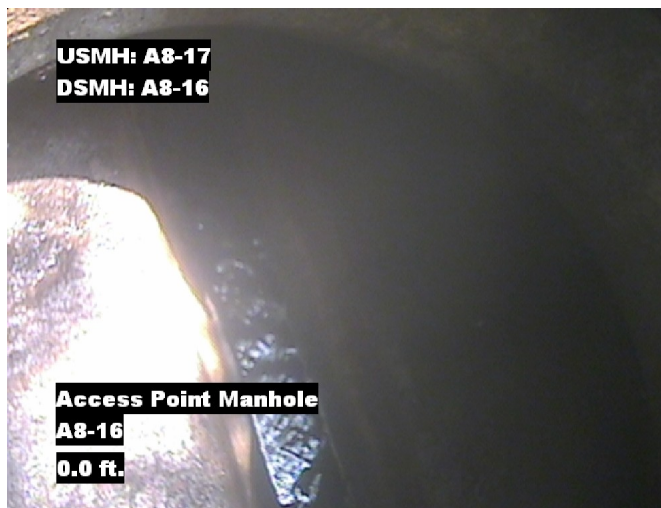
Distance: 0.0 ft. Grade: 0
Condition: Access Point Manhole
Remarks: A8-16

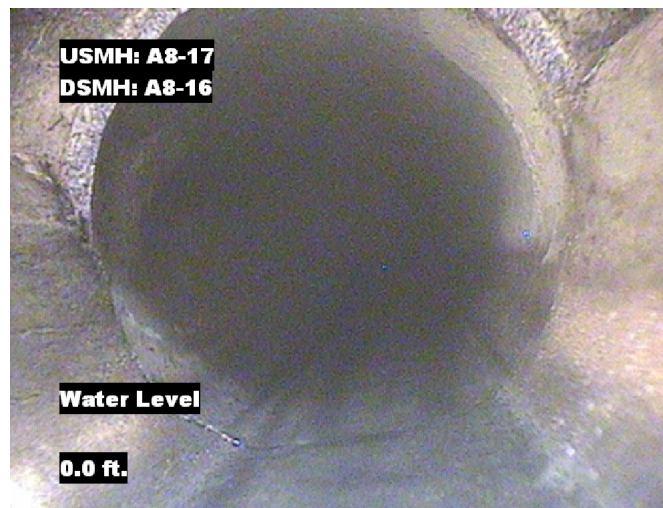
Distance: 0.0 ft. Grade: 0
Condition: Water Level
Remarks: N/A

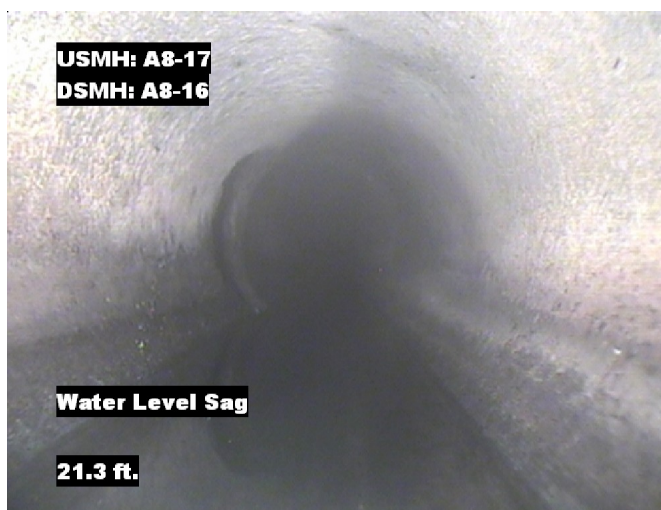
Distance: 21.3 ft. Grade: 2
Condition: Water Level Sag
Remarks: N/A

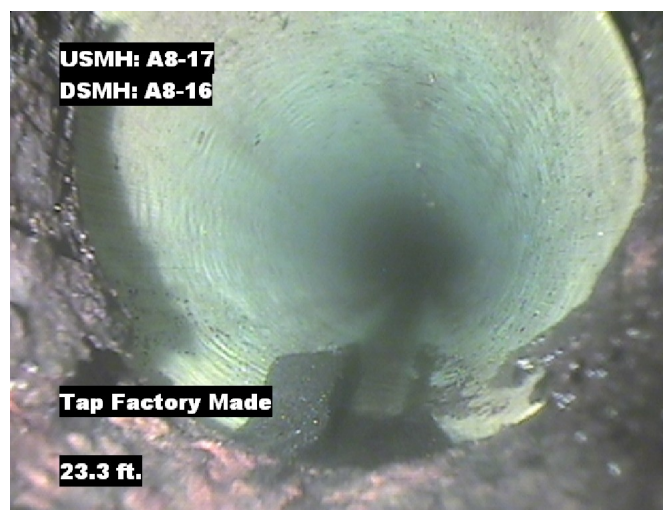
Distance: 23.3 ft. Grade: 0
Condition: Tap Factory Made
Remarks: N/A

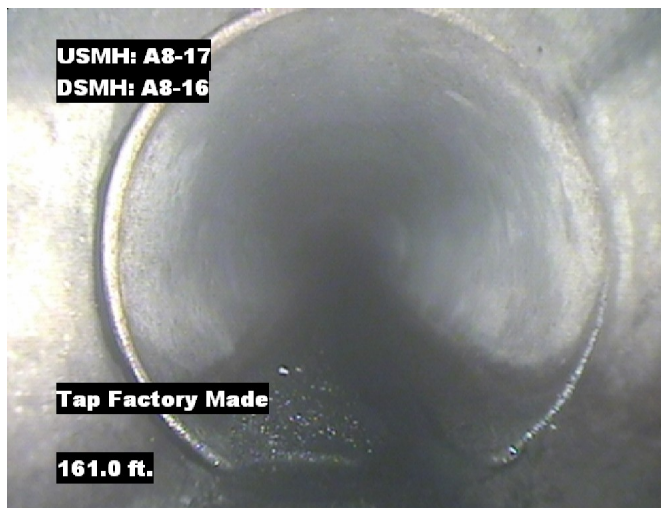
Distance: 161.0 ft. Grade: 0
Condition: Tap Factory Made
Remarks: N/A

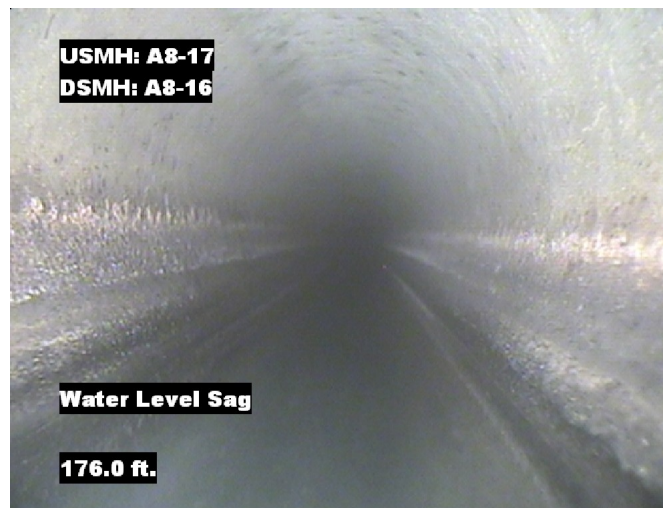
Distance: 176.0 ft. Grade: 2
Condition: Water Level Sag
Remarks: N/A

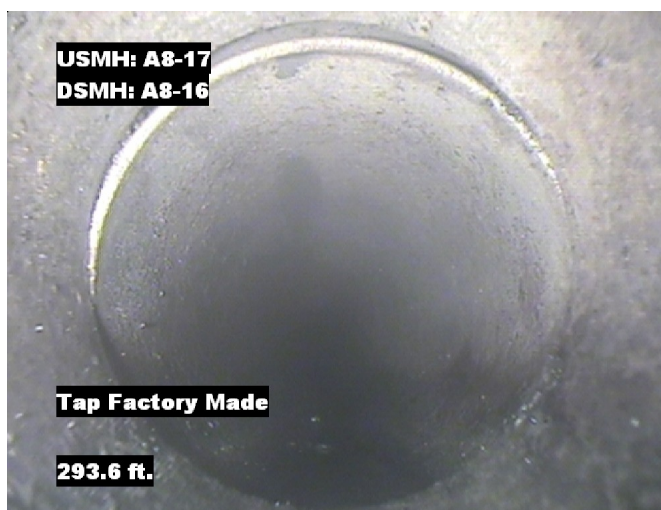
Distance: 293.6 ft. Grade: 0
Condition: Tap Factory Made
Remarks: N/A

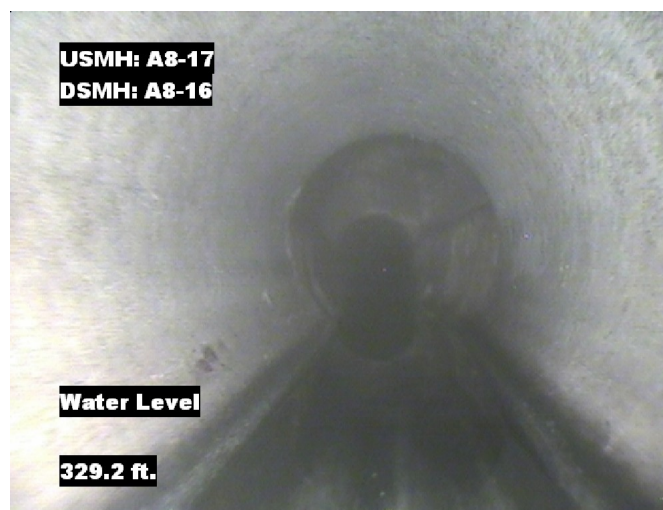
Distance: 329.2 ft. Grade: 0
Condition: Water Level
Remarks: N/A

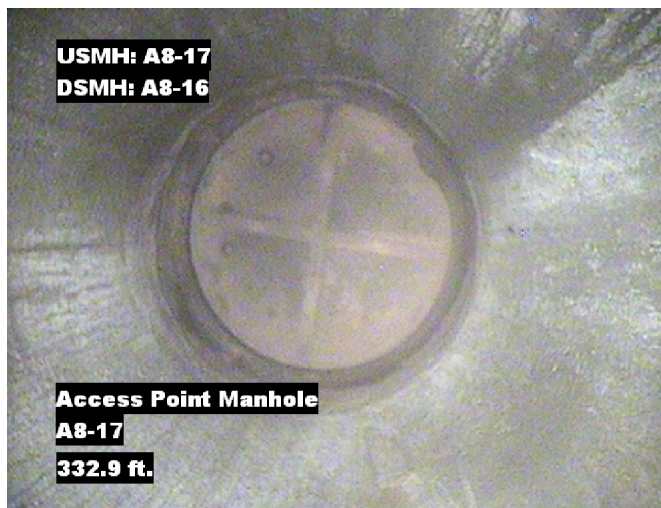
Distance: 332.9 ft. Grade: 0
Condition: Access Point Manhole
Remarks: A8-17
