Defect Listing

Pipe Segment Refere... A8-18_A8-17	City Oliver Springs	Street Walden Rd	Material Concrete Pipe (non-...	Location C... Light High...	Sewer Use Sanitary
Upstream MH A8-18	Total Length 258.6	Year Laid	Shape Circular	Location Details	
DS Manhole A8-17	Length surveyed 258.6	Year Renewed	Height 8	Width 8	Pipe Joint... 4

SPR N/A	MPR 9	PO Number 4397-03	Customer GRW
SPRI N/A	MPRI 2.3	Work Order 4397-02	Purpose Pre-Rehabilitation Survey
QSR N/A	QMR 3123		
OPR 9	Surveyed By Barry Rogers	Direction Downstream	Date 20150730
OPRI 2.3	Certificate Number U-1012-16405	Pre-Cleaning Jetting	Time 12:56
	Date Cleaned 20150730	End Time 13:09	Weather Dry
			Media label
			Additional Info

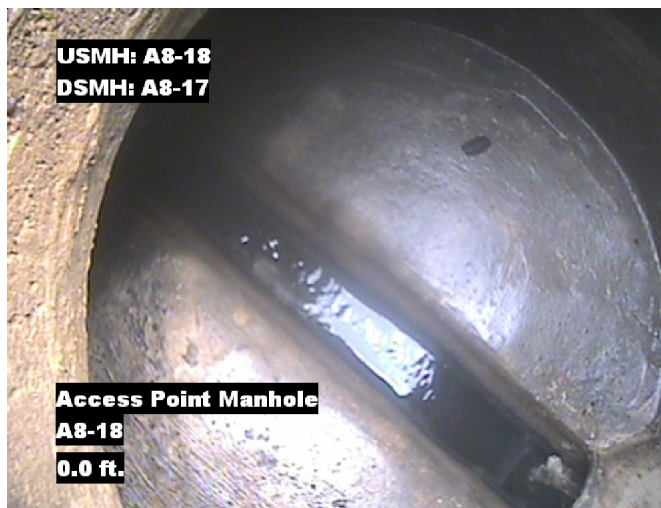
Distance: 0.0 ft. Grade: 0
Condition: Access Point Manhole
Remarks: A8-18

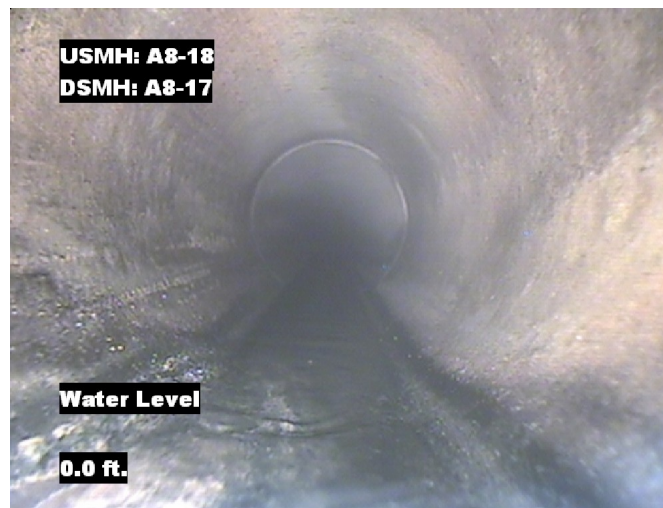
Distance: 0.0 ft. Grade: 0
Condition: Water Level
Remarks: N/A

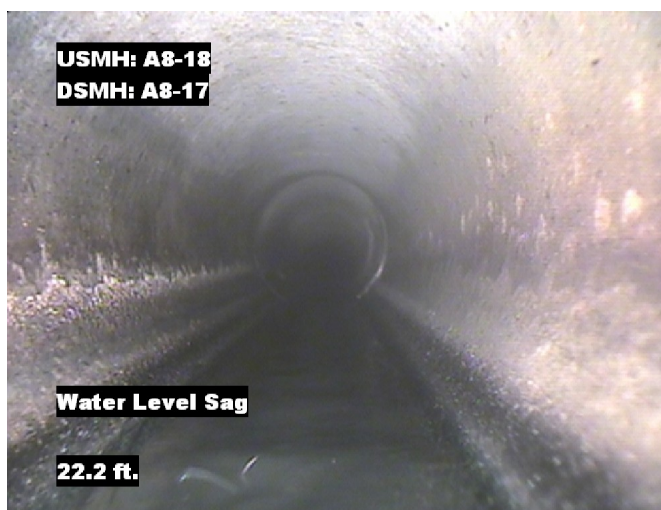
Distance: 22.2 ft. Grade: 2
Condition: Water Level Sag
Remarks: N/A

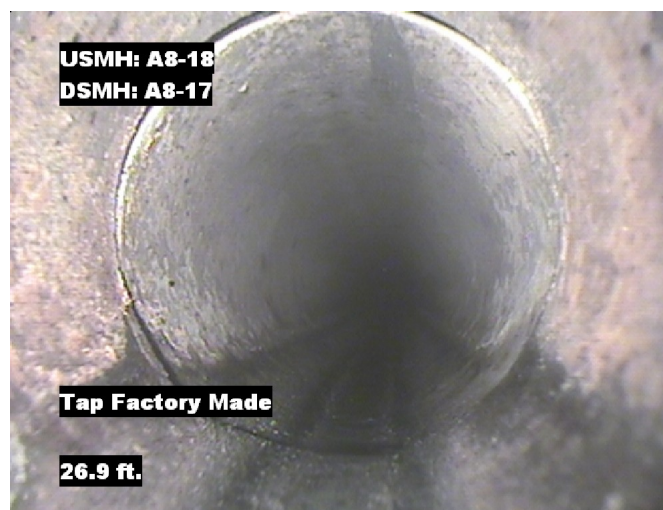
Distance: 26.9 ft. Grade: 0
Condition: Tap Factory Made
Remarks: N/A

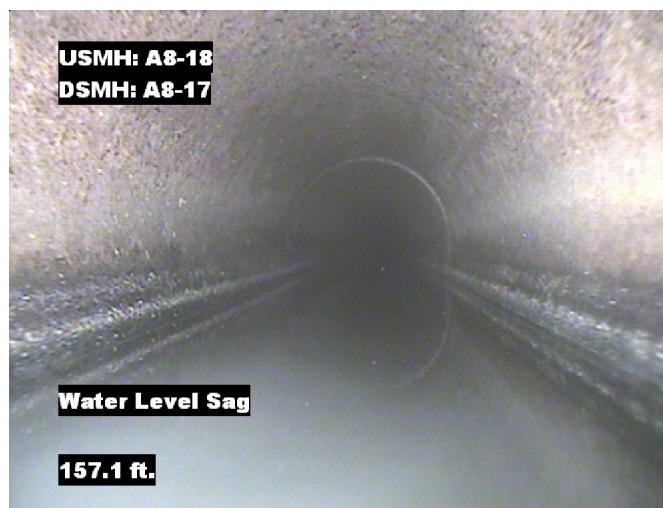
Distance: 157.0 ft. Grade: 2
Condition: Water Level Sag
Remarks: N/A

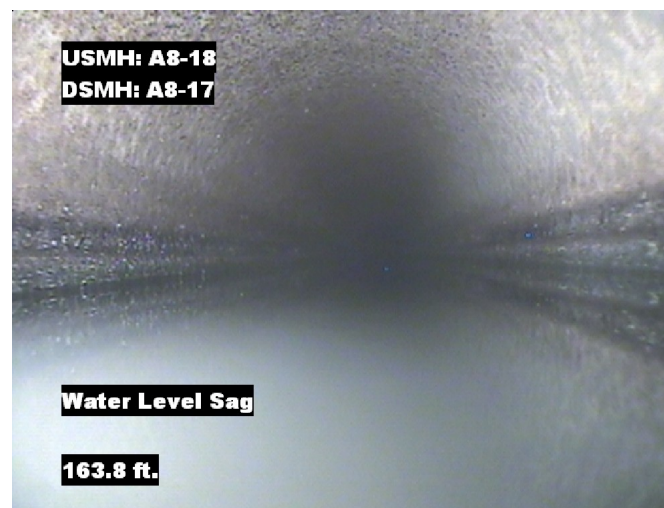
Distance: 163.8 ft. Grade: 3
Condition: Water Level Sag
Remarks: N/A

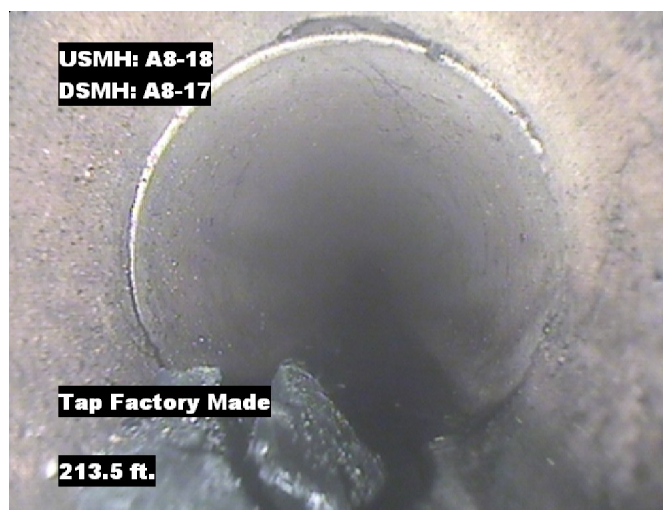
Distance: 213.5 ft. Grade: 0
Condition: Tap Factory Made
Remarks: N/A

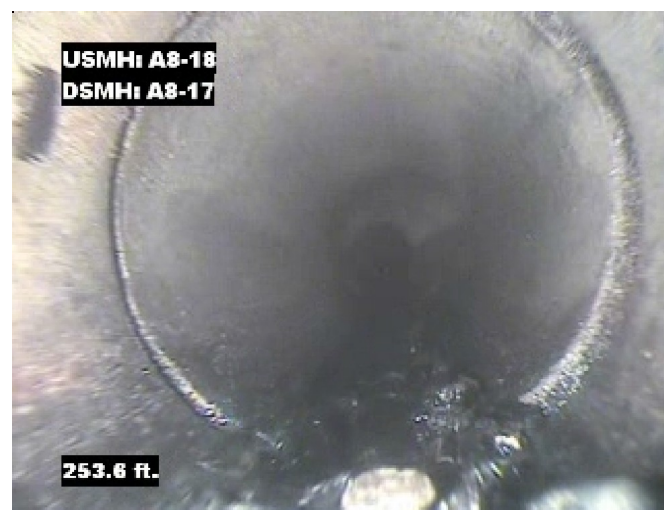
Distance: 253.6 ft. Grade: 2
Condition: Deposits Settled Other
Remarks: ROCKS AN SLUDGE

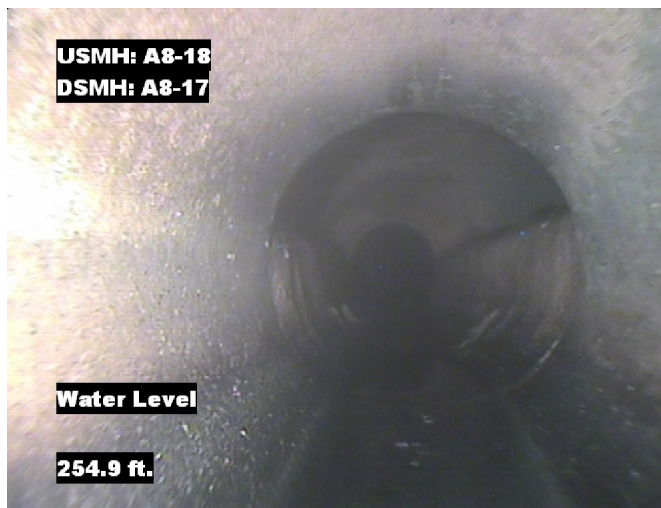
Distance: 254.9 ft. Grade: 0
Condition: Water Level
Remarks: N/A

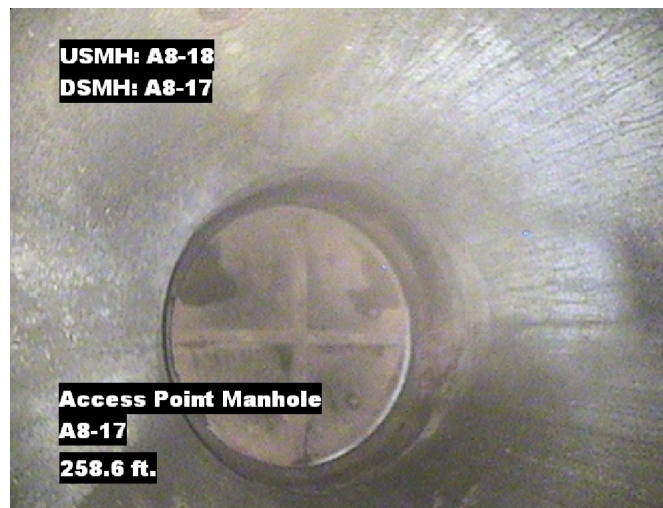
Distance: 258.6 ft. Grade: 0
Condition: Access Point Manhole
Remarks: A8-17
