Defect Listing

Pipe Segment Refere... A8-19_A8-18	City Oliver Springs	Street Walden Rd	Material Concrete Pipe (non-...	Location C... Light High...	Sewer Use Sanitary
Upstream MH A8-19	Total Length 264	Year Laid	Shape Circular	Location Details	
DS Manhole A8-18	Length surveyed 264	Year Renewed	Height 8	Width 8	Pipe Joint... 4

SPR N/A	MPR N/A	PO Number 4397-03	Customer GRW
SPRI N/A	MPRI N/A	Work Order 4397-02	Purpose Pre-Rehabilitation Survey
QSR N/A	QMR N/A		
OPR N/A	Surveyed By Barry Rogers	Direction Upstream	Date 20150730
OPRI N/A	Certificate Number U-1012-16405	Pre-Cleaning Jetting	Time 12:36
	Date Cleaned 20150730	End Time 12:51	Weather Dry
			Additional Info

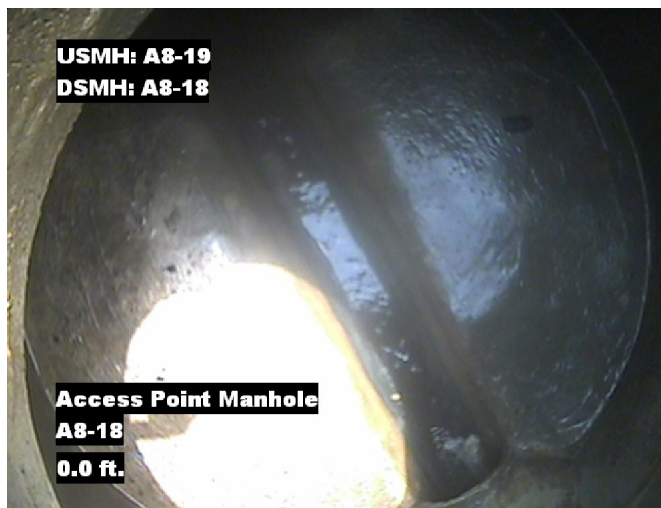
Distance: 0.0 ft. Grade: 0
Condition: Access Point Manhole
Remarks: A8-18

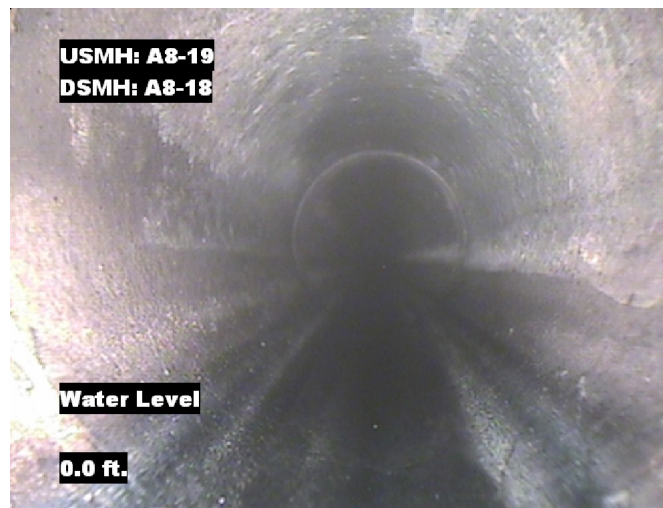
Distance: 0.0 ft. Grade: 0
Condition: Water Level
Remarks: N/A

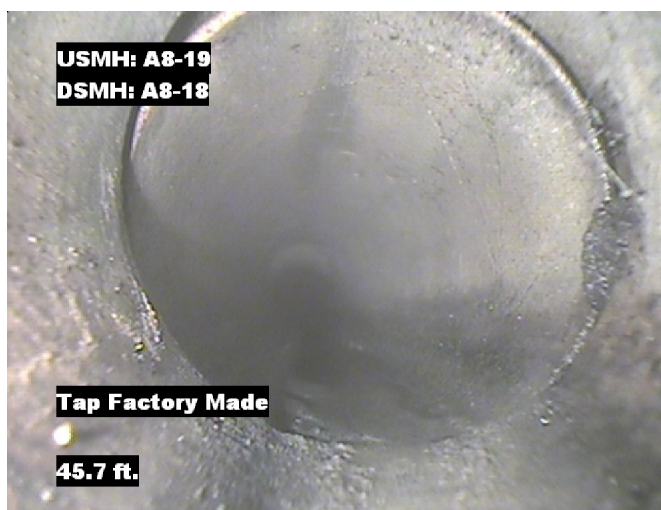
Distance: 45.7 ft. Grade: 0
Condition: Tap Factory Made
Remarks: N/A

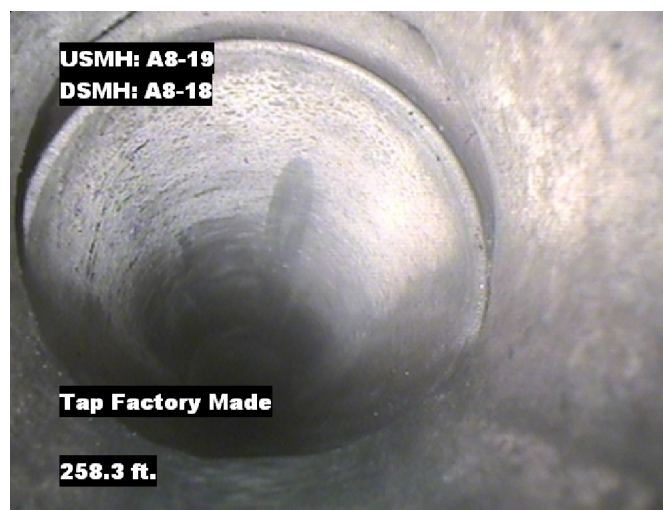
Distance: 258.3 ft. Grade: 0
Condition: Tap Factory Made
Remarks: N/A

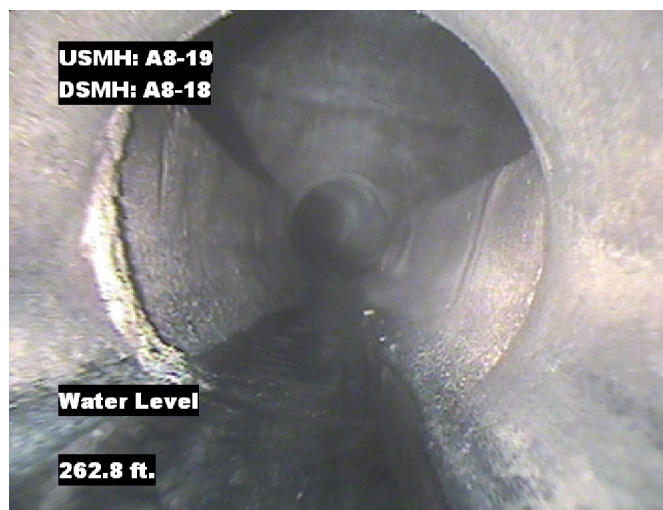
Distance: 262.8 ft. Grade: 0
Condition: Water Level
Remarks: N/A

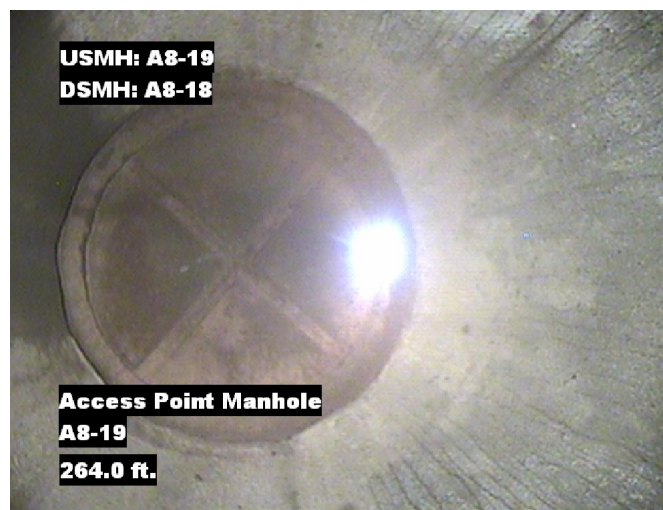
Distance: 264.0 ft. Grade: 0
Condition: Access Point Manhole
Remarks: A8-19
