Defect Listing

Pipe Segment Refere... A8-2_A8-1	City Oliver Springs	Street Central Ave	Material Fibreglass Reinforc...	Location C... Light High...	Sewer Use Sanitary
Upstream MH A8-2	Total Length 210.8	Year Laid	Shape Circular	Location Details	
DS Manhole A8-1	Length surveyed 210.8	Year Renewed	Height 8	Width 8	Pipe Joint... N/A

SPR N/A	MPR 21	PO Number 4397-03	Customer GRW
SPRI N/A	MPRI 2.6	Work Order 4397-02	Purpose Pre-Rehabilitation Survey
QSR N/A	QMR 4231		
OPR 21	Surveyed By Charlie Gordon	Direction Downstream	Date 20150818
OPRI 2.6	Certificate Number U-615-07000491	Pre-Cleaning Jetting	Time 08:15
	Date Cleaned 20150818	End Time 08:29	Weather Damp
			Media label
			Additional Info

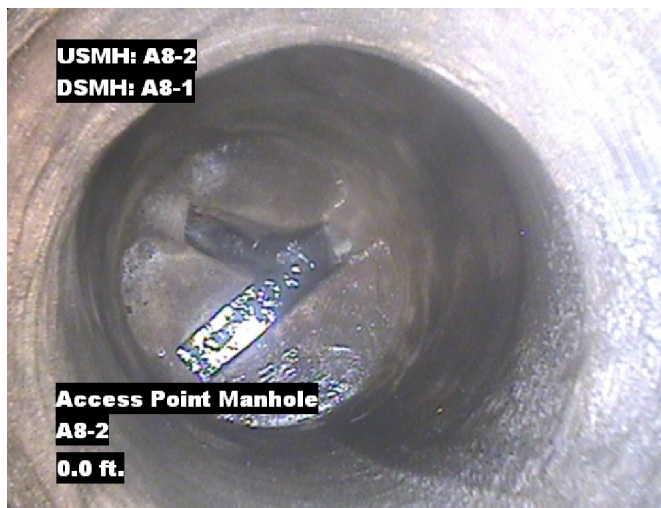
Distance: 0.0 ft. Grade: 0
Condition: Access Point Manhole
Remarks: A8-2

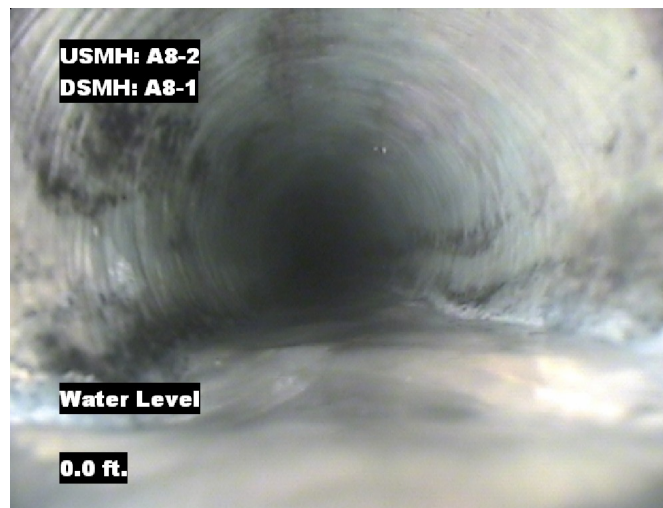
Distance: 0.0 ft. Grade: 0
Condition: Water Level
Remarks: N/A

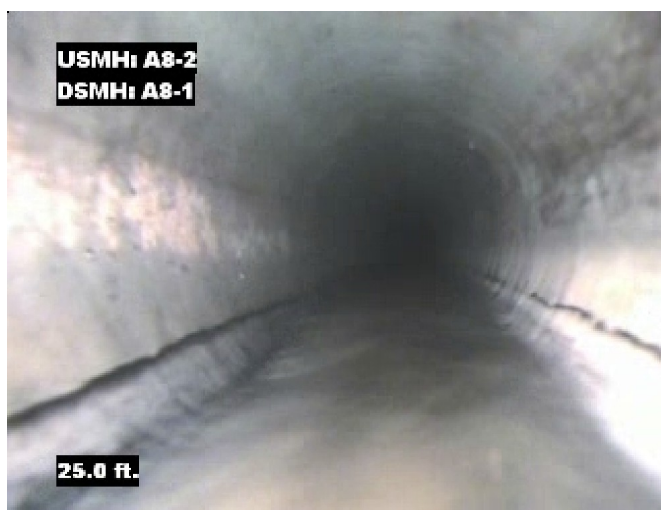
Distance: 25.0 ft. Grade: 2
Condition: Deposits Attached Grease
Remarks: N/A

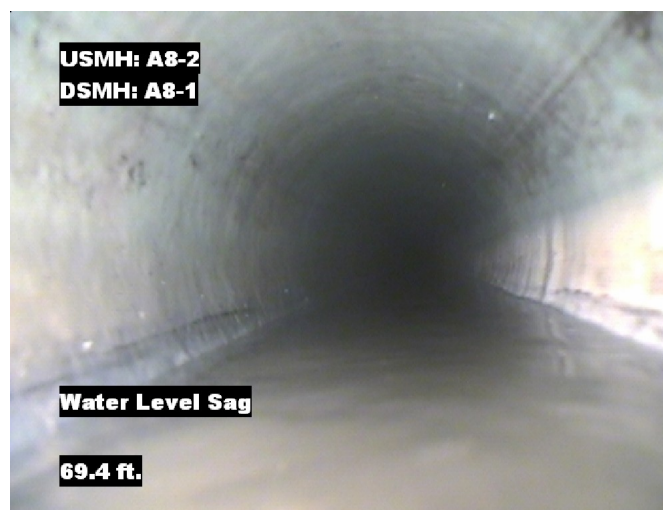
Distance: 69.4 ft. Grade: 2
Condition: Water Level Sag
Remarks: N/A

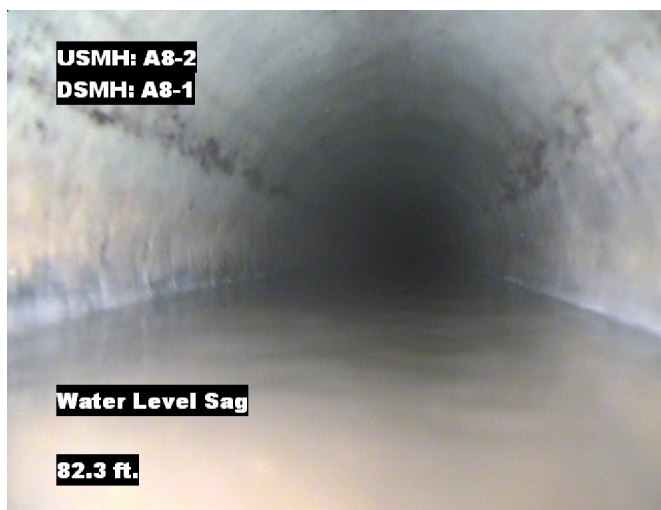
Distance: 82.3 ft. Grade: 2
Condition: Water Level Sag
Remarks: N/A

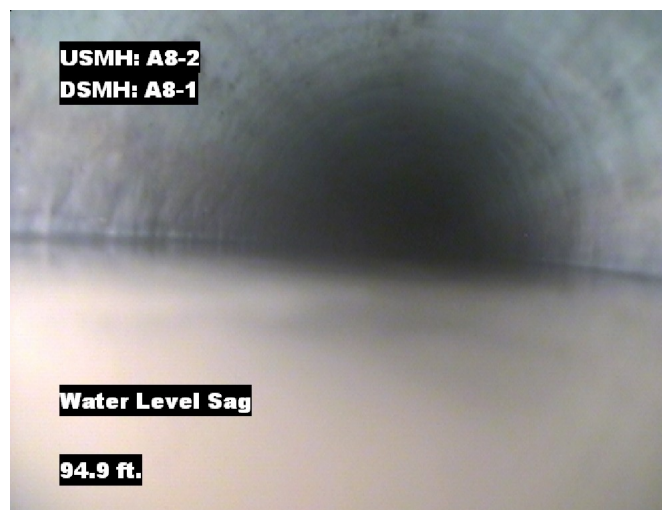
Distance: 94.9 ft. Grade: 3
Condition: Water Level Sag
Remarks: N/A

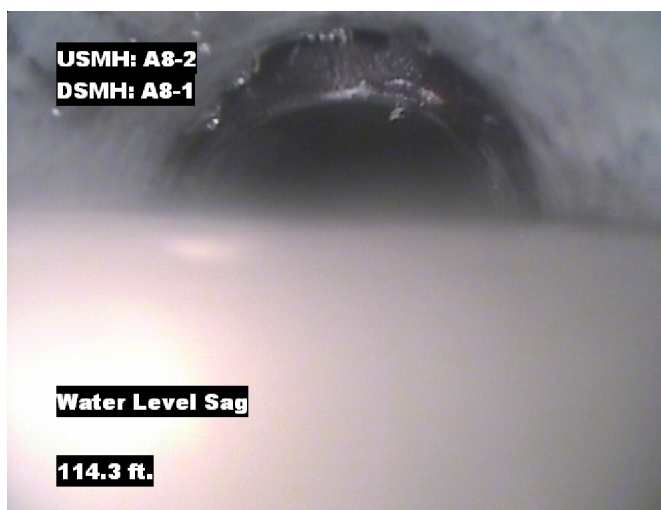
Distance: 114.3 ft. Grade: 4
Condition: Water Level Sag
Remarks: N/A

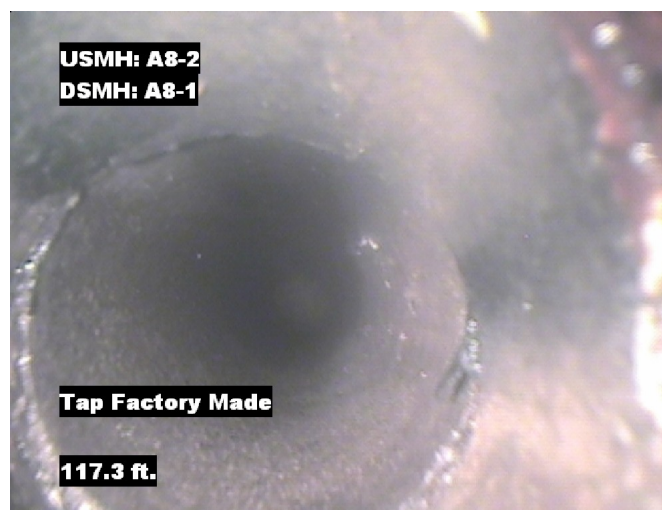
Distance: 117.3 ft. Grade: 0
Condition: Tap Factory Made
Remarks: N/A

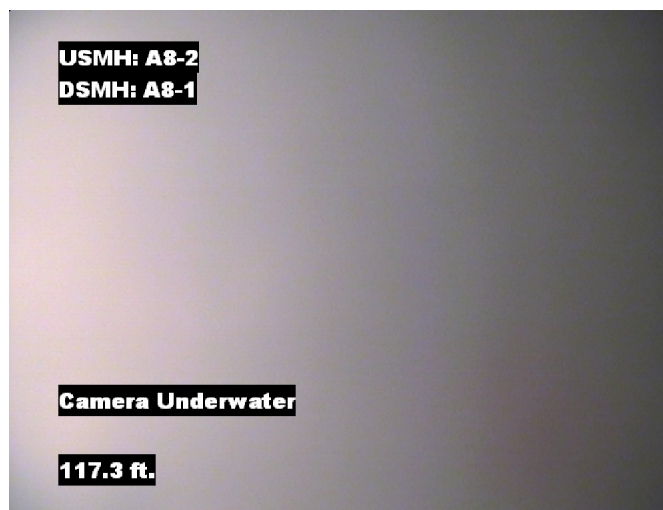
Distance: 117.3 ft. Grade: 4
Condition: Camera Underwater
Remarks: N/A

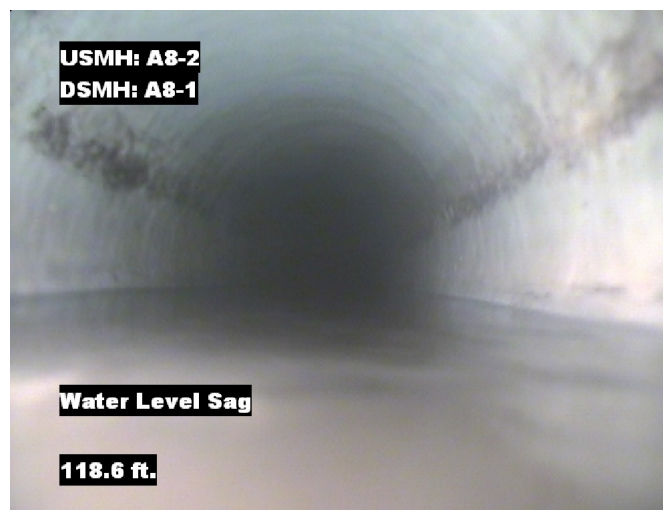
Distance: 118.6 ft. Grade: 2
Condition: Water Level Sag
Remarks: N/A

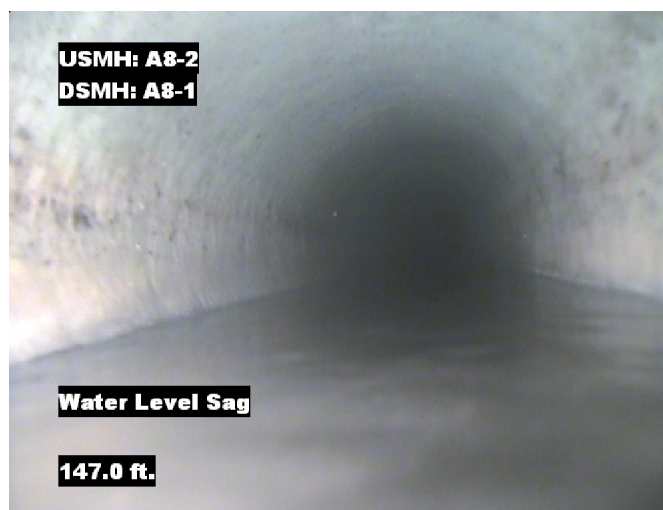
Distance: 147.0 ft. Grade: 2
Condition: Water Level Sag
Remarks: N/A

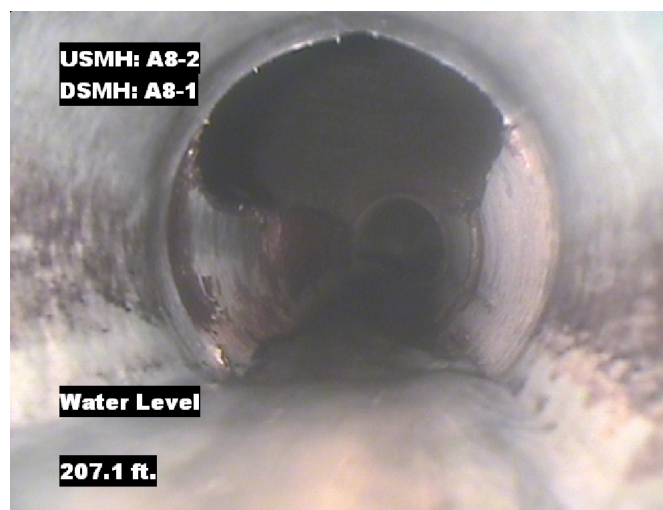
Distance: 207.1 ft. Grade: 0
Condition: Water Level
Remarks: N/A

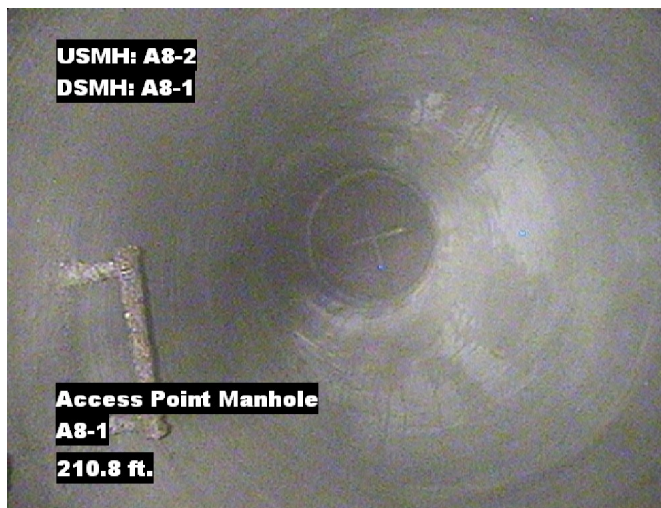
Distance: 210.8 ft. Grade: 0
Condition: Access Point Manhole
Remarks: A8-1
