Defect Listing

Pipe Segment Refere... A8-20_A8-19	City Oliver Springs	Street Walden Rd	Material Concrete Pipe (non-...	Location C... Light High...	Sewer Use Sanitary
Upstream MH A8-20	Total Length 216.1	Year Laid	Shape Circular	Location Details	
DS Manhole A8-19	Length surveyed 216.1	Year Renewed	Height 8	Width 8	Pipe Joint... 4

SPR N/A	MPR 2	PO Number 4397-03	Customer GRW
SPRI N/A	MPRI 2	Work Order 4397-02	Purpose Pre-Rehabilitation Survey
QSR N/A	QMR 2100		
OPR 2	Surveyed By Barry Rogers	Direction Downstream	Date 20150730
OPRI 2	Certificate Number U-1012-16405	Pre-Cleaning Jetting	Time 10:55
	Date Cleaned 20150730	End Time 11:06	Weather Dry
		Additional Info

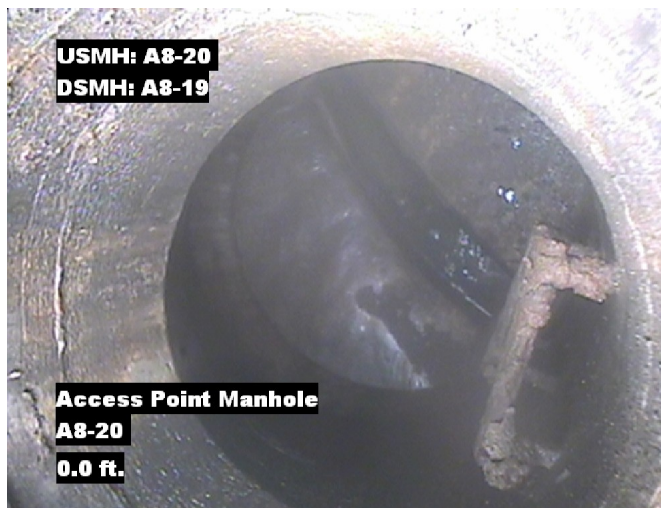
Distance: 0.0 ft. Grade: 0
Condition: Access Point Manhole
Remarks: A8-20

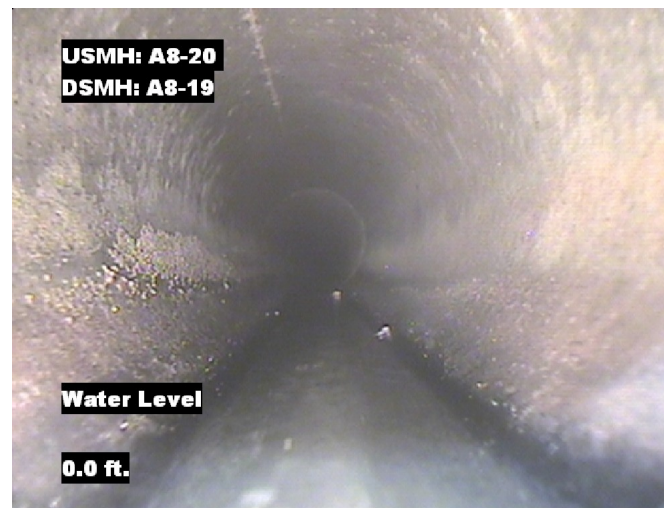
Distance: 0.0 ft. Grade: 0
Condition: Water Level
Remarks: N/A

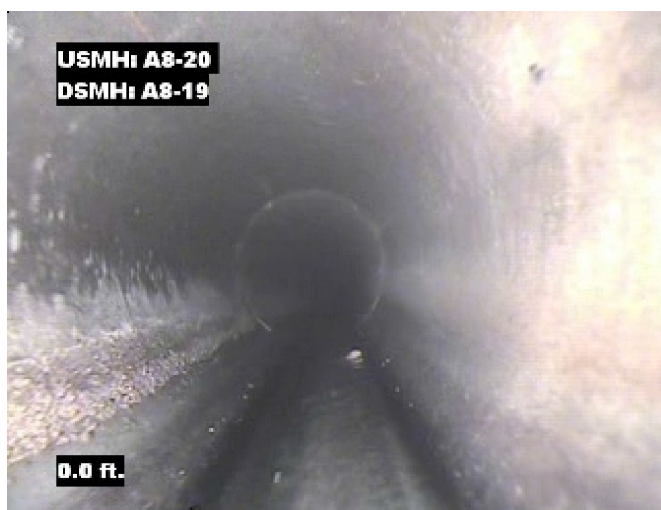
Distance: 2.0 ft. Grade: 2
Condition: Deposits Attached Grease
Remarks: THIS A CONTINUOUS DEFECT

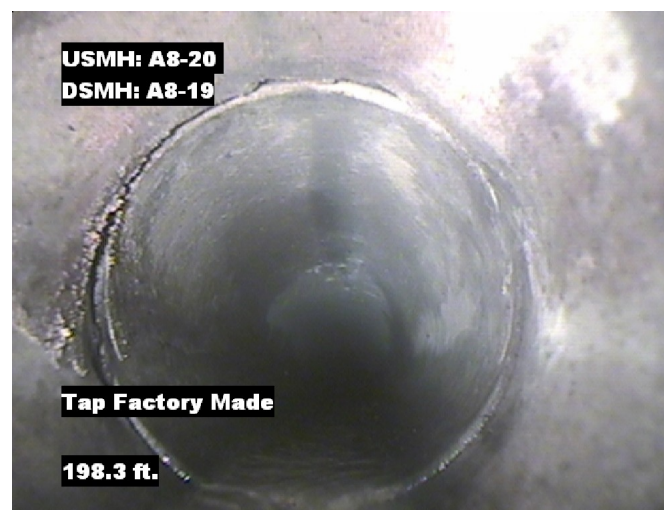
Distance: 198.3 ft. Grade: 0
Condition: Tap Factory Made
Remarks: N/A

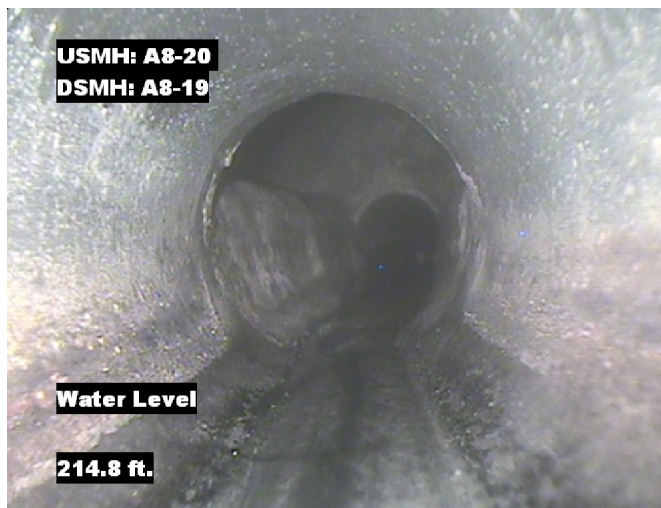
Distance: 214.8 ft. Grade: 0
Condition: Water Level
Remarks: N/A

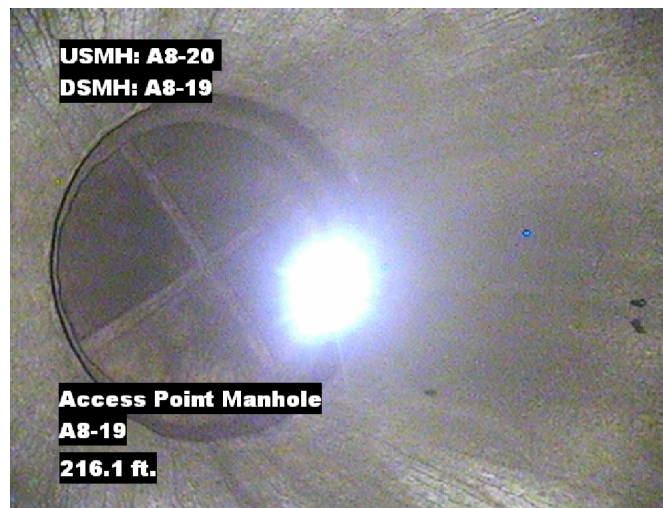
Distance: 216.1 ft. Grade: 0
Condition: Access Point Manhole
Remarks: A8-19
