Defect Listing

| Pipe Segment Refere... A8-21_A8-20 | City Oliver Springs | Street Walden Rd | Material Concrete Pipe (non-... | Location C... Light High... | Sewer Use Sanitary |

| SPRI N/A | MPRI N/A | Work Order 4397-02 | | Purpose Pre-Rehabilitation Survey | |

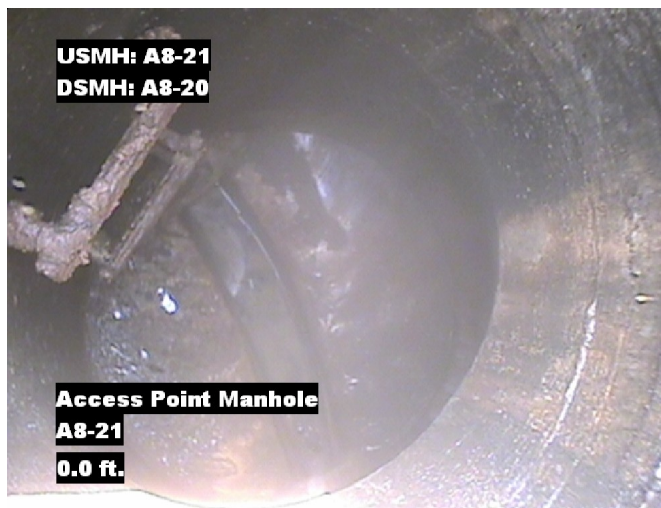
Distance: 0.0 ft. Grade: 0
Condition: Access Point Manhole
Remarks: A8-21

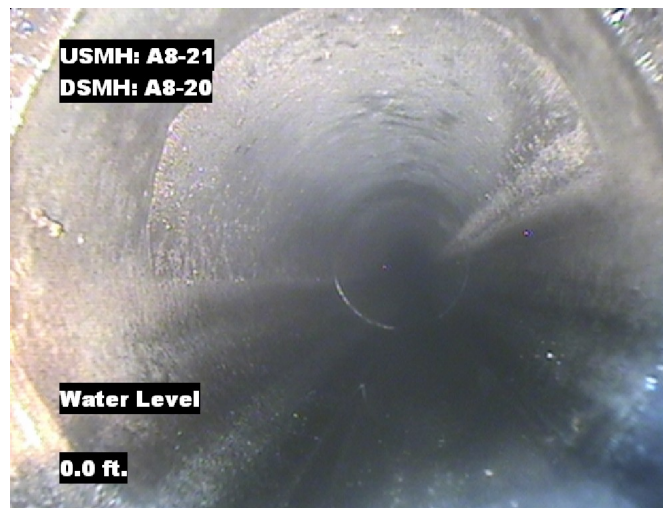
Distance: 0.0 ft. Grade: 0
Condition: Water Level
Remarks: N/A

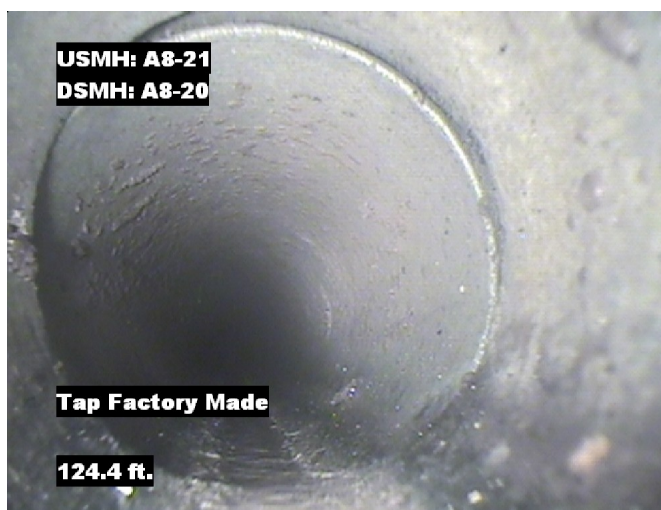
Distance: 124.4 ft. Grade: 0
Condition: Tap Factory Made
Remarks: N/A

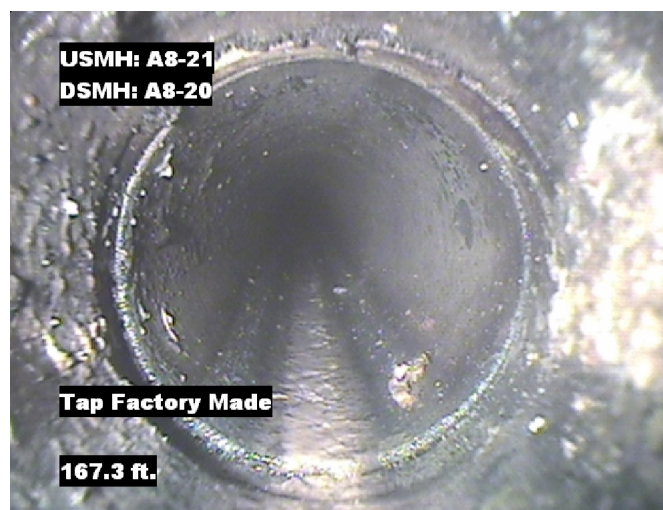
Distance: 167.3 ft. Grade: 0
Condition: Tap Factory Made
Remarks: N/A

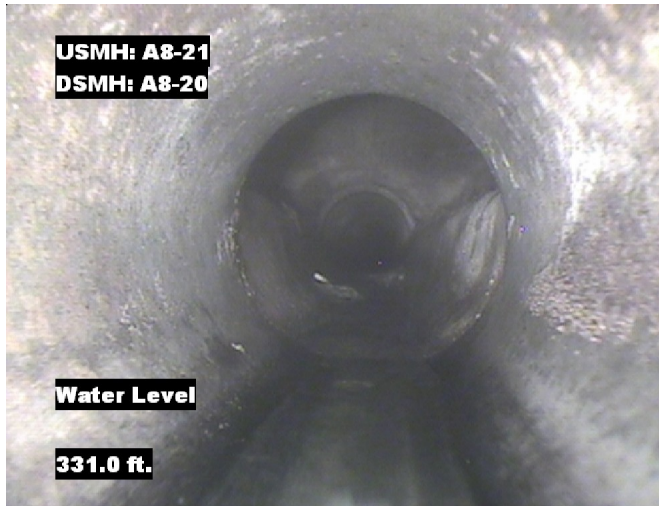
Distance: 330.9 ft. Grade: 0
Condition: Water Level
Remarks: N/A

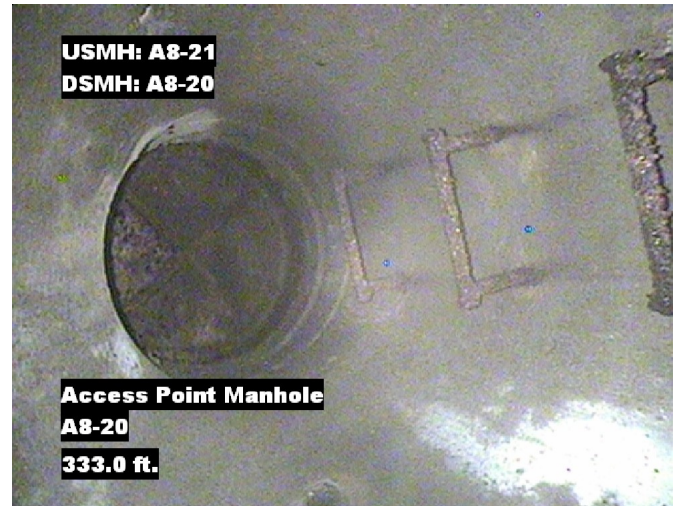
Distance: 333.0 ft. Grade: 0
Condition: Access Point Manhole
Remarks: A8-20
