## Defect Listing

Pipe Segment Refere... <b>A8-22_A8-21</b>	City <b>Oliver Springs</b>	Street <b>Walden Rd.</b>	Material <b>Concrete Pipe (non-...</b>	Location C... <b>Light High...</b>	Sewer Use <b>Sanitary</b>
Upstream MH <b>A8-22</b>	Total Length <b>330.6</b>	Year Laid	Shape <b>Circular</b>	Location Details	
DS Manhole <b>A8-21</b>	Length surveyed <b>330.6</b>	Year Renewed	Height <b>8</b>	Width <b>8</b>	Pipe Joint... <b>4</b>

SPR <b>N/A</b>	MPR <b>2</b>	PO Number <b>4397-03</b>	Customer <b>GRW</b>
SPRI <b>N/A</b>	MPRI <b>2</b>	Work Order <b>4397-02</b>	Purpose <b>Pre-Rehabilitation Survey</b>
QSR <b>N/A</b>	QMR <b>2100</b>		
OPR <b>2</b>	Surveyed By <b>Barry Rogers</b>	Direction <b>Downstream</b>	Date <b>20150730</b>
OPRI <b>2</b>	Certificate Number <b>U-1012-16405</b>	Pre-Cleaning <b>Jetting</b>	Time <b>09:42</b>
	Date Cleaned <b>20150730</b>	End Time <b>10:02</b>	Weather <b>Dry</b>
		Additional Info

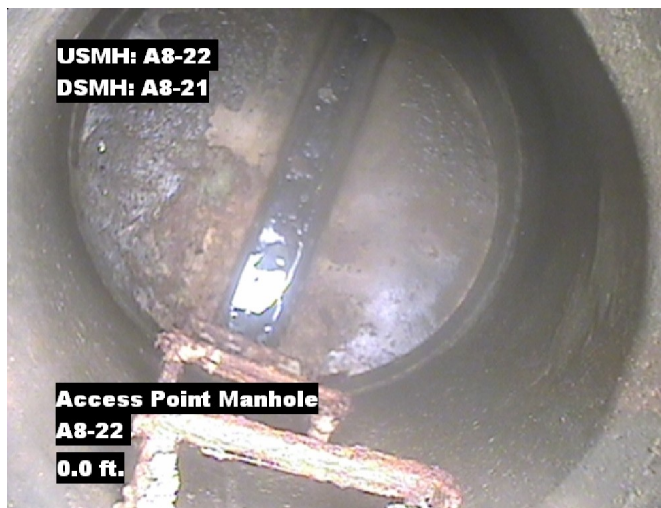
Distance: 0.0 ft. Grade: 0  
Condition: Access Point Manhole  
Remarks: A8-22

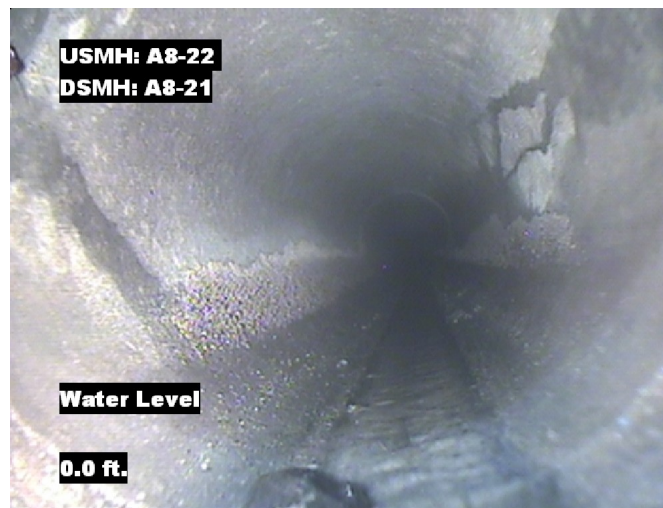
Distance: 0.0 ft. Grade: 0  
Condition: Water Level  
Remarks: N/A

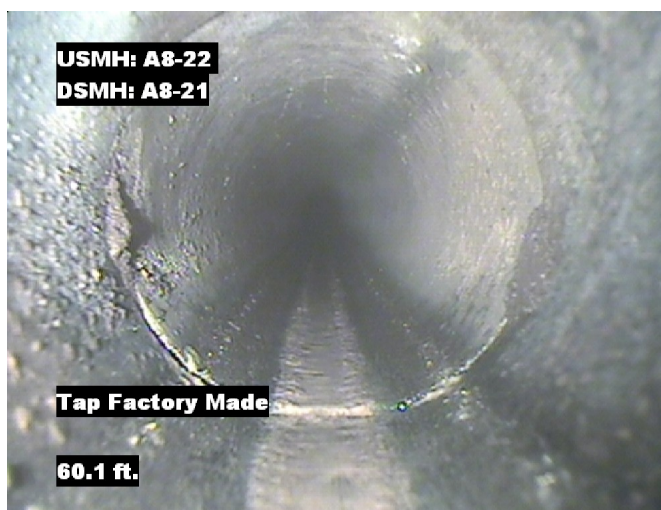
Distance: 60.1 ft. Grade: 0  
Condition: Tap Factory Made  
Remarks: N/A

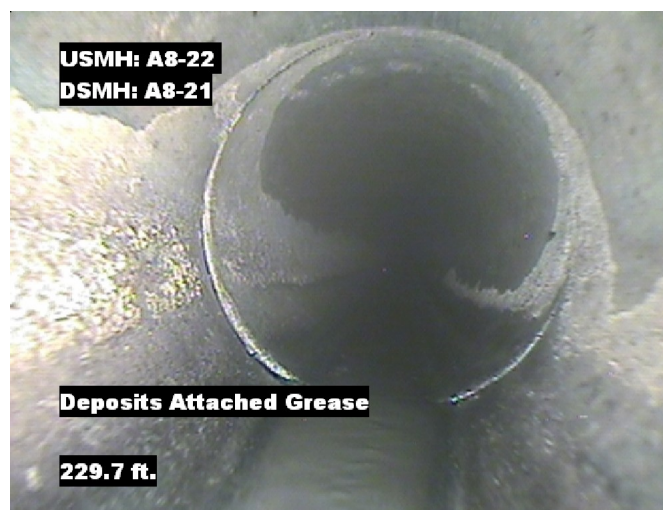
Distance: 229.7 ft. Grade: 2  
Condition: Deposits Attached Grease  
Remarks: N/A

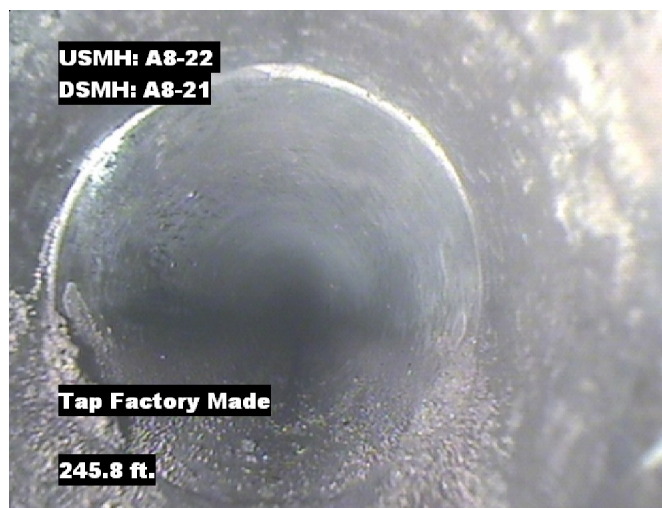
Distance: 245.8 ft. Grade: 0  
Condition: Tap Factory Made  
Remarks: N/A

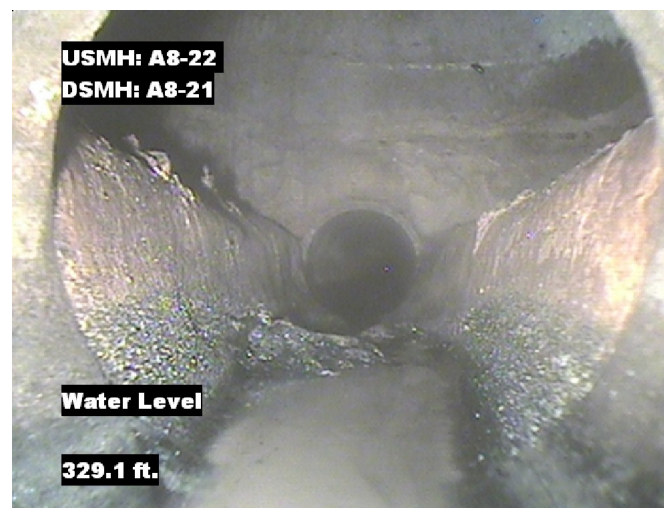
Distance: 329.1 ft. Grade: 0  
Condition: Water Level  
Remarks: N/A

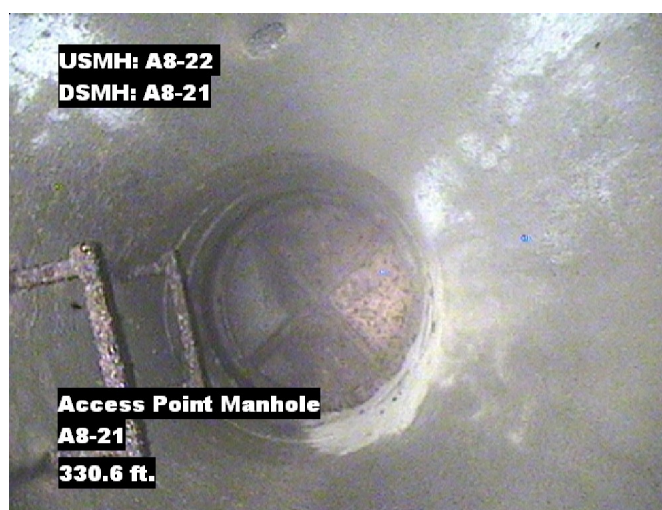
Distance: 330.6 ft. Grade: 0  
Condition: Access Point Manhole  
Remarks: A8-21
