Defect Listing

Pipe Segment Refere... A8-23_A8-22	City Oliver Springs	Street Walden Rd	Material Concrete Pipe (non-...	Location C... Light High...	Sewer Use Sanitary
Upstream MH A8-23	Total Length 319.1	Year Laid	Shape Circular	Location Details	
DS Manhole A8-22	Length surveyed 319.1	Year Renewed	Height 8	Width 8	Pipe Joint... 4

SPR N/A	MPR N/A	PO Number 4397-03	Customer GRW
SPRI N/A	MPRI N/A	Work Order 4397-02	Purpose Pre-Rehabilitation Survey
QSR N/A	QMR N/A		
OPR N/A	Surveyed By Barry Rogers	Direction Downstream	Date 20150730
OPRI N/A	Certificate Number U-1012-16405	Pre-Cleaning Jetting	Time 08:56
	Date Cleaned 20150730	End Time 09:13	Weather Dry
			Additional Info

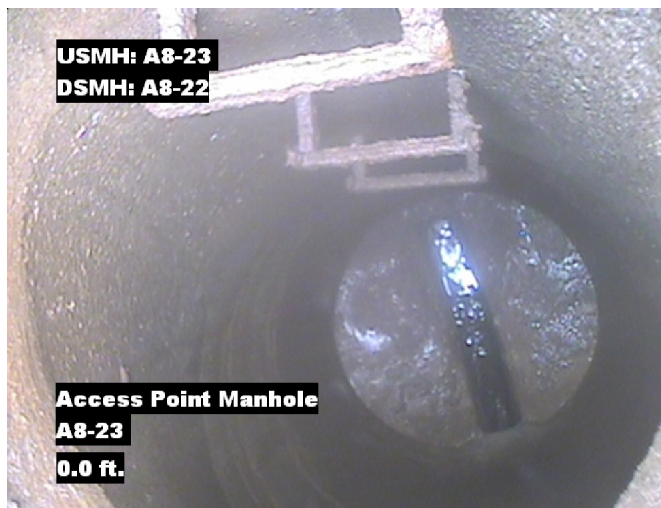
Distance: 0.0 ft. Grade: 0
Condition: Access Point Manhole
Remarks: A8-23

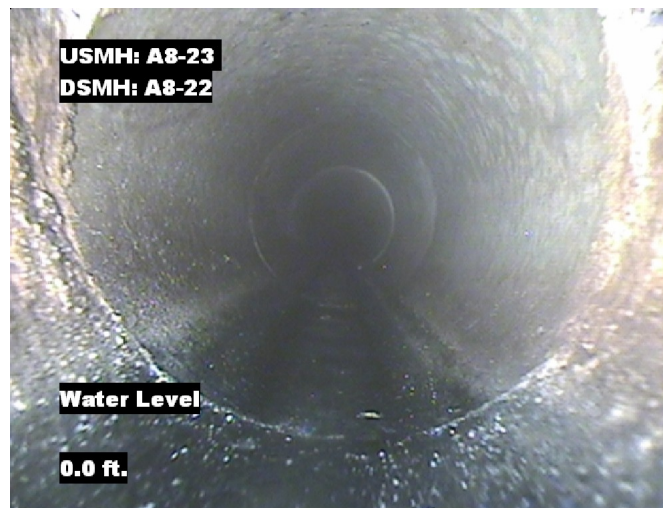
Distance: 0.0 ft. Grade: 0
Condition: Water Level
Remarks: N/A

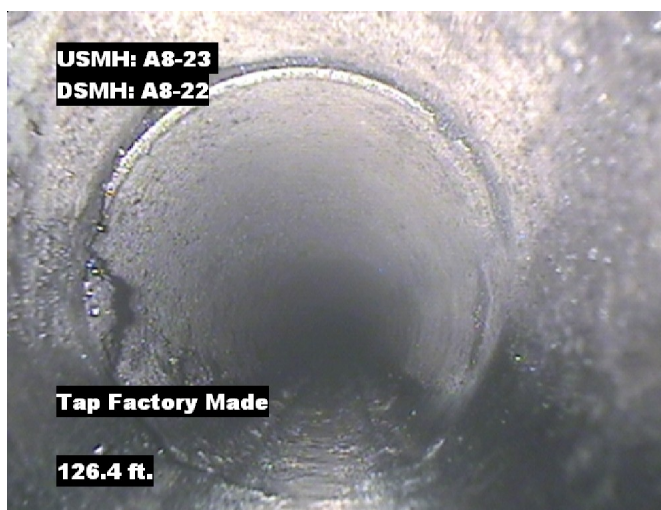
Distance: 126.4 ft. Grade: 0
Condition: Tap Factory Made
Remarks: N/A

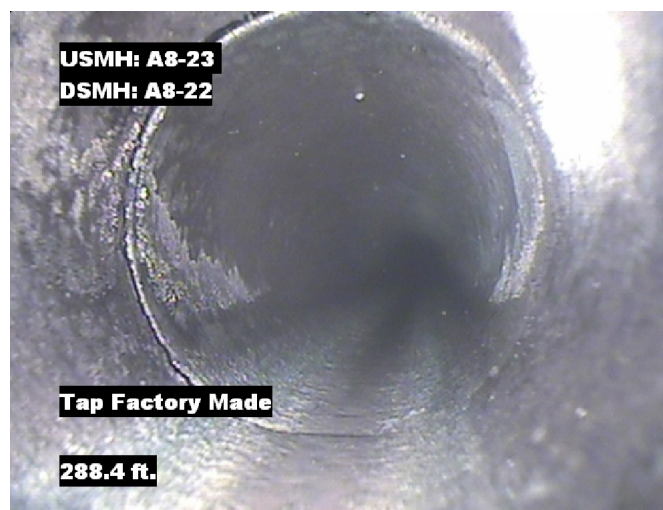
Distance: 288.4 ft. Grade: 0
Condition: Tap Factory Made
Remarks: N/A

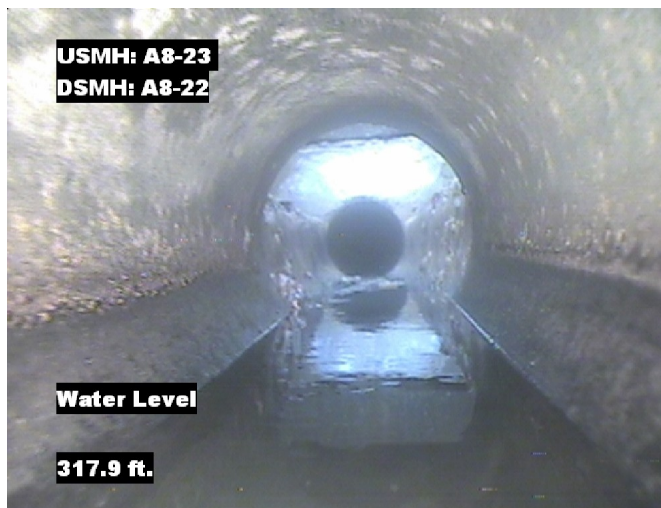
Distance: 317.9 ft. Grade: 0
Condition: Water Level
Remarks: N/A

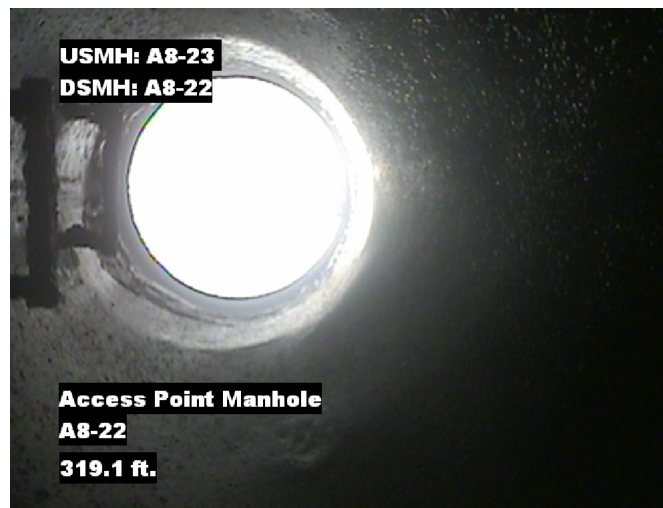
Distance: 319.1 ft. Grade: 0
Condition: Access Point Manhole
Remarks: A8-22
