Defect Listing

Pipe Segment Refere... A8-24_A8-23	City Oliver Springs	Street Walden Rd	Material Concrete Pipe (non-...	Location C... Light High...	Sewer Use Sanitary
Upstream MH A8-24	Total Length 317.5	Year Laid	Shape Circular	Location Details	
DS Manhole A8-23	Length surveyed 317.5	Year Renewed	Height 8	Width 8	Pipe Joint... 4

SPR N/A	MPR N/A	PO Number 4397-03	Customer GRW
SPRI N/A	MPRI N/A	Work Order 4397-02	Purpose Pre-Rehabilitation Survey
QSR N/A	QMR N/A		
OPR N/A	Surveyed By Barry Rogers	Direction Downstream	Date 20150730
OPRI N/A	Certificate Number U-1012-16405	Pre-Cleaning Jetting	Time 07:54
	Date Cleaned 20150730	End Time 08:29	Weather Dry
			Additional Info

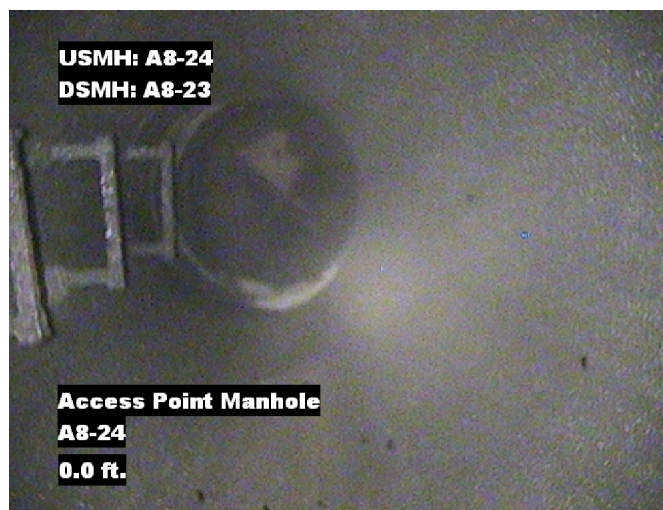
Distance: 0.0 ft. Grade: 0
Condition: Access Point Manhole
Remarks: A8-24

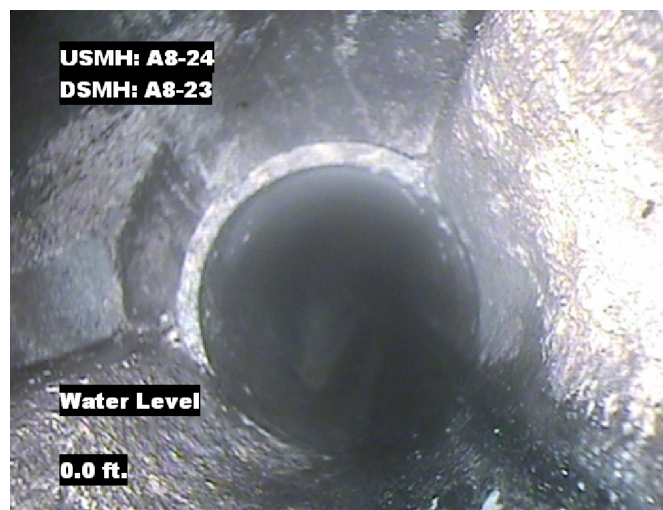
Distance: 0.0 ft. Grade: 0
Condition: Water Level
Remarks: N/A

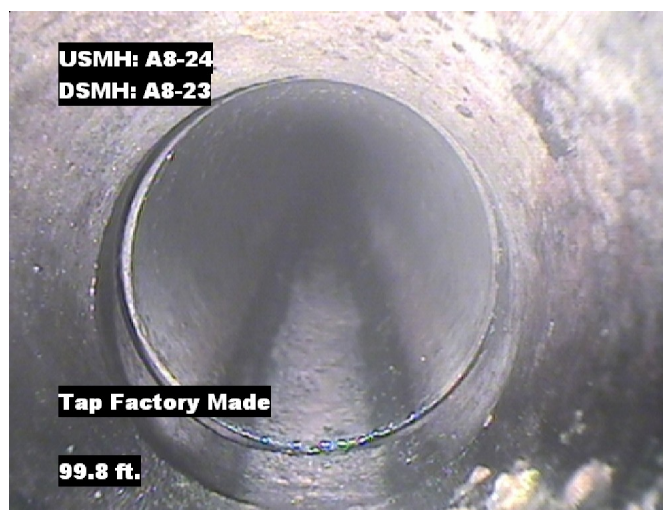
Distance: 99.8 ft. Grade: 0
Condition: Tap Factory Made
Remarks: N/A

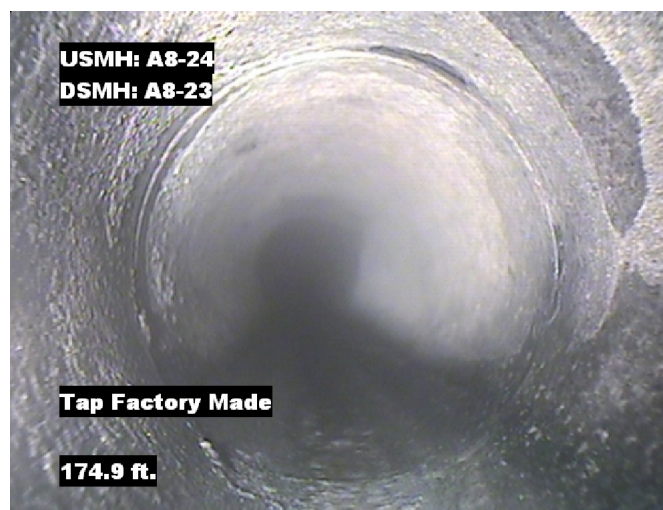
Distance: 174.9 ft. Grade: 0
Condition: Tap Factory Made
Remarks: N/A

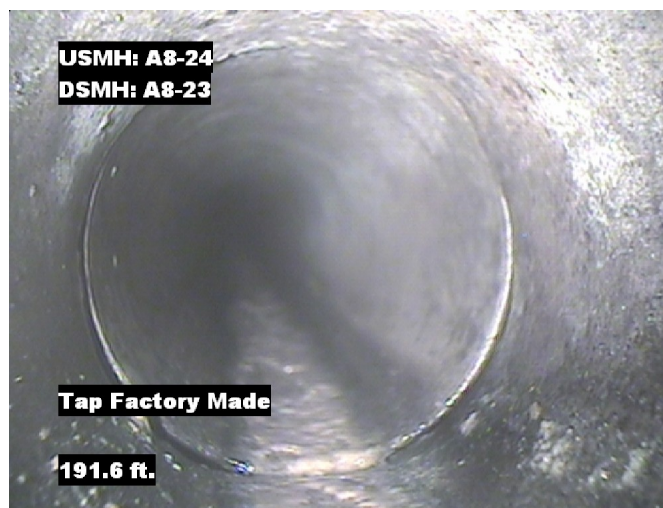
Distance: 191.6 ft. Grade: 0
Condition: Tap Factory Made
Remarks: N/A

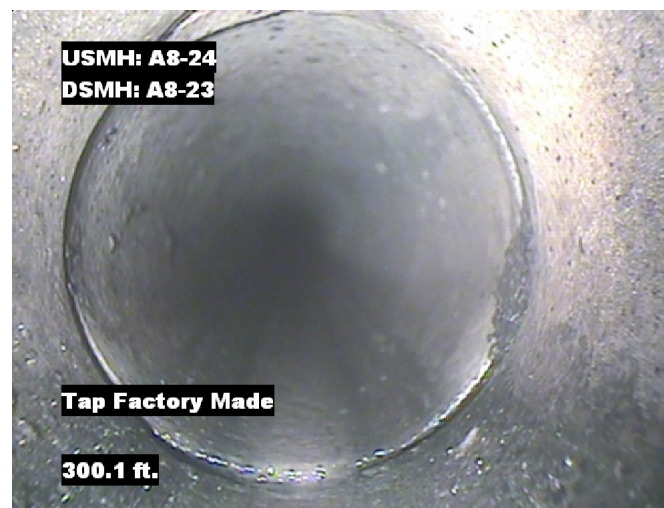
Distance: 300.1 ft. Grade: 0
Condition: Tap Factory Made
Remarks: N/A

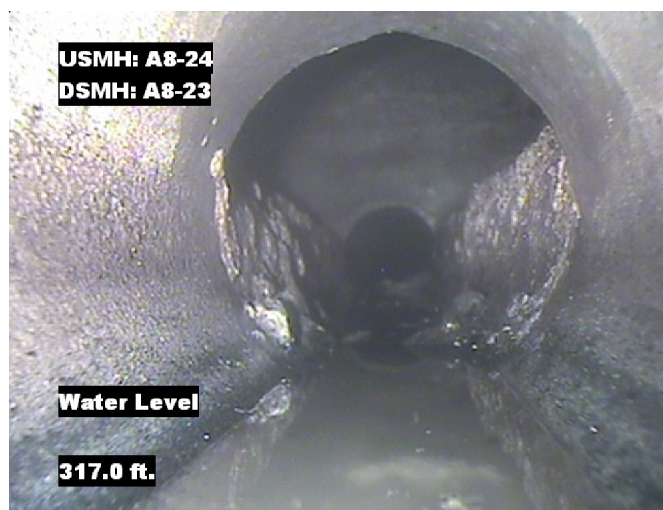
Distance: 317.0 ft. Grade: 0
Condition: Water Level
Remarks: N/A

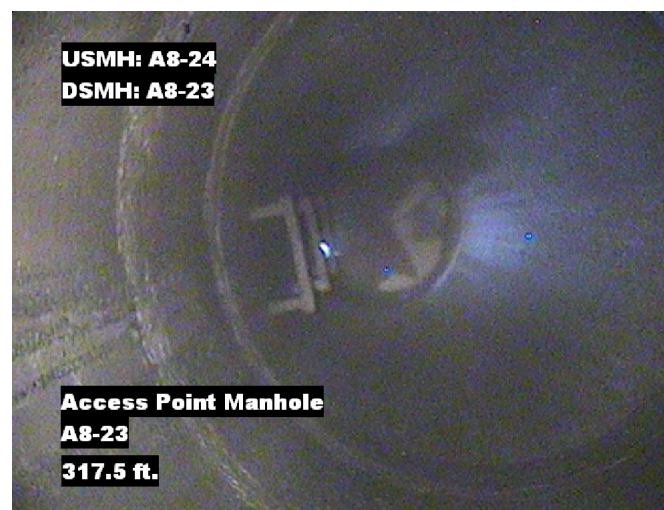
Distance: 317.5 ft. Grade: 0
Condition: Access Point Manhole
Remarks: A8-23
